DEVELOPING AN EVALUATION PROTOCOL FOR THE TORONTO PUBLIC LIBRARY (TPL)
SYSTEM THROUGH THE APPLICATION OF A BUILDING PERFORMANCE EVALUATION
(BPE) OF A BRANCH LIBRARY TO INFORM ITS RETROFIT STRATEGY

A Major Research Project
presented to Ryerson University

in partial fulfillment of the requirements
for the degree of Master of Building Science
in the program of Building Science

Toronto, Ontario, Canada, 2019

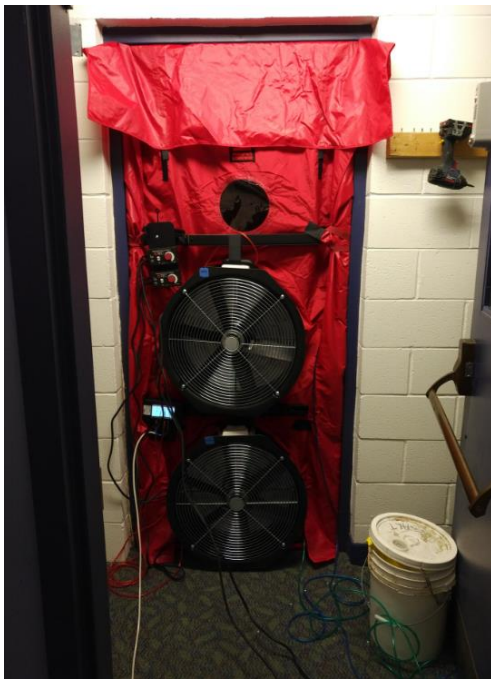
Figure 15 – Blower Door Set Up

Figure 15 shows the blower door setup. Figures 16 to 18 illustrate examples of sealed openings in the building enclosure.

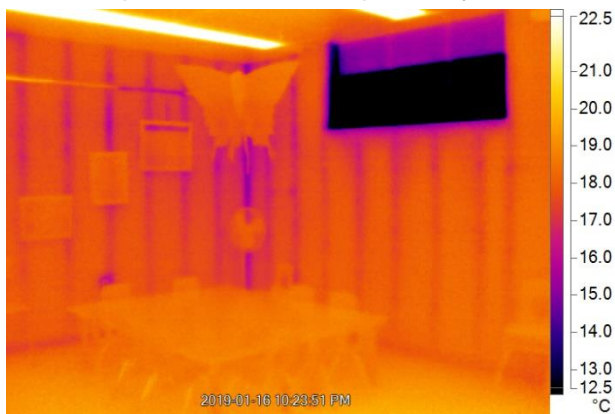
Figure 21 – Program Meeting Room, Pressurization

Thermography identifies thermal anomalies in the building enclosure (e.g., thermal bridges, exfiltration/infiltration, incorrectly installed services). Figures 21 and 22 show thermal bridges

through the steel studs in the basement of the Program Meeting Room during pressurization and depressurization, respectively.

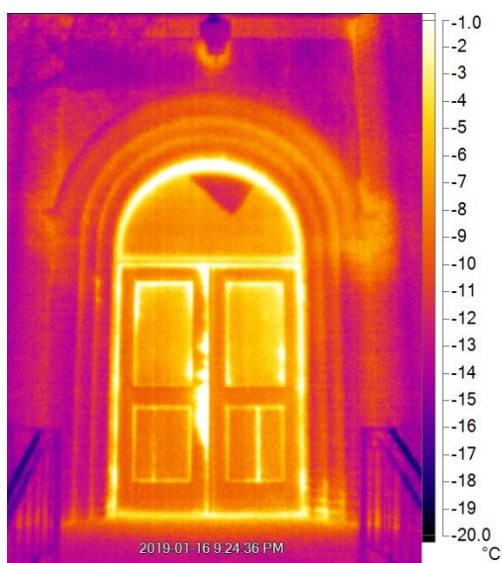
Figure 23 – Emergency Exit, Pressurization

Figures 23 and 24 illustrate air leakage through the emergency exit from the Adult Zone during pressurization and depressurization, respectively.

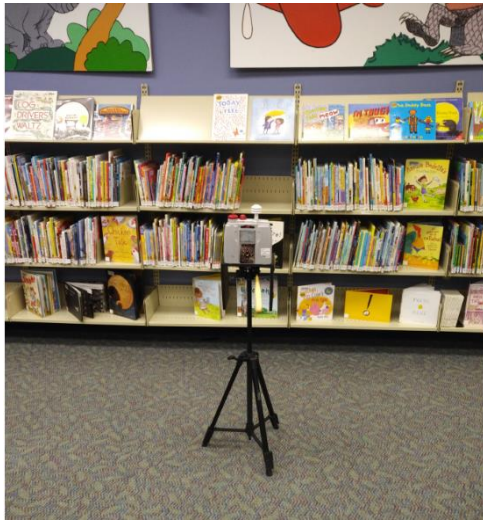
Figure 27 – Children Zone, South Stack

Spot measurements of IEQ and IAQ parameters, with the exception of lighting and noise levels, were collected at 17 sampling locations in the library during a six-day period, from February 21 to 23, and from March 16 to 18, 2019. Measurements were taken from approximately 3 pm to 5 pm on February 21, and 2:30 pm to 4:30 pm on February 22 and February 23. During the March sampling, measurements were recorded from approximately 2:00 pm to 4:00 pm daily. The researcher noticed lingering odours and stale air occasionally and high noise levels frequently when sampling the IEQ and IAQ parameters. Figures 27 to 30 show examples of several sampling locations.

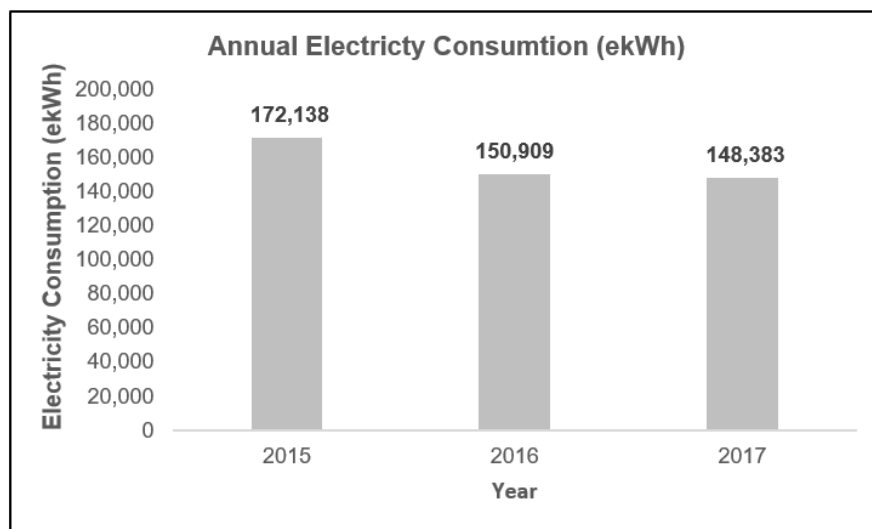
Figure 35 – Annual Electricity Consumption

Figures 35 illustrates the annual electricity consumption from 2015 to 2017. Electricity consumption in 2016 and 2017 decreased from 2015 levels by 12% and 14%, respectively. Similar to natural gas consumption, the reasons for the variations in electricity consumption from year to year could not be determined conclusively. The impact of weather could not account for the variation. The number of cooling degree days (CDD) (°C) in 2015, 2016 and 2017 were 351, 566 and 349, respectively (Environment Canada, ND). Based solely on the CDD, one would expect the electricity consumption to increase rather than decrease from 2015 to 2016. The changeout of the chiller to an RTU may have contributed to the decreased consumption between 2015 and 2017.

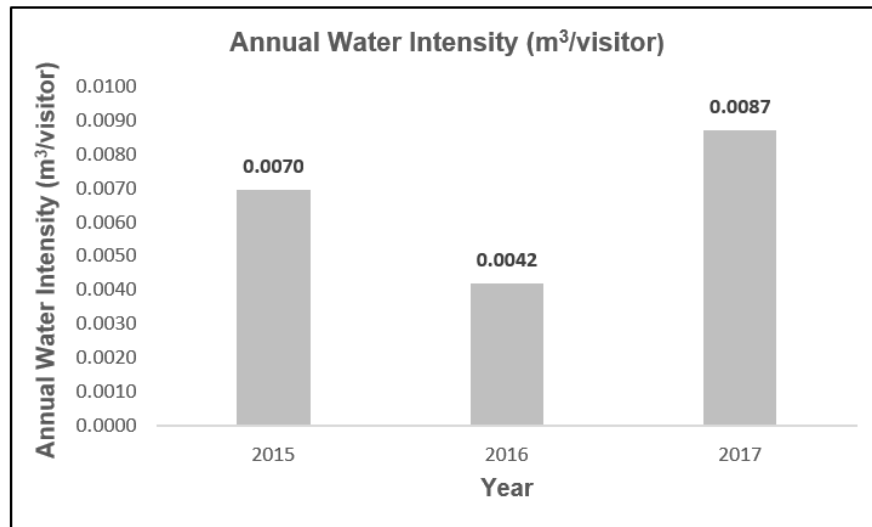
Figure 42 – Annual Water Intensity by Visitor

Figure 42 depicts the 2015 to 2017 annual water intensities by visitor (i.e., m³/visitor). Compared to the 2015 annual water intensity, the 2016 value decreased by 40% and the 2017 value increased by 25%. The annual number of visitors increased by 12% in 2016 and decreased by 7% in 2017 compared to 2015 figures. These changes accounted for some of the variation in the water intensities.

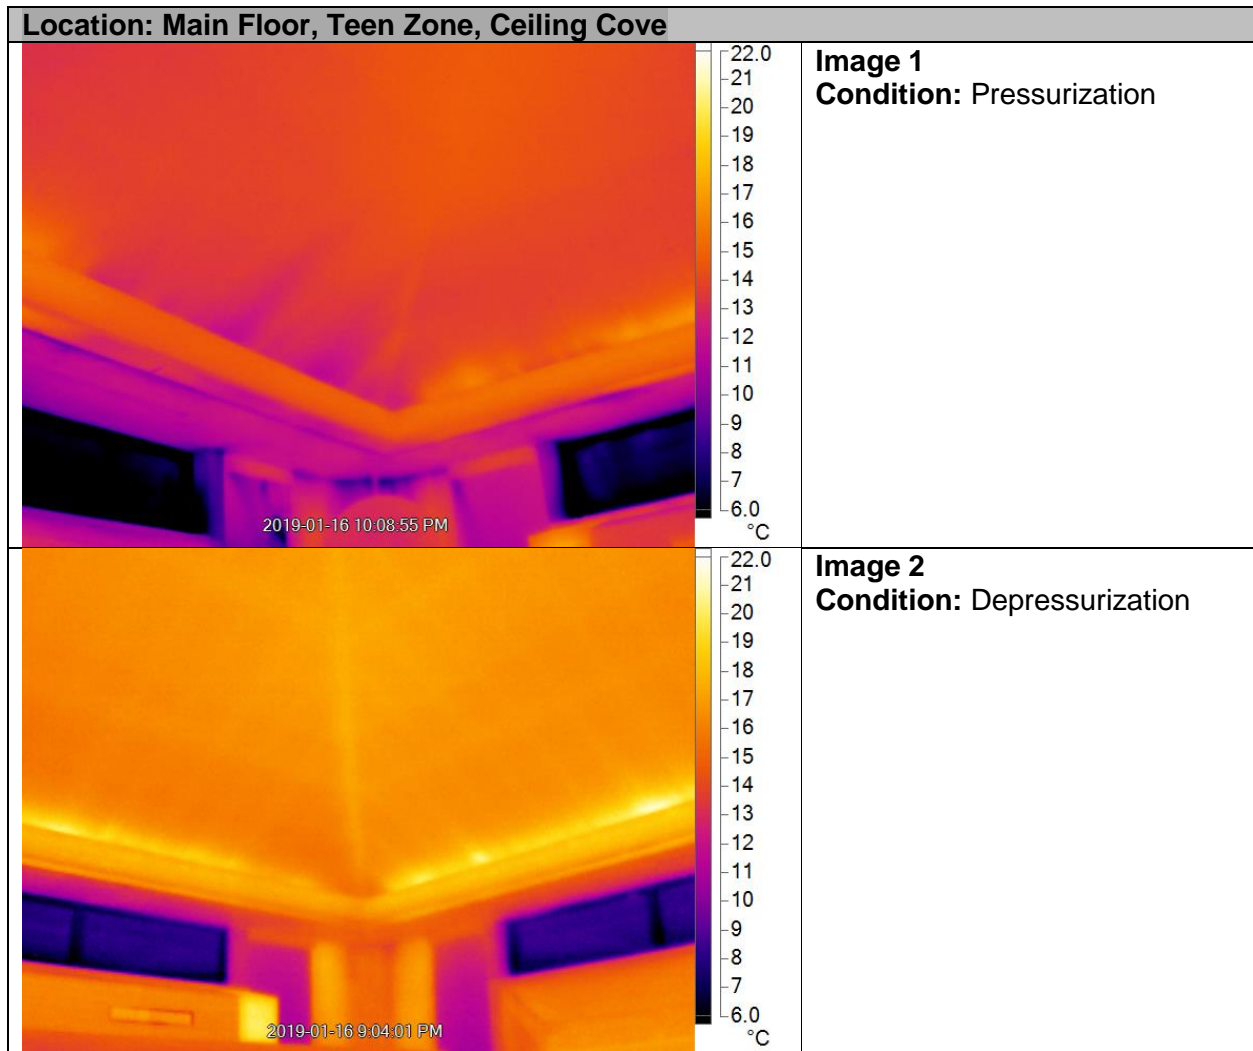
Notes: Thermal losses through interface between wall and ceiling/roof.

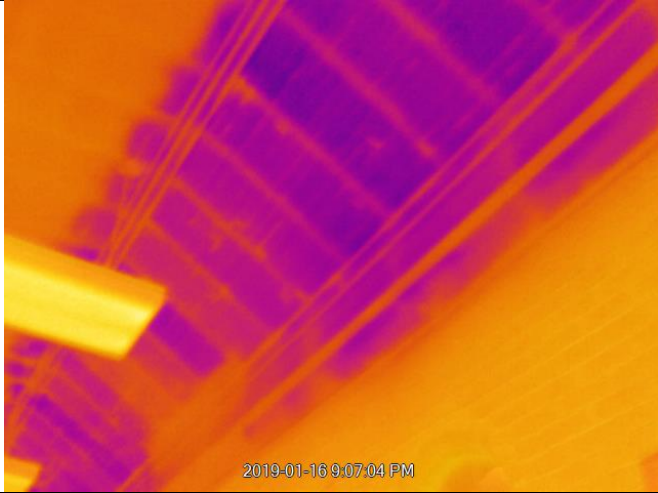
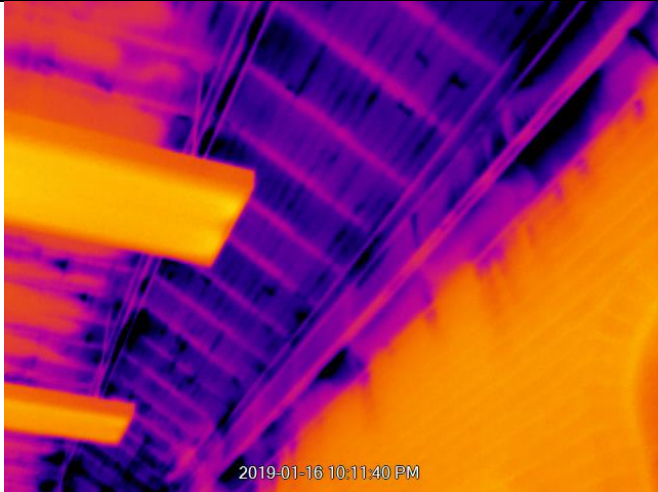
Location: Main Floor, Adult Zone, Ceiling Cove

Image 3 Condition: Pressurization
		Image 4 Condition: Depressurization

Notes: Thermal losses through interface between wall and ceiling	Visible Image  
--	--

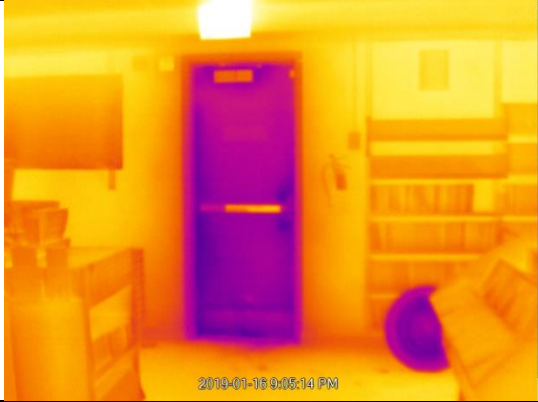
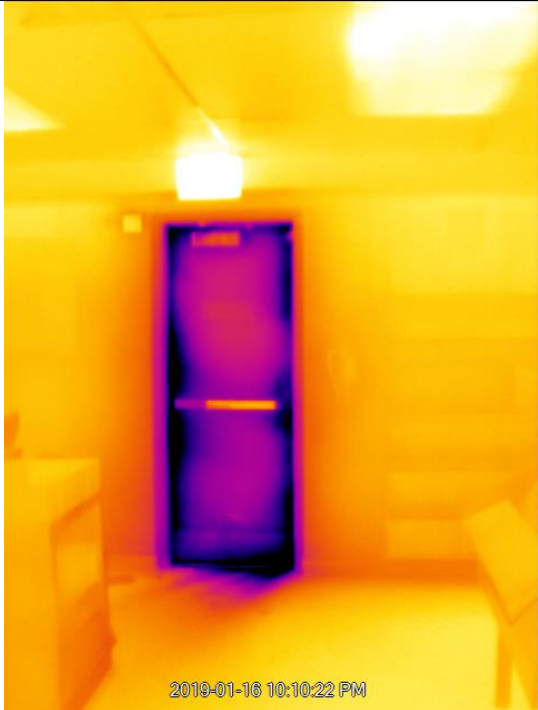
Location: Main Floor, Circulation Desk, Door

<p>2019-01-16 4:05:14 PM</p>		<p>Image 5 Condition: Pressurization</p>

<p>2019-01-16 10:10:22 PM</p>		<p>Image 6 Condition: Depressurization</p>

<p>Notes: Air leakage through door frame</p>	<p>Visible image</p>  
--	---

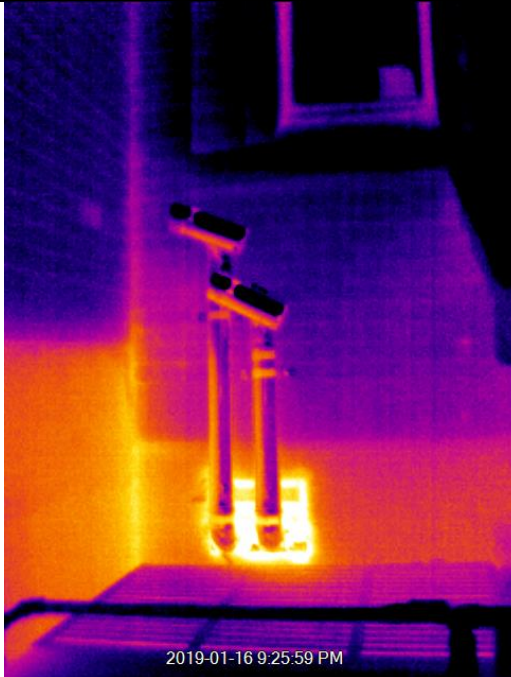
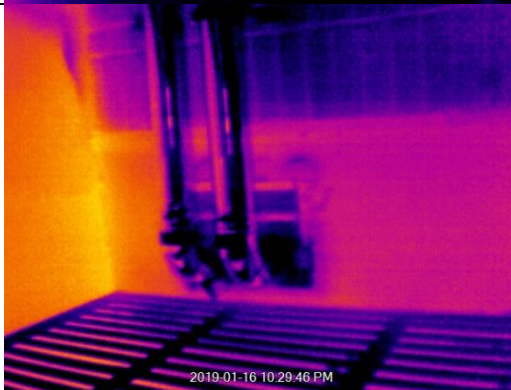
Location: Basement, Mechanical Room, Combustion Exhaust Stack

<p>Image 7 Condition: Pressurization</p>

<p>Image 8 Condition: Depressurization</p>

<p>Notes: Air leakage surrounding combustion exhaust stacks</p>	<p>Visible image</p>

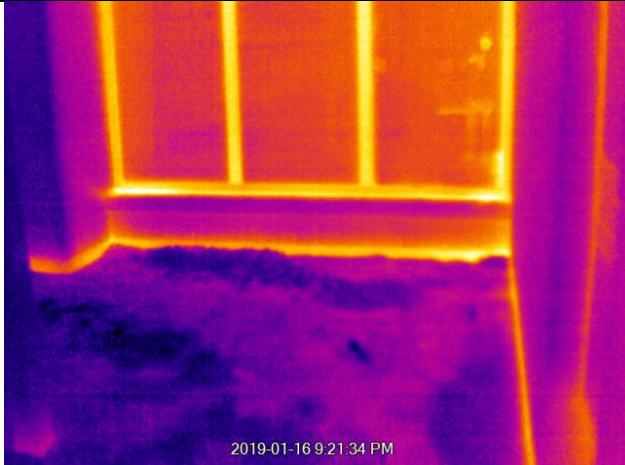
Location: Exterior, Window Facing South

Image 9 Condition: Pressurization
		Image 10 Condition: Depressurization

Notes: Thermal losses through window frame and at slab edge	Visible image  
---	---

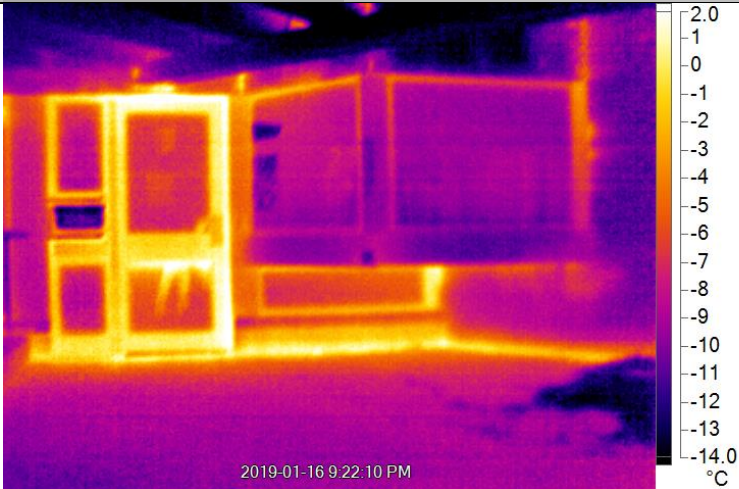
Location: Main Entrance

Image 11
Condition: Pressurization

Image 12
Condition: Depressurization

Notes: Air leakage through main door frame and drop box. Thermal losses along slab edge.

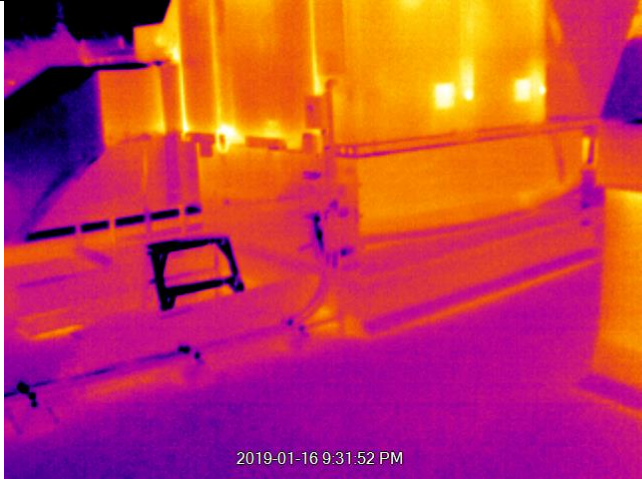
Location: Roof, Air-Handling Unit (AHU)

Image 13 Condition: Pressurization
		Image14 Condition: Depressurization
Notes: Air leakage through AHU	Visible image None available

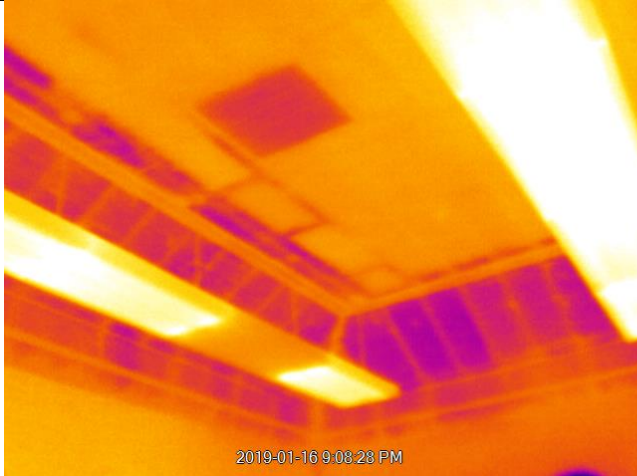
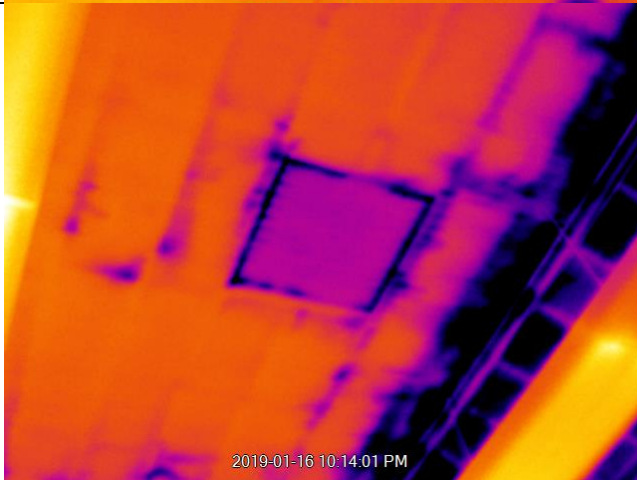
Location: Adult Zone, Roof Hatch

Image 15 Condition: Pressurization
		Image 16 Condition: Depressurization

Notes: Air leakage through roof hatch	Visible image
