ASSESSMENT OF LOAD BEARING CLAY BRICK MASONRY FOR ANALYZING LONG-TERM
DURABILITY THROUGH FIELD MEASUREMENT AND VISUAL REVIEW

A thesis presented to Ryerson University

In partial fulfillment of the
requirements for the degree of
Master of Applied Science
on the Program of
Building Science

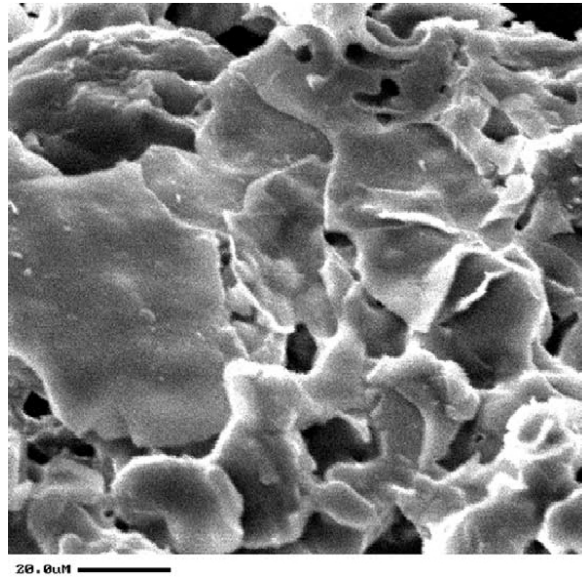
FIGURE 1: SCANNING ELECTRON MICROSCOPE IMAGE OF INTERNAL PORE STRUCTURE OF CLAY BRICK(Kavenagh & Wheeler, 2003).

In hydrophilic porous material, such as clay brick, moisture travels by a number of methods. Bricks are comprised of a fired clay material, which melts together during the firing process and also creates massive network of pores and microscopic tunnels. These pores provide an internal volume of space that can be occupied by air or water (Figure 1 and Figure 2). When a pore is fine enough (approximately 10-100 nanometers) water vapour in the air condenses on the sides of the pore walls, and forms a small amount of liquid water. Once the water is out of vapour form, and in liquid form it travels through the pore of the material via a phenomenon called capillary suction (Straube & Burnett, 2005). This phenomenon occurs when water molecules are more attracted to the molecules of the pore wall than the molecules of the air, and creep up the pore, causing a meniscus (Hugo Hens, 2007). This creeping up of water molecules occurs in practically all stony and wood materials, and are therefore called “hydrophilic” effect (Hugo Hens, 2007).

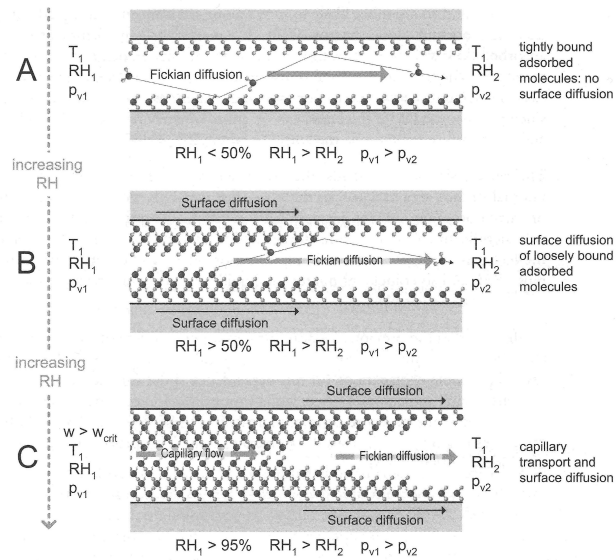
FIGURE 3: AS RELATIVE HUMIDITY INCREASES, SURFACE DIFFUSION LINES THE PORE WALLS WITH WATER MOLECULES (Straube & Burnett, 2005).

At a high ambient relative humidity, enough moisture condenses inside the pores of the brick that it can reach a point of capillary saturation (Figure 3). That is, the point where the brick cannot absorb any more moisture from the air. In order to add more moisture to a brick at this point, it must be supersaturated with water. The network of pores is not entirely interconnected; some are isolated and many are dead-ended. In order to fill these dead ends with water, Hall and Hoff (2012) note that super saturation is “not easy to achieve and not

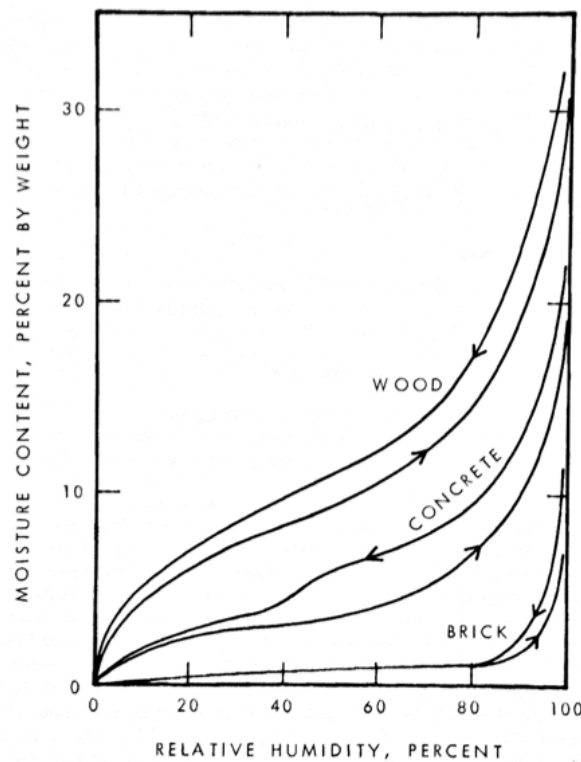
FIGURE 4: SORPTION ISOTHERMS: MOISTURE STORAGE IN POROUS MATERIALS (Hutcheon & Handegord, 1995).

Various porous materials store moisture differently from one another. As the relative humidity fluctuates, the moisture content that fills the pores of a given material change at different proportions. As the sorption isotherms show in Figure 4, the moisture content of brick remains fairly unchanged until a very high relative humidity is achieved. Conversely, the moisture content of wood follows the relative humidity very closely, as is depicted by the near 45-degree slope of the graph. The fact that wood has such a gentle slope in this situation proves useful: wood can be used as a surrogate material inside a porous material that has a much more flat sorption isotherm, in order to accurately relate moisture content to relative humidity.

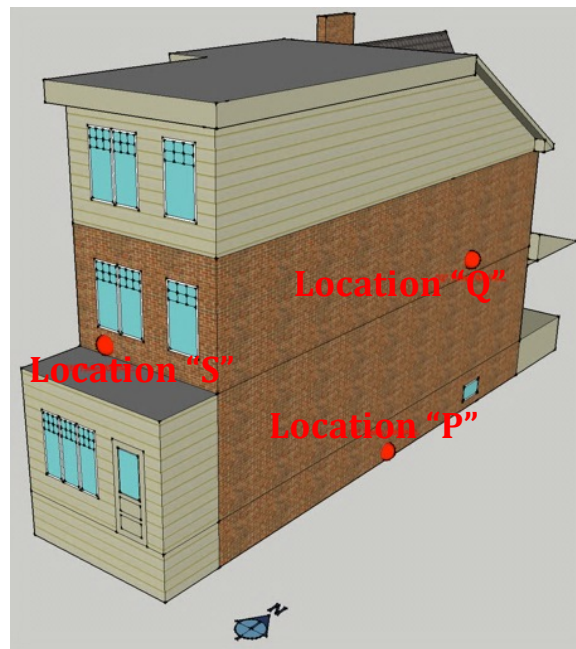
FIGURE 7: TEST HOUSE WITH SENSOR CLUSTER LOCATIONS "P", "Q" AND "S."

Clusters of Temperature/RH and Moisture Content sensors have been installed at four locations of the building to measure conditions through the depth of the building envelope. The locations of these clusters of sensors were labeled: "P", "Q", "R" and "S." Locations are of these clusters of sensors are illustrated in Figure 7 and Figure 8.

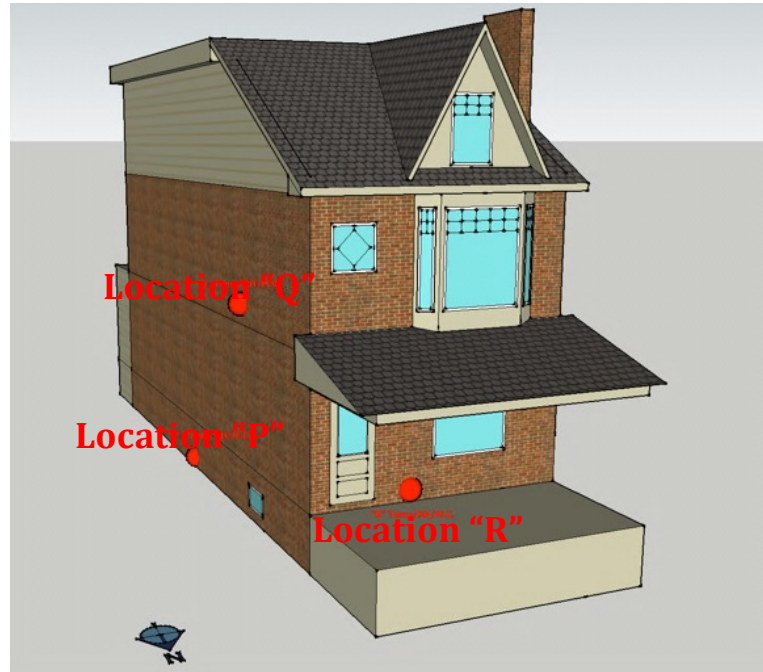
FIGURE 8: SENSOR CLUSTER LOCATIONS: P, Q AND R.

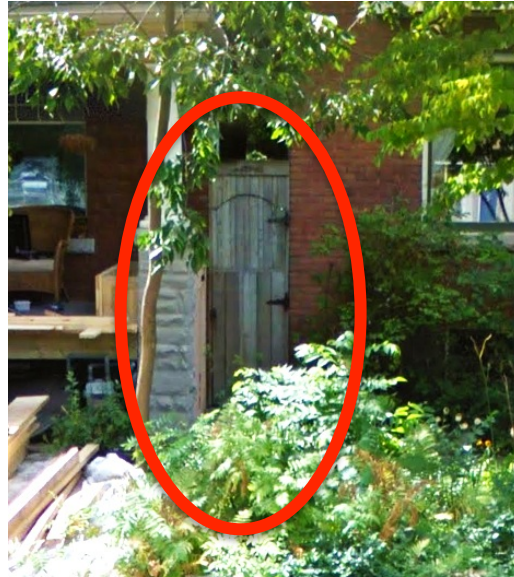
FIGURE 9: GATE INSTALLED BETWEEN TEST HOUSE AND ONE NEIGHBOURING PROPERTY APPEARS TO BE STAGNATING THE AIR FLOW, AND PREVENTING BRICK MASONRY WALLS FROM DRYING (Google Maps, 2014).

Sensor clusters are not installed on the West wall. A solid gate at the south end of the buildings block the lower portion of the west corridor (Figure 9). The gate appears to impede airflow as the clay bricks are drying inadequately on both this test house as well as the neighbouring building at this location. The clay brick walls are generally damp to the touch, and there are signs of moss growth beginning on areas of the walls. It was decided this microclimate is not representative of the overall exposure experienced by the clay brick masonry at this site. As such, the various sensors of cluster “Q” were installed on the East at 2nd floor height, instead of on the West wall. The added benefit of this positioning the sensor clusters in this manner allowed for the comparison of two different areas of the same East wall.

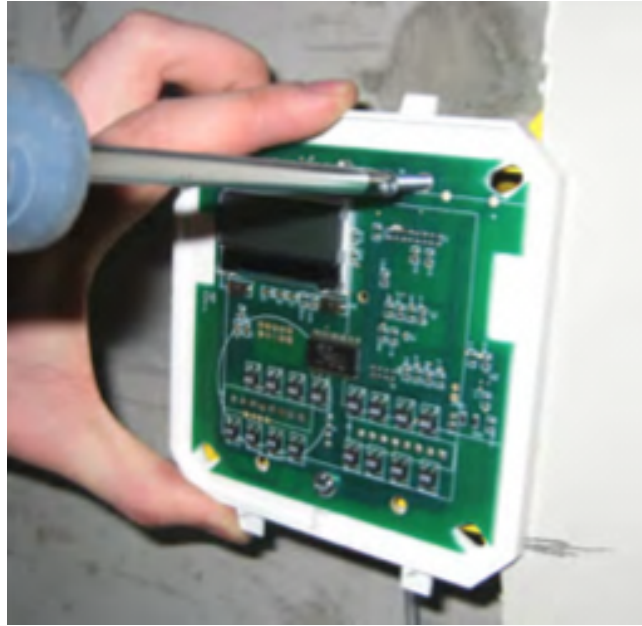
FIGURE 18: SMT A3 DATA ACQUISITION UNIT.

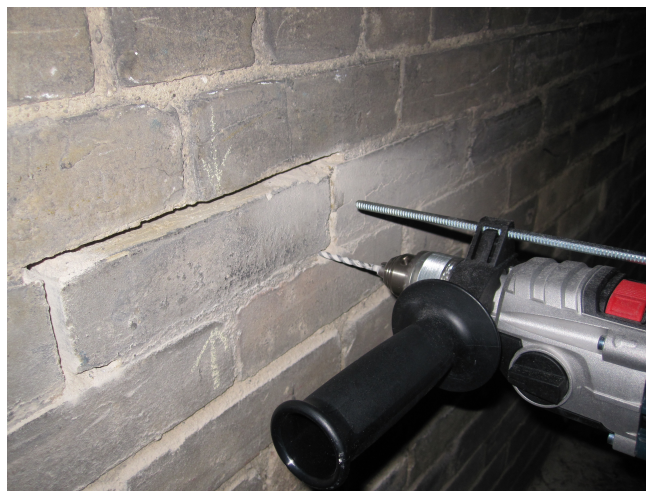
FIGURE 19: EXTRACTING CLAY BRICK UNITS

The installation process for the wood surrogate moisture sensors involved using a hammer-drill to carve out mortar joints, and then extracting clay bricks from the wall (Figure 19).

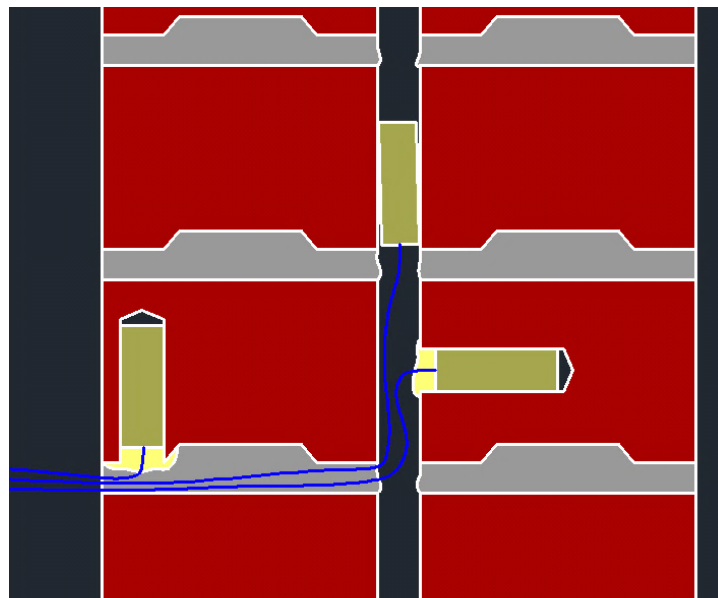
FIGURE 24: SECTION OF THE TEST BUILDING'S CLAY BRICK WALL SHOWS TYPICAL MOISTURE CONTENT SENSOR ARRANGEMENT.

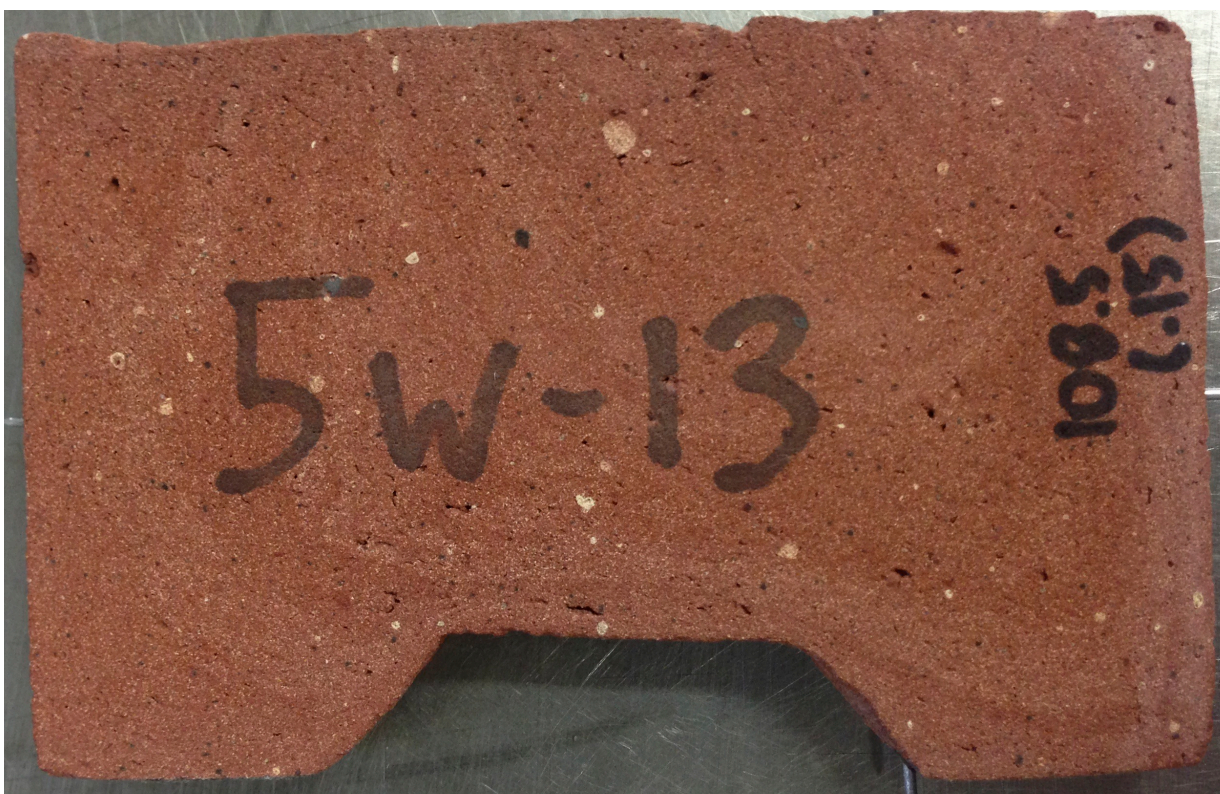
FIGURE 25: SLICED CENTURY OLD CLAY BRICKS REVEAL THE VISIBLY INHOMOGENEOUS SWIRL PATTERN WITHIN, AS WELL AS POCKETS, VOIDS AND INCLUSIONS NOTE THE “MARBLE” SWIRL PATTERN.

Measuring moisture content of clay brick in real-time, in situ, outside of a laboratory is a challenging task (Ueno & Straube, 2008). The problem is that no sensor currently exists that can directly measure the moisture content of clay brick, given two fundamental physical characteristics: (1) the physical makeup of clay brick is not necessarily homogenous and uniform, and (2) clay brick has varying degrees of porosity. As a result the measurement of moisture content in clay brick by electrical resistance alone is not a reliable method. This variation is visually evident in Figure 25.

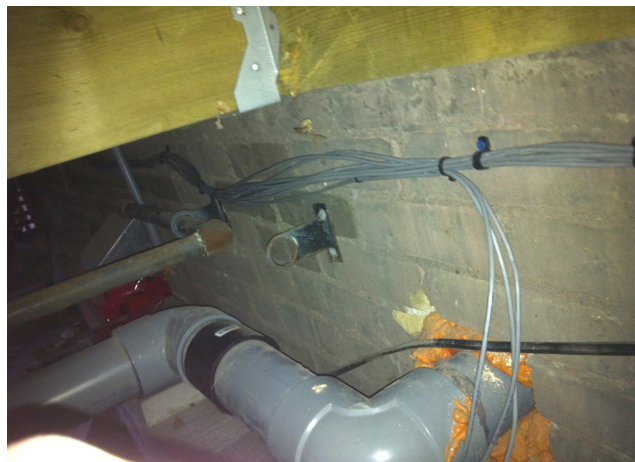
FIGURE 27: MOISTURE SENSOR CABLES ROUTED AROUND THE EXTERIOR OF THE HOUSE.

A total of 12 sensors are permanently installed into the exterior-wythe clay brick units, the collar joints, and the interior-wythe clay brick units at the four measurement locations. As a method of increasing capillary flow between the clay brick and the wood surrogate sensor, the boreholes for the M.C. sensors are sized as closely as possible to the diameter of the sensor body. Also, clay brick dust recovered from the drilling process is packed between the borehole and the wooden sensor body, as recommended by the manufacturer as the best procedure for increasing capillary flow into the sensor. All cables from the moisture content sensors are routed along the exterior of the building, and into an instrumentation room in the basement of the house where four SMT 24-bit data loggers were centrally positioned (Figure 27 and Figure 28).

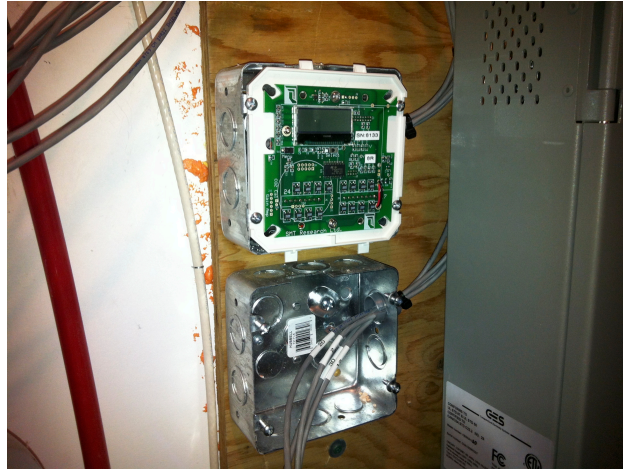
FIGURE 28: 1 OF 4 SMT MOISTURE CONTENT DATA LOGGERS DURING INSTALLATION.

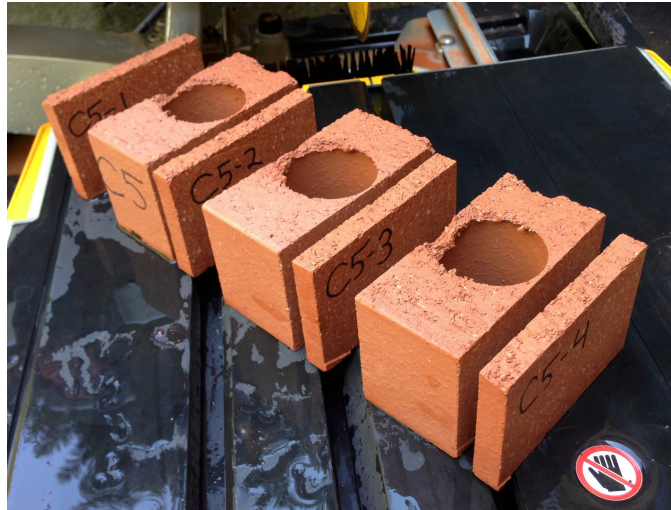
FIGURE 29: CORED CONTEMPORARY CLAY BRICK ONLY YIELDS 4 SPECIMENS OF APPROPRIATE SIZE FOR COMPARISON.

did not have “frog” indentations in the bottoms; they had hollow cores that passed clear through the clay brick. As a result, each of the contemporary clay bricks yielded only 4 specimens, whereas the century old clay brick yielded 12 to 17 specimens (Figure 29).

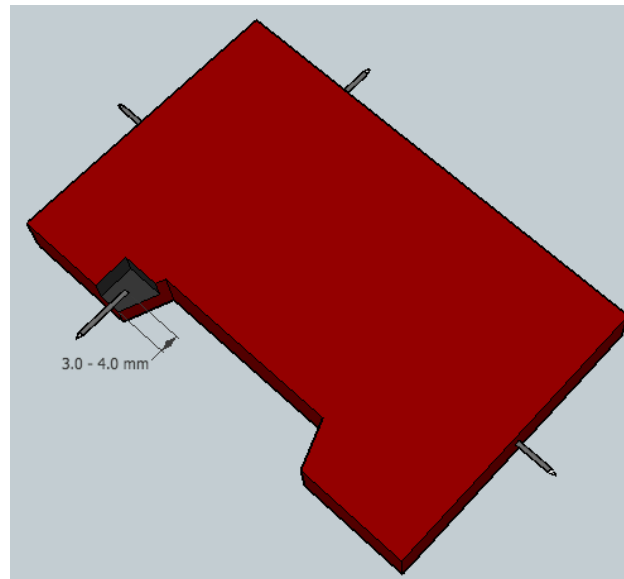
FIGURE 31: WEAR-PINS INSTALLED INTO CLAY BRICK SPECIMENS FOR MICROMETER MEASUREMENTS.

The first step in the process is to measure the starting dimensions of the clay brick samples.

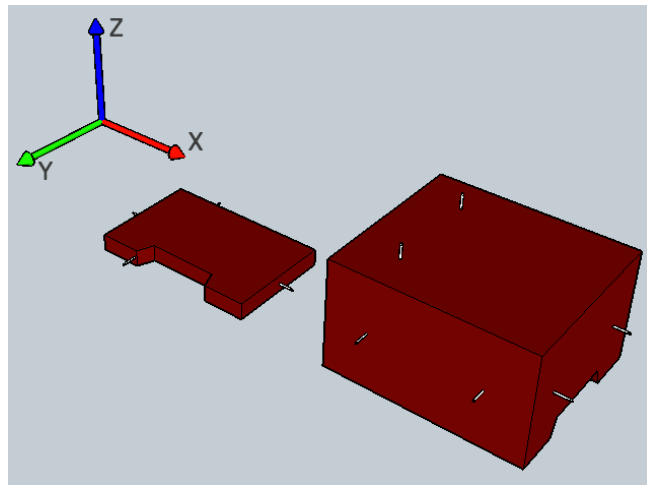
FIGURE 32: CLAY BRICK SPECIMENS MEASUREMENT AXES.

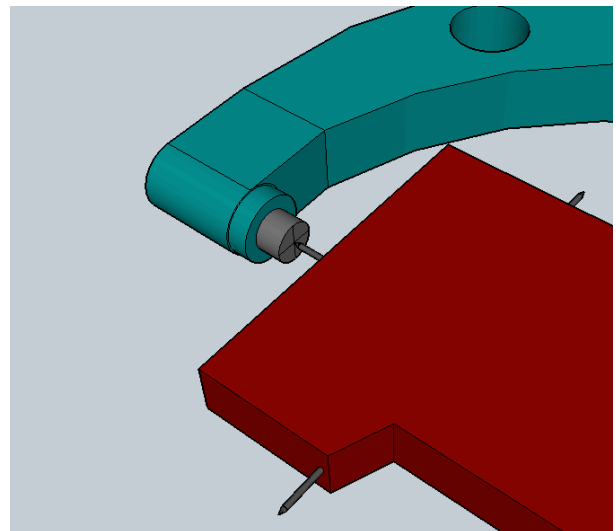
FIGURE 34: PINS MUST BE POSITIONED AT DEAD CENTRE OF FIXED ANVIL DURING MEASUREMENT FOR CONSISTENCY.

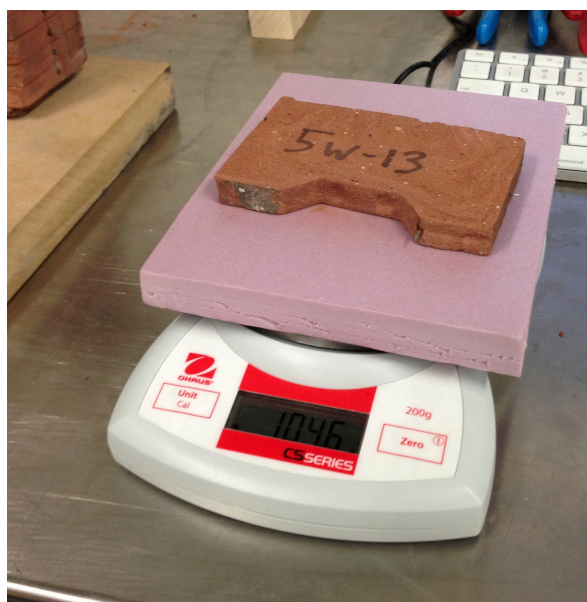
FIGURE 36: 0.1 G RESOLUTION SCALE

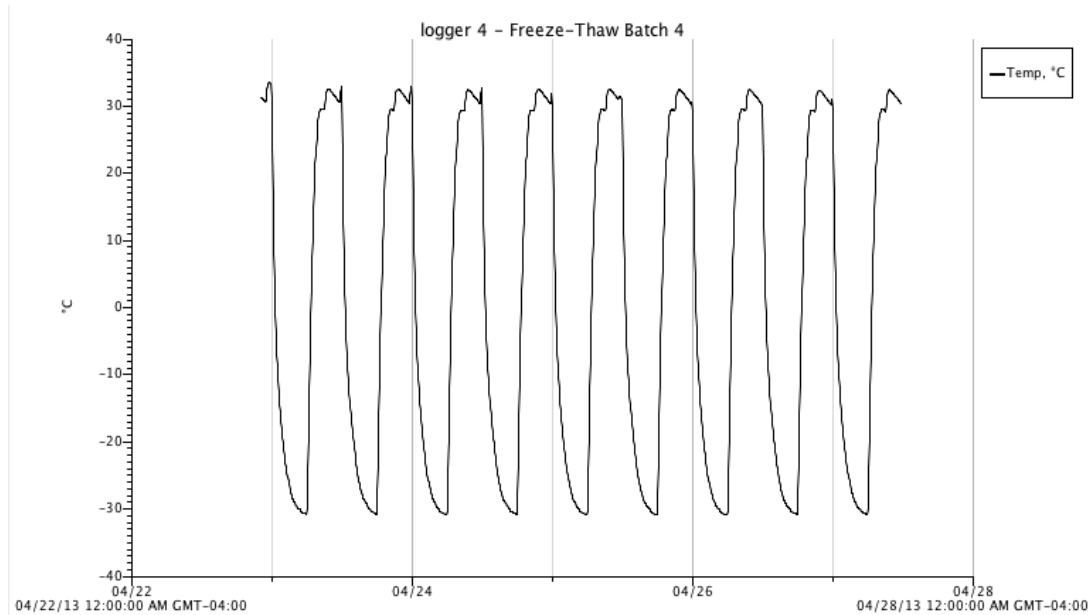
FIGURE 44: 9-CYCLE COOLING AND HEATING PROFILE FOR FREEZE-THAW CHAMBER.

Once the 24 hour distribution period had passed, the specimens are placed into an automatic freeze-thaw chamber. The chamber automatically cycles between freezing and thawing every 12 hours: each freeze cycle is 12 hour in duration, and drops beyond -30°C . The freeze cycle is followed by a 12 hour thaw period where the temperature inside the freeze-thaw chamber reaches $+30^{\circ}\text{C}$ (Refer to Figure 44). A total of 9 freeze-thaw cycles are performed on each specimen. Previous work by Peter Mensinga exposed the brick specimens to 6 cycles of freeze thaw (Mensinga, 2009). Since this equipment for cycling freeze -thaw is automatic, a few extra cycles have been added in an attempt to make any dilatometry occurring in the specimens more evident.

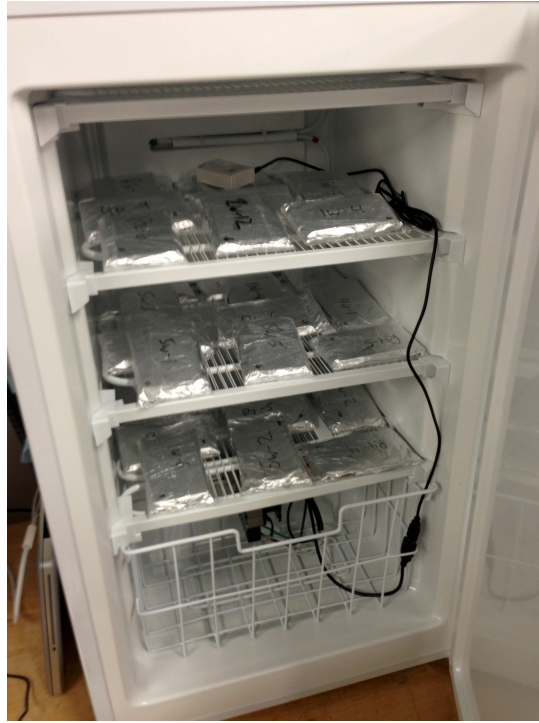
FIGURE 45: WRAPPED BRICK SPECIMENS INSIDE THE FREEZE-THAW CHAMBER.

Specimens are placed flat directly onto the refrigerated shelves of the freeze-thaw chamber, so that the maximum surface area of the specimen is in contact with shelves where the cooling lines were located (Figure 45). During the cooling cycle, the samples are chilled by a combination of conductive heat flow to the shelves, and convection within the chamber. During the heating cycle, the specimens are warmed convectively by a small heater-fan that circulates warm air throughout the chamber. Once the 9 freeze-thaw cycles complete, specimens are removed from the chamber, dimensioned with the micrometers in both directions and the average measurement taken. Measurements are logged into a spreadsheet, and analysed.

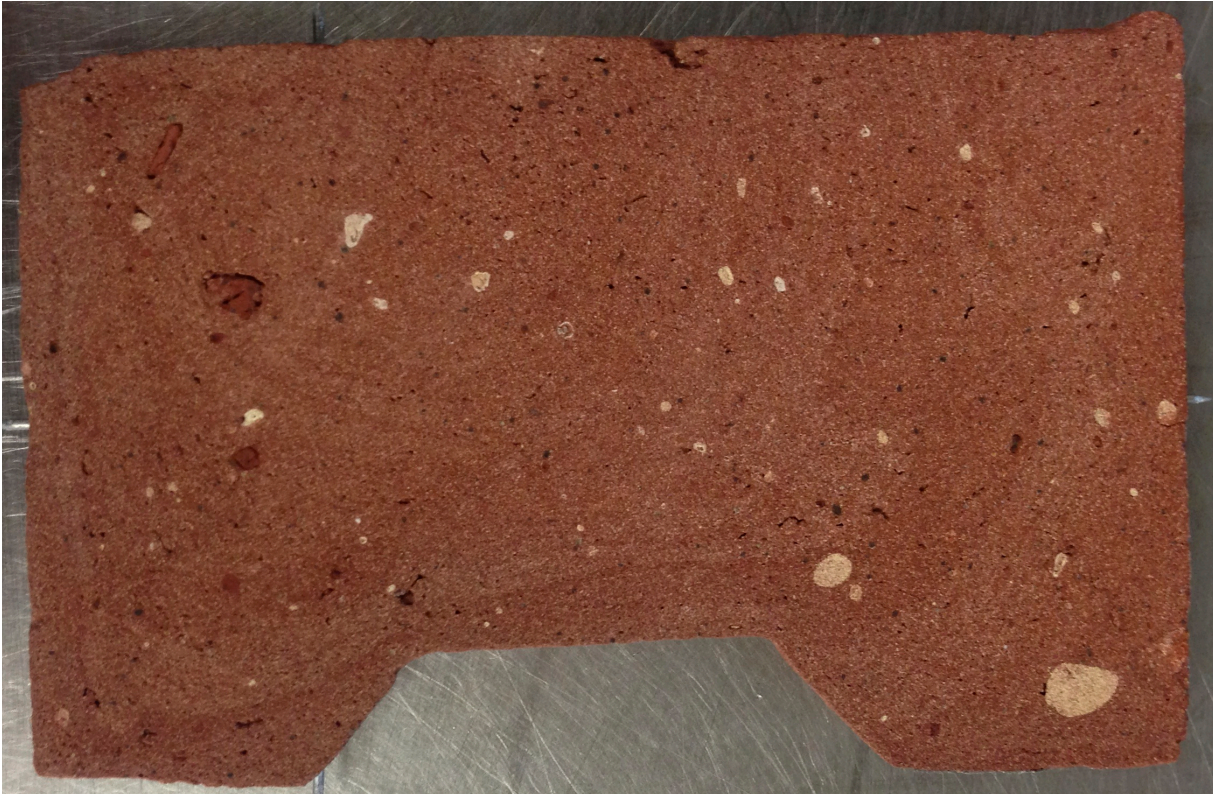
FIGURE 46: VISIBLY INHOMOGENEOUS CLAY BRICK CONSTITUTION. (BLOWN UP TO SHOW TEXTURE.)

Precisely correlating the moisture content of the SMT wooden moisture content sensors to the M.C. of the clay brick is performed in the lab. It should be noted that only a limited number of bricks are available for testing. Of the bricks extracted from the walls, a total of 5 beige bricks and 8 red bricks were undamaged and suitable for laboratory analysis. (Several bricks extracted from the walls were discarded due to fissures and voids in the clay.) The remaining bricks were divided up amongst the various sections of lab work for this project. A single red clay brick (upper wall) and a single beige clay brick (foundation), chosen at random, are used for this portion of the analysis, to correlate the R.H. to M.C. data. A brick of each type was chosen to identify what effect the type of brick might have on correlating the moisture content to the relative humidity. Any measurement error resulting from the inhomogeneous constitution of the clay brick may be offset by the large size of the SMT Moisture Content sensors. Figure 46 and Figure 47 show examples of clay brick with visible signs of inhomogeneity: marbling within the clay, as well as inclusions and air pockets can be seen. The 12.7 mm diameter by 65 mm depth of the borehole for the sensors requires a relatively large amount of surface area for the Moisture Content sensor to make contact, inside of the clay brick, and bisects multiple zones of clay brick composition.

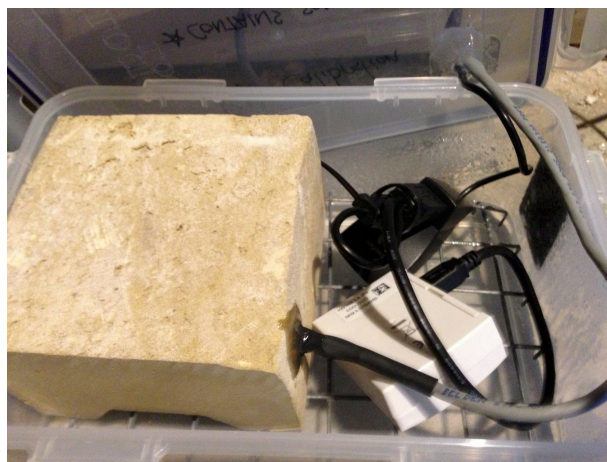
FIGURE 48: RH VESSEL WITH BRICK SPECIMEN (WITH MOISTURE CONTENT SENSORS INSTALLED), SALT SOLUTION (BELOW BRICK), TEMP/RH DATA LOGGER, AND AIRTIGHT LID.

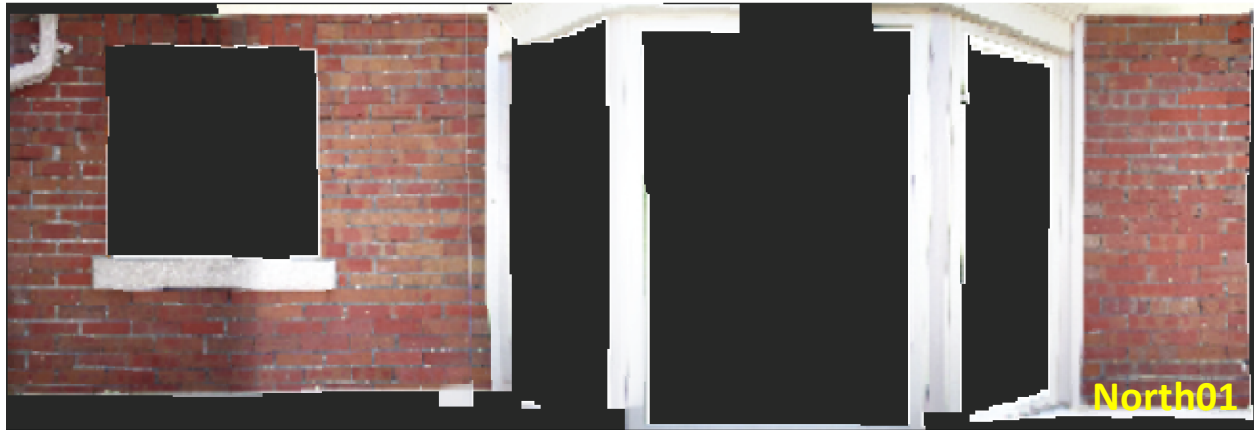
FIGURE 50: NORTH ELEVATION KEY MAP.

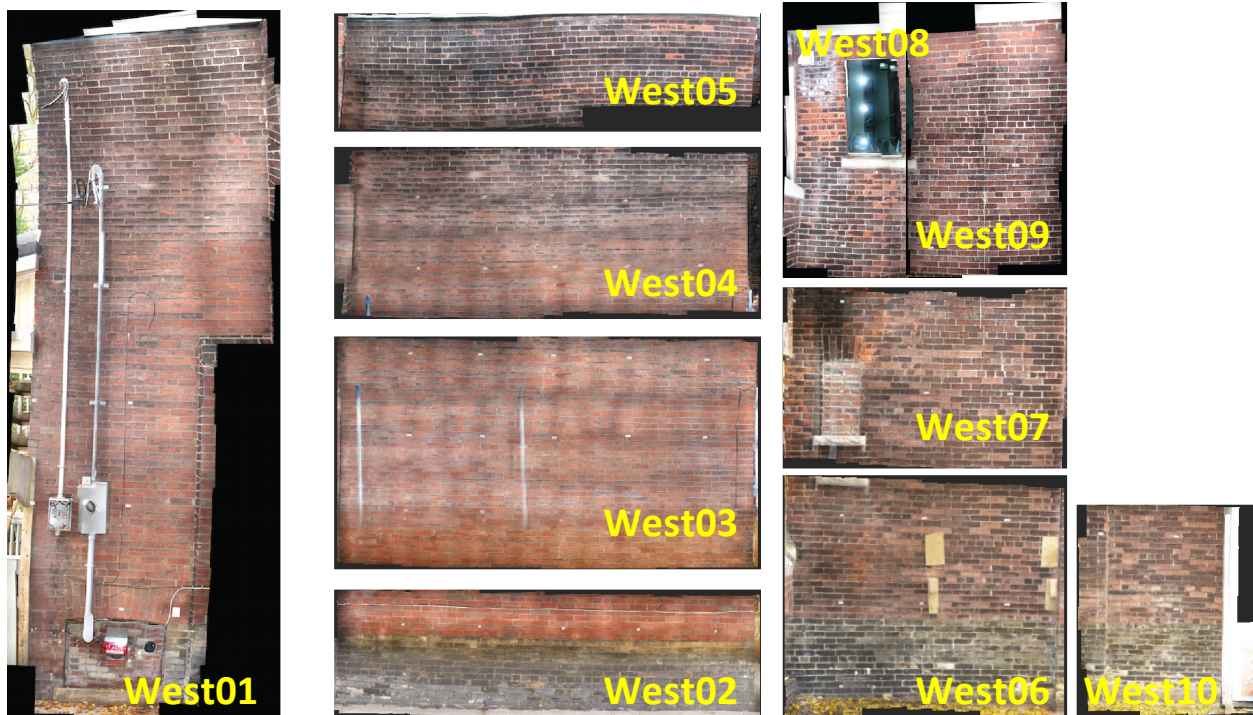
FIGURE 51: WEST ELEVATION KEY MAP.

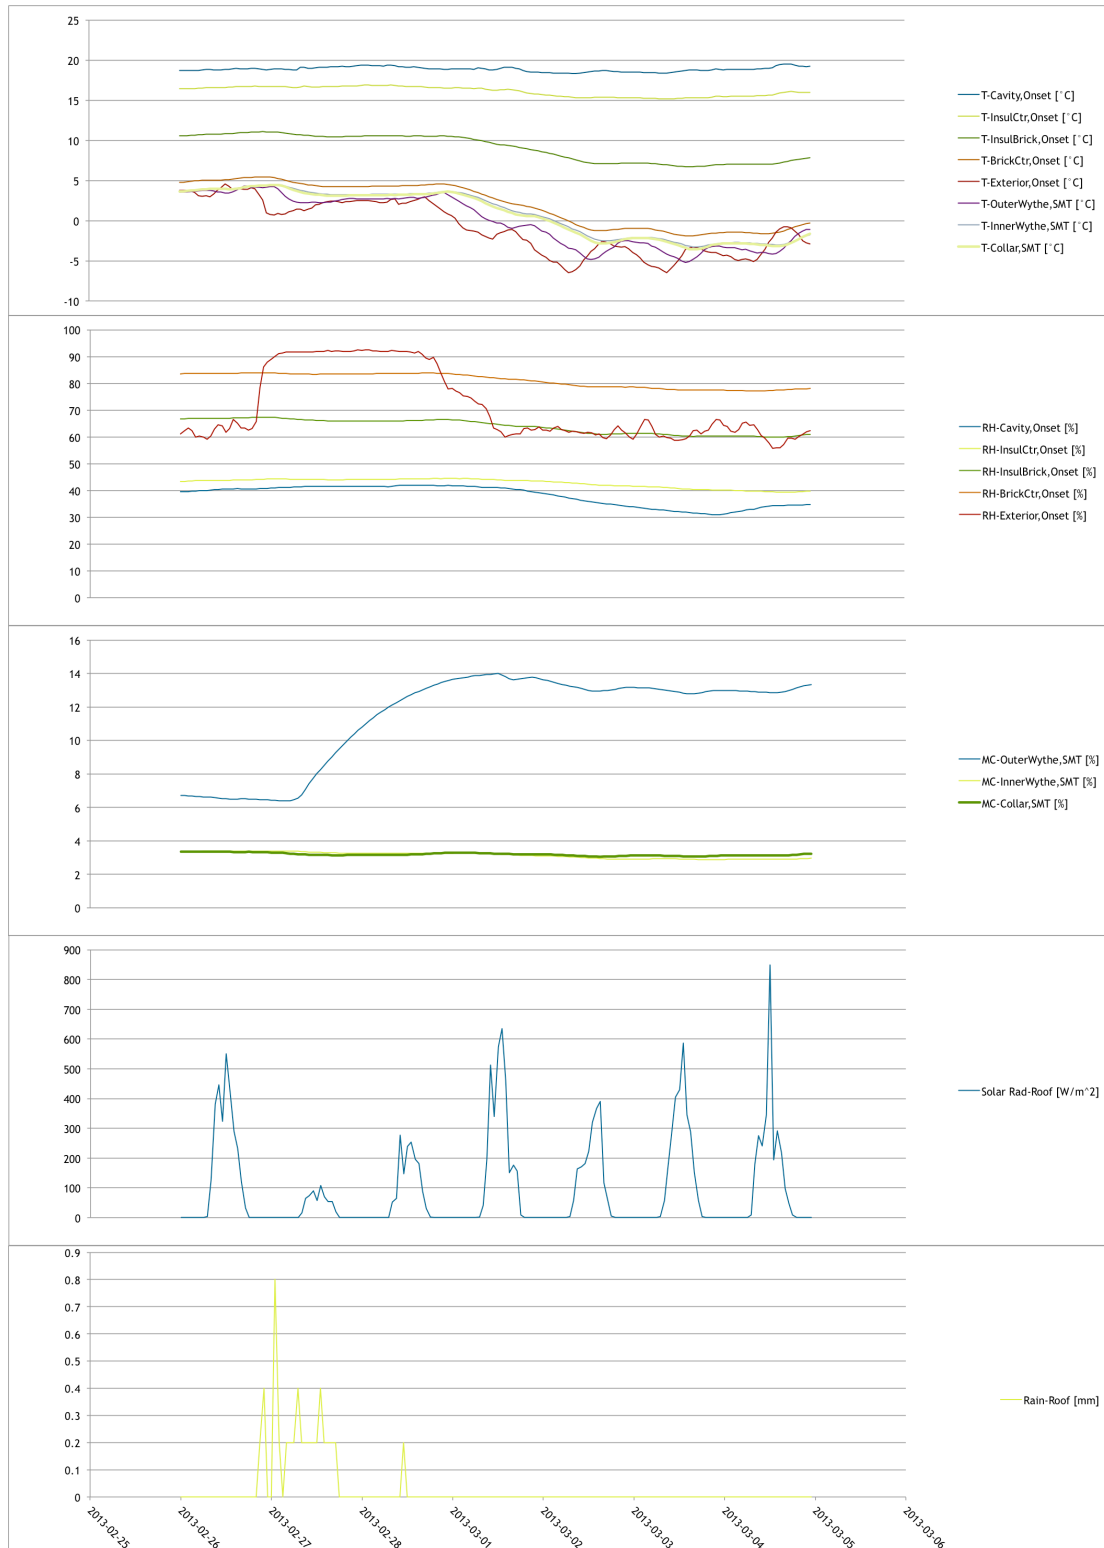
Location "Q" – East elevation 3 m above grade.

At four locations around the house, the moisture content sensors are positioned at three depths within the brick masonry portion of the envelope: one is in the exterior wythe, the second is at the collar joint, and the third at each location is in the interior wythe of brick. The measurement trend lines are generally stratified and follow each other. When compared to the exterior wythe moisture content measurements, there is generally a delay in the collar joint measurement, and even more of a delay of the interior wythe measurement. This is a result of the time it takes for moisture to travel through the pores of the brick masonry envelope after a rain event. The sensor measurements show that the moisture content sensor in the exterior wythe can respond to moisture from a rain even in only a few hours (Refer to Figure 53). But for the interior wythe Moisture Content Sensor, it can take several days to respond and the reaction is less severe (Refer to MC measurements in Figure 53, Figure 54, Figure 55 and Figure 56). This demonstrates the time it takes for moisture to transfer from the exterior face of the clay brick by way of capillary suction. What is unknown is the additional time it takes for the moisture to travel from the brick to the Moisture Content sensor by way of vapour diffusion. However, because the wooden Moisture Content sensors are at least in partial contact with the boreholes in which they have been inserted, and the then tightly packed with brick dust, at least a partial path for moisture to travel to the sensors by way of capillary suction exists. Note that the exterior RH measurement reached a ceiling of approximate 92% for two days (Refer to Figure 53). This is most likely caused by a wind blown rain/snow event, with water coming into contact with the surface-mounted sensor on the east elevation. The 92% RH measured by the instrument is the maximum it measures, and the length of the plateau indicates that it was wet for several days.

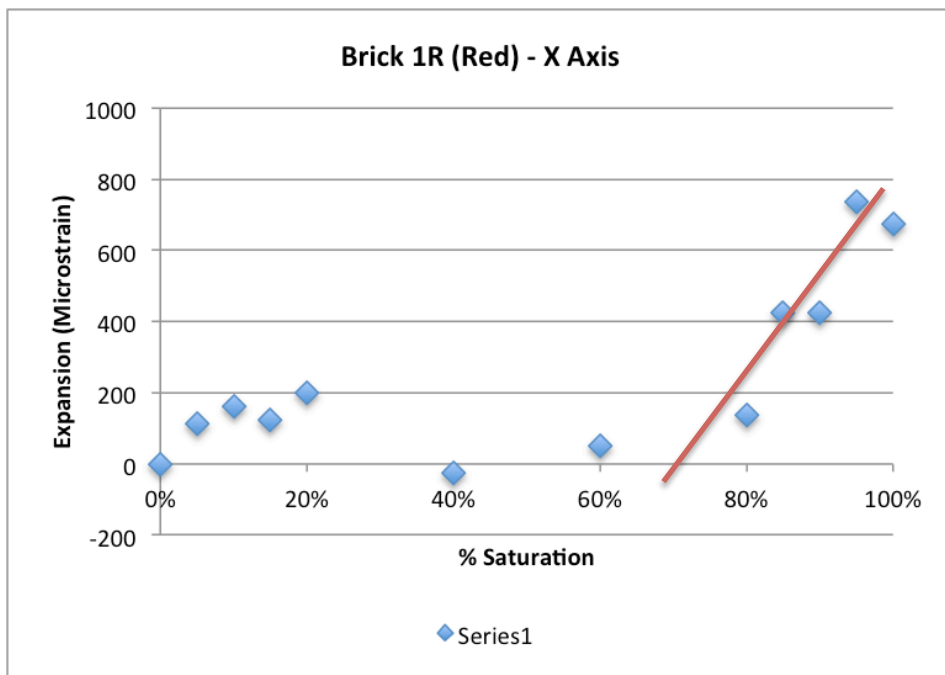
FIGURE 62: 2-DIMENSIONAL FROST DILATOMETRY RESULTS – BRICK SPECIMEN 1R – X AXIS AVERAGE ϵ_{CRIT} MEASUREMENTS.

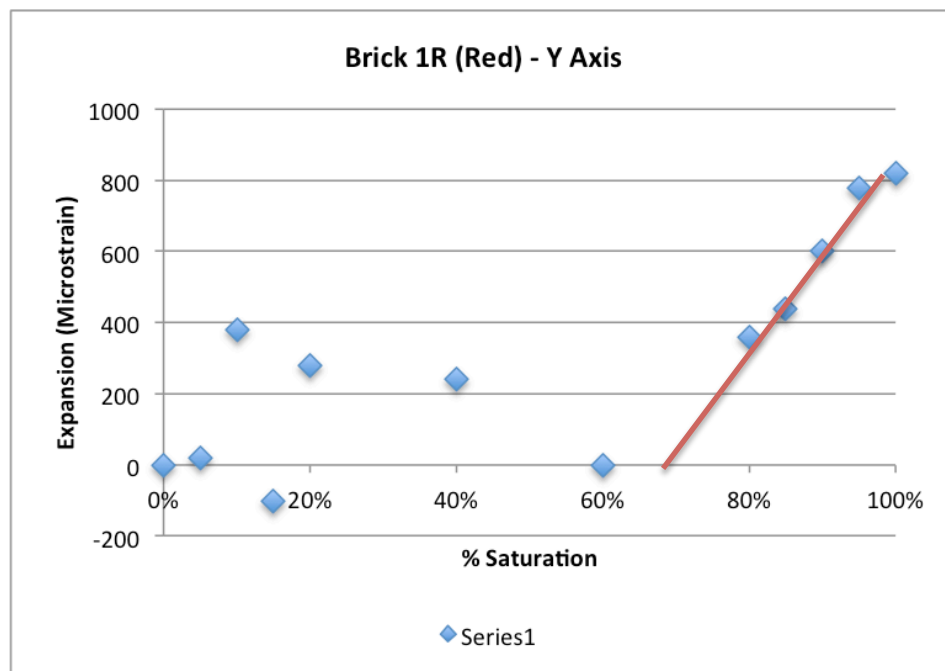
FIGURE 63: 2-DIMENSIONAL FROST DILATOMETRY RESULTS – BRICK SPECIMEN 1R – Y AXIS AVERAGE ϵ_{CRIT} MEASUREMENTS.

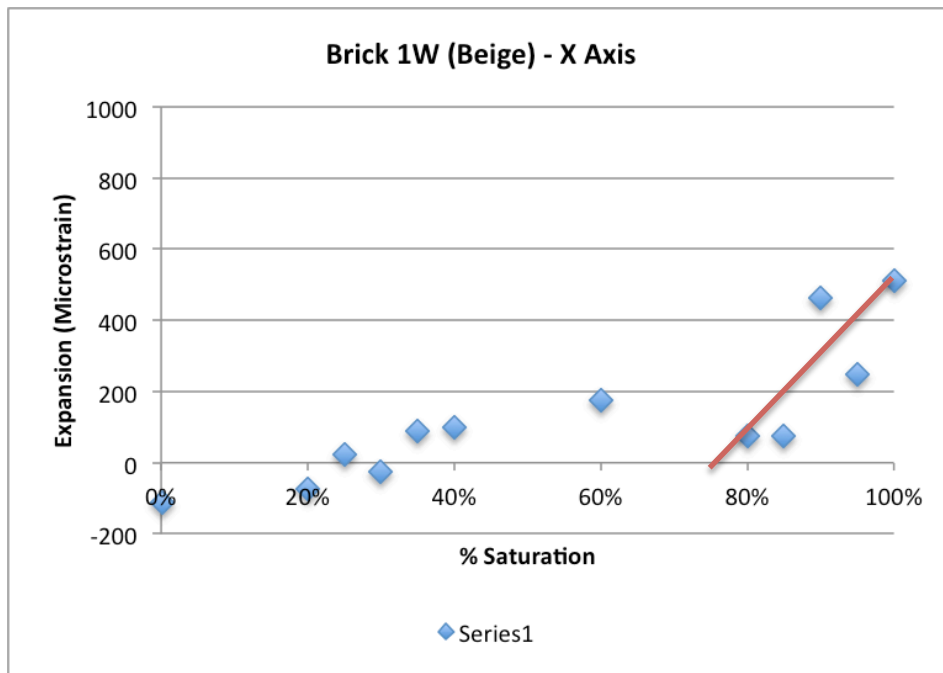
FIGURE 64: 2-DIMENSIONAL FROST DILATOMETRY RESULTS – BRICK SPECIMEN 1W – X AXIS AVERAGE ϵ_{CRIT} MEASUREMENTS.

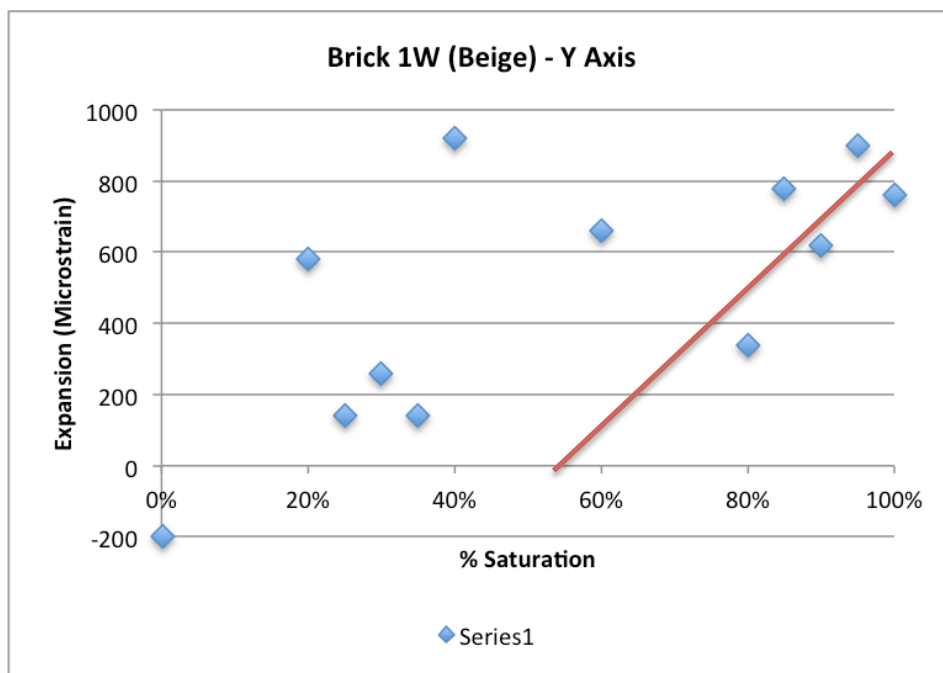
FIGURE 65: 2-DIMENSIONAL FROST DILATOMETRY RESULTS – BRICK SPECIMEN 1W – Y AXIS AVERAGE ϵ_{CRIT} MEASUREMENTS.

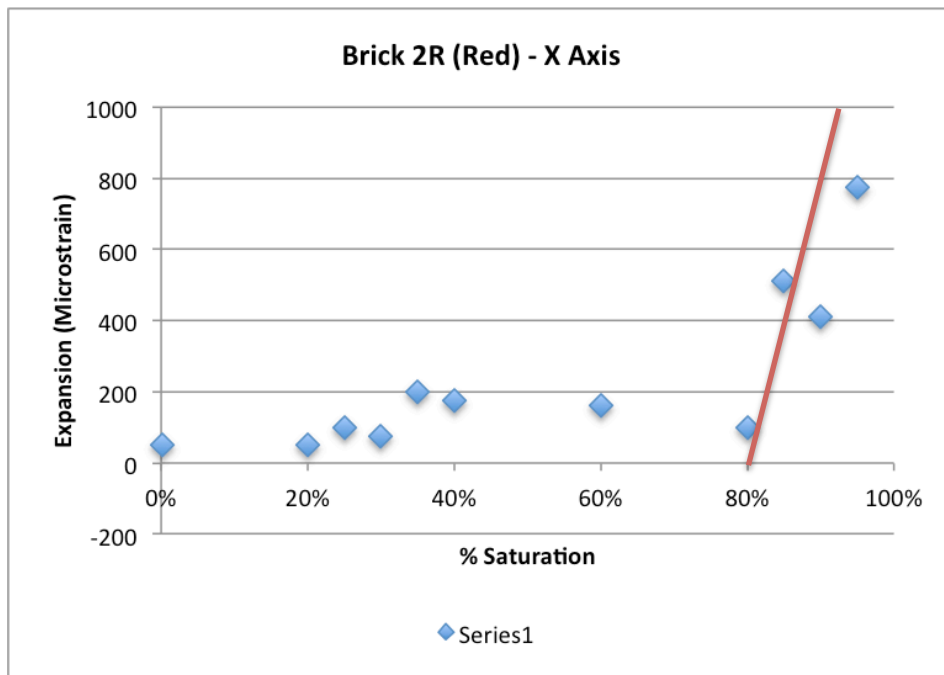
FIGURE 66: 2-DIMENSIONAL FROST DILATOMETRY RESULTS – BRICK SPECIMEN 2R – X AXIS AVERAGE S_{CRIT} MEASUREMENTS.

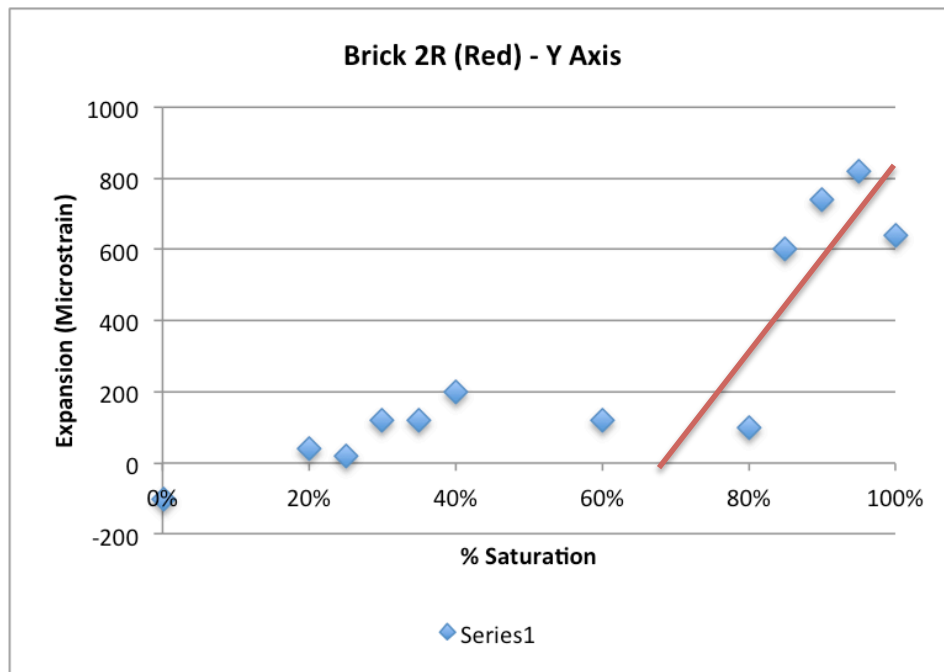
FIGURE 67: 2-DIMENSIONAL FROST DILATOMETRY RESULTS – BRICK SPECIMEN 2R – Y AXIS AVERAGE S_{CRIT} MEASUREMENTS.

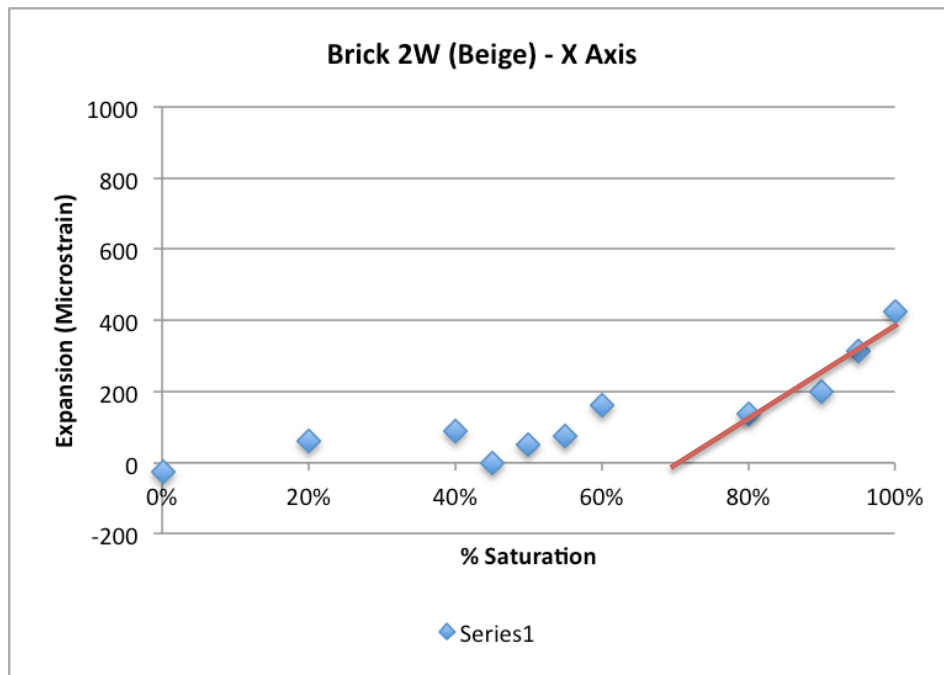
FIGURE 68: 2-DIMENSIONAL FROST DILATOMETRY RESULTS – BRICK SPECIMEN 2W – X AXIS AVERAGE ϵ_{CRIT} MEASUREMENTS.

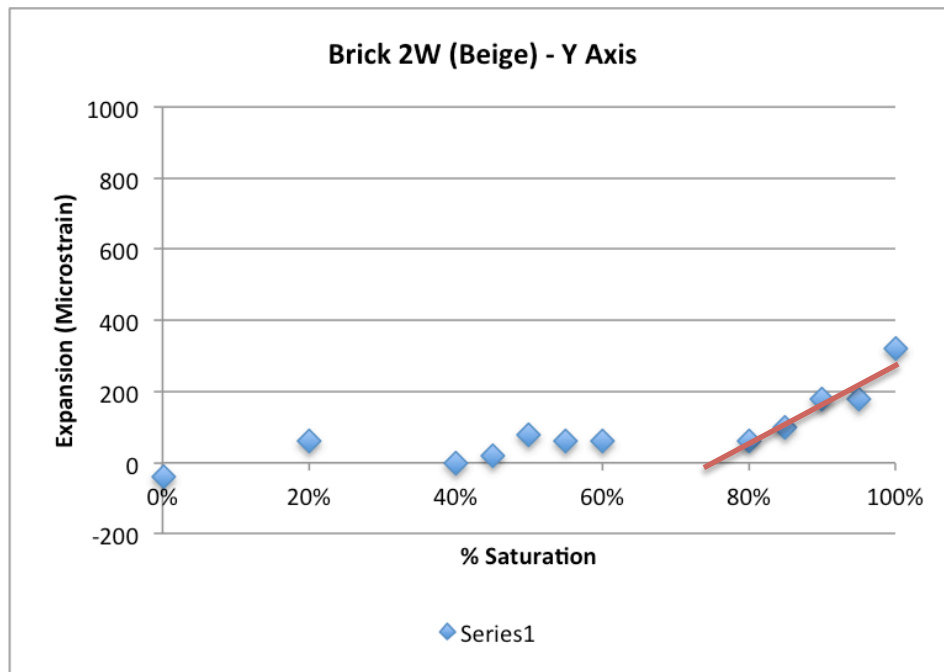
FIGURE 69: 2-DIMENSIONAL FROST DILATOMETRY RESULTS – BRICK SPECIMEN 2W – Y AXIS AVERAGE ϵ_{CRIT} MEASUREMENTS.

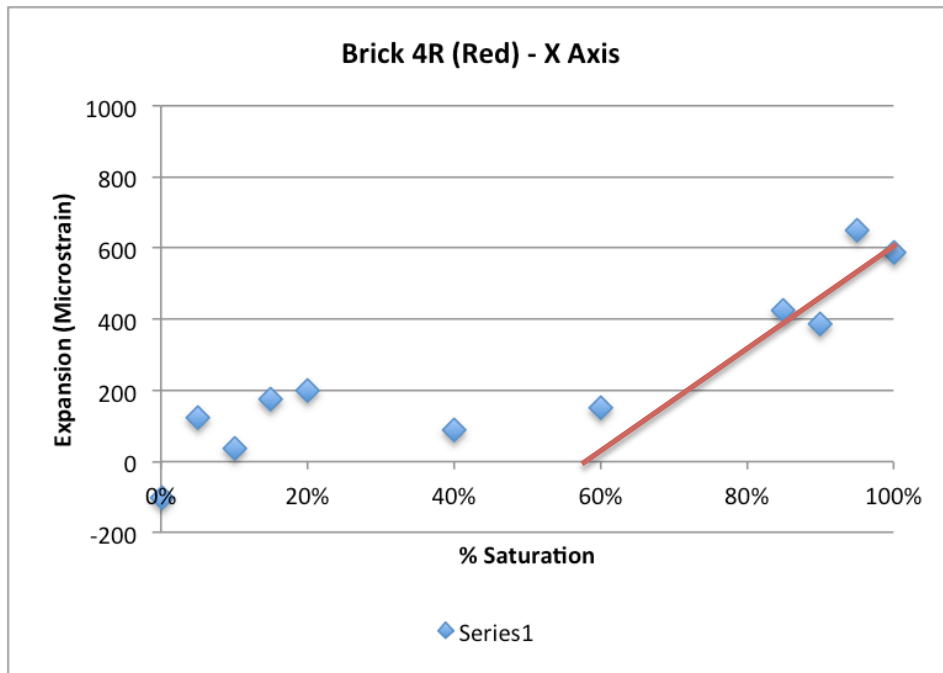
FIGURE 70: 2-DIMENSIONAL FROST DILATOMETRY RESULTS – BRICK SPECIMEN 4R – X AXIS AVERAGE S_{CRIT} MEASUREMENTS.

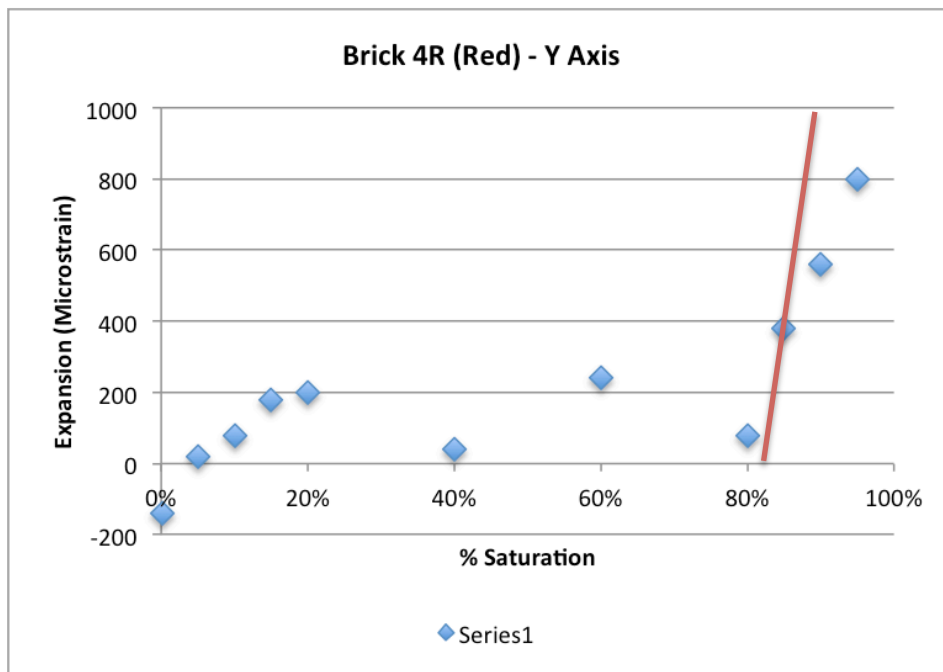
FIGURE 71: 2-DIMENSIONAL FROST DILATOMETRY RESULTS – BRICK SPECIMEN 4R – Y AXIS AVERAGE S_{CRIT} MEASUREMENTS.
