ASSESSMENT OF LOAD BEARING CLAY BRICK MASONRY FOR ANALYZING LONG-TERM
DURABILITY THROUGH FIELD MEASUREMENT AND VISUAL REVIEW

A thesis presented to Ryerson University

In partial fulfillment of the
requirements for the degree of
Master of Applied Science
on the Program of
Building Science

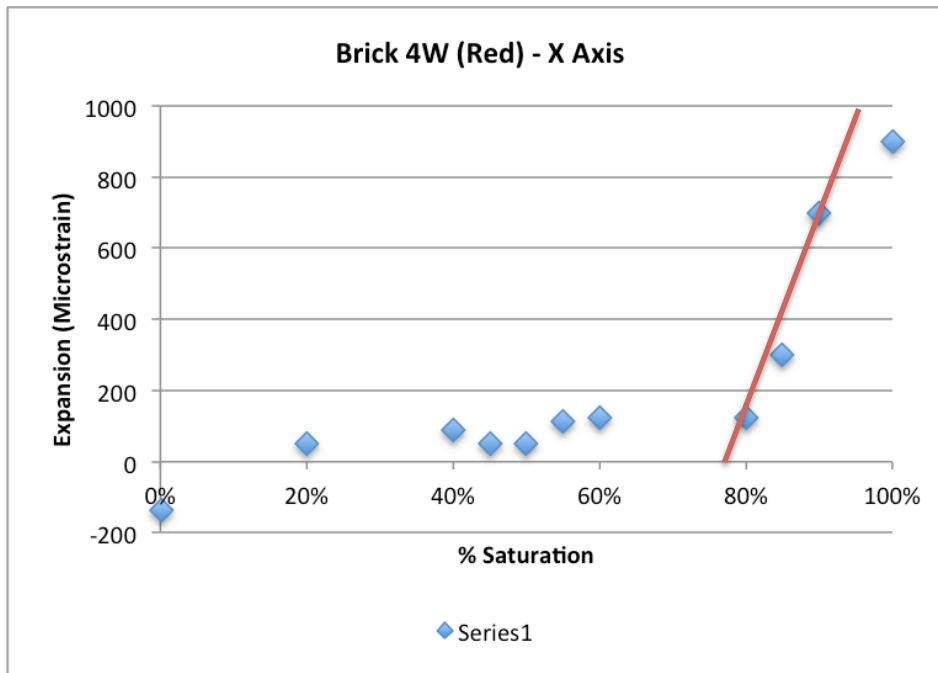
FIGURE 72: 2-DIMENSIONAL FROST DILATOMETRY RESULTS – BRICK SPECIMEN 4W – X AXIS AVERAGE ϵ_{CRIT} MEASUREMENTS.

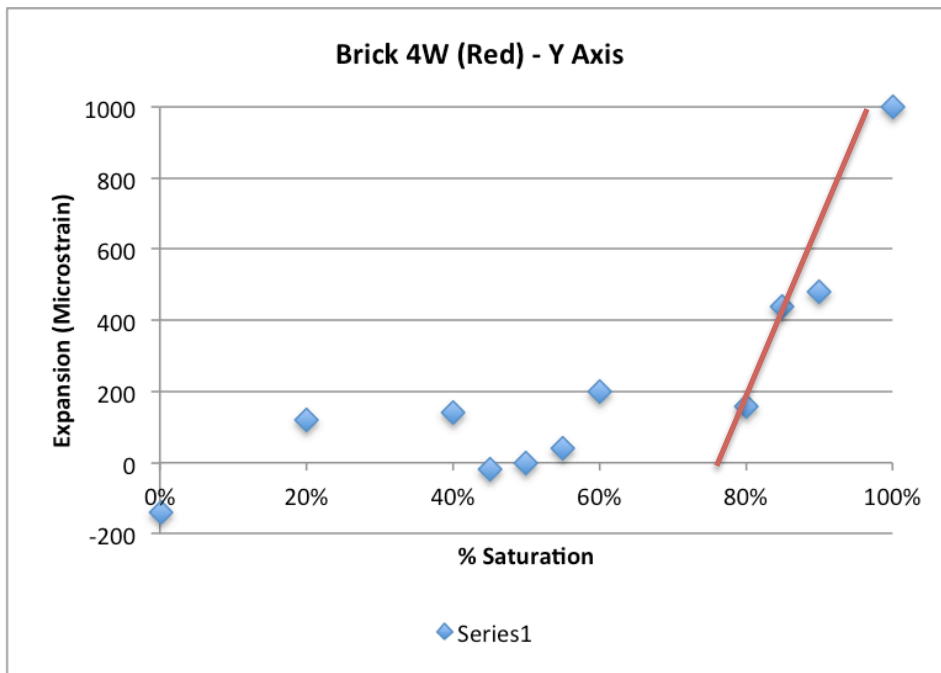
FIGURE 73: 2-DIMENSIONAL FROST DILATOMETRY RESULTS – BRICK SPECIMEN 4W – Y AXIS AVERAGE ϵ_{CRIT} MEASUREMENTS.

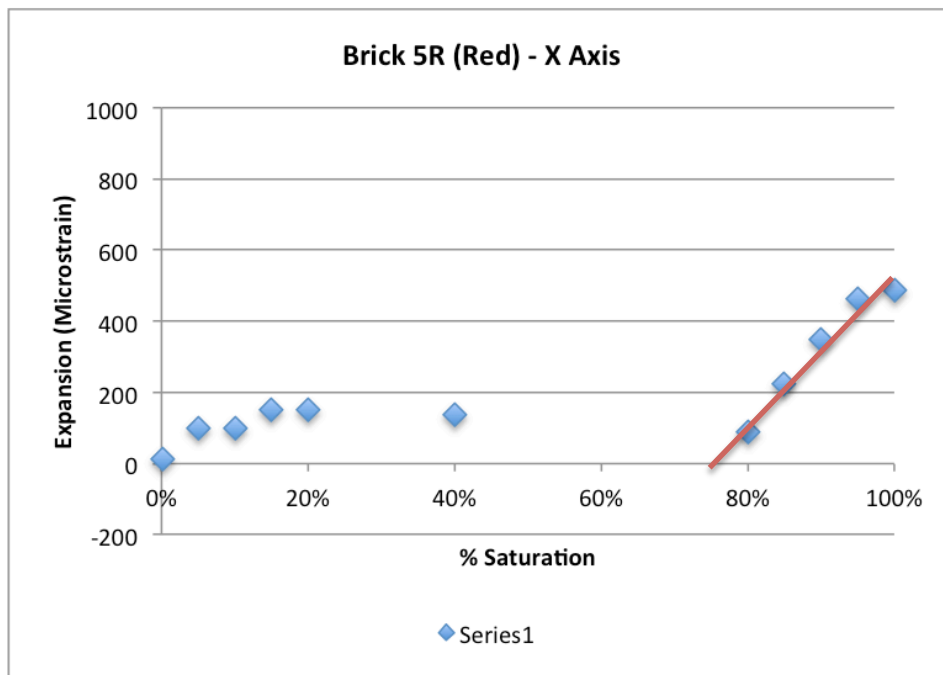
FIGURE 74: 2-DIMENSIONAL FROST DILATOMETRY RESULTS – BRICK SPECIMEN 5R – X AXIS AVERAGE S_{CRIT} MEASUREMENTS.

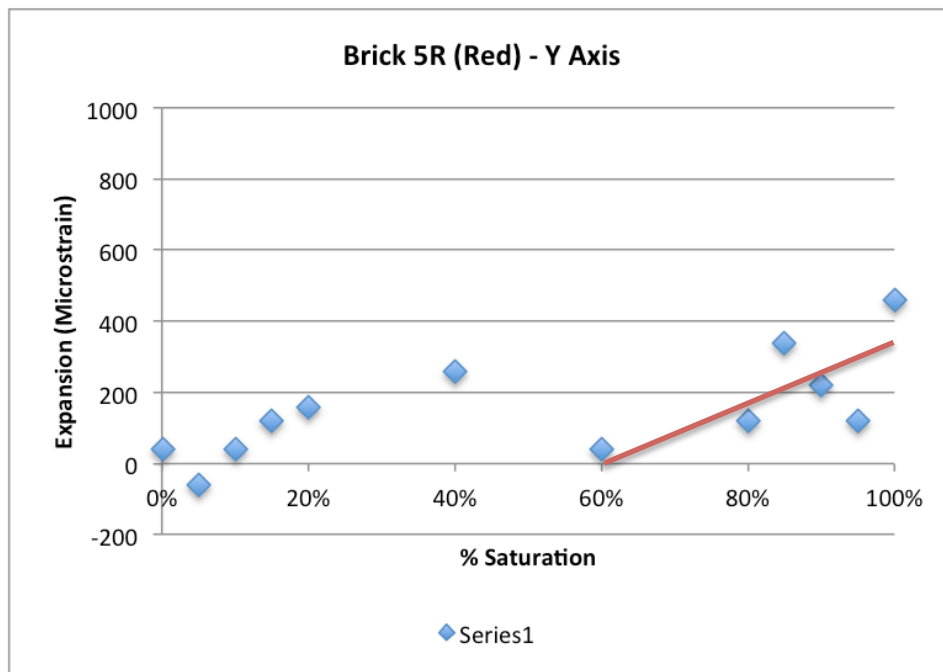
FIGURE 75: 2-DIMENSIONAL FROST DILATOMETRY RESULTS – BRICK SPECIMEN 5R – Y AXIS AVERAGE S_{CRIT} MEASUREMENTS.

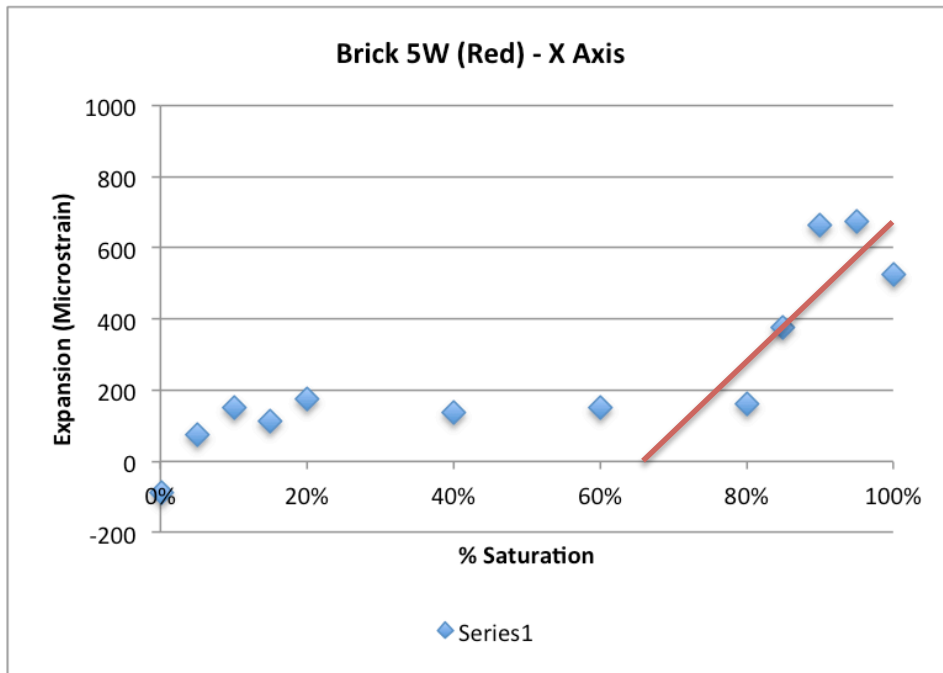
FIGURE 76: 2-DIMENSIONAL FROST DILATOMETRY RESULTS – BRICK SPECIMEN 5W – X AXIS AVERAGE ϵ_{CRIT} MEASUREMENTS.

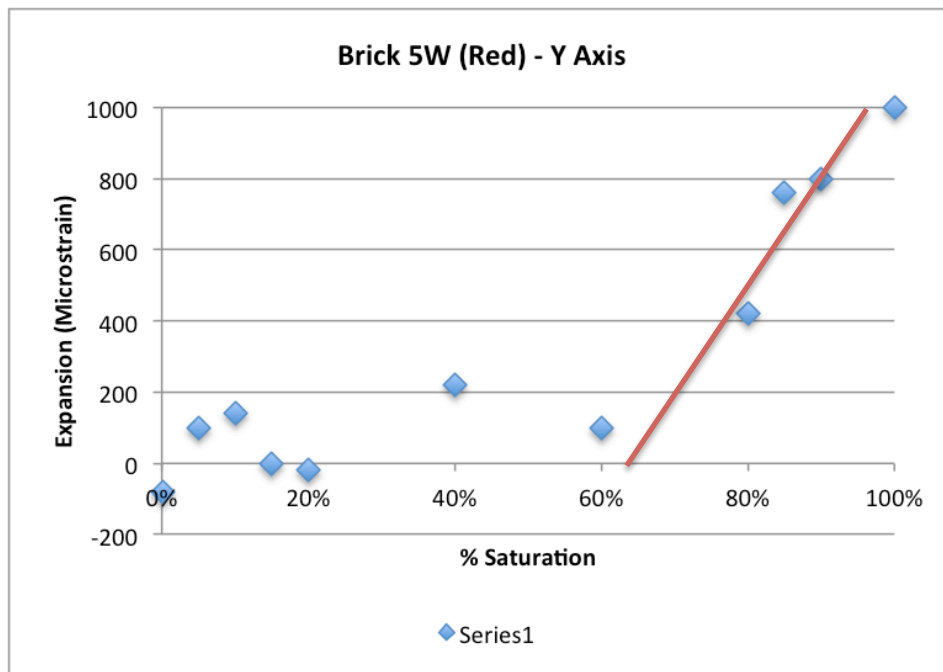
FIGURE 77: 2-DIMENSIONAL FROST DILATOMETRY RESULTS – BRICK SPECIMEN 5W – Y AXIS AVERAGE ϵ_{CRIT} MEASUREMENTS.

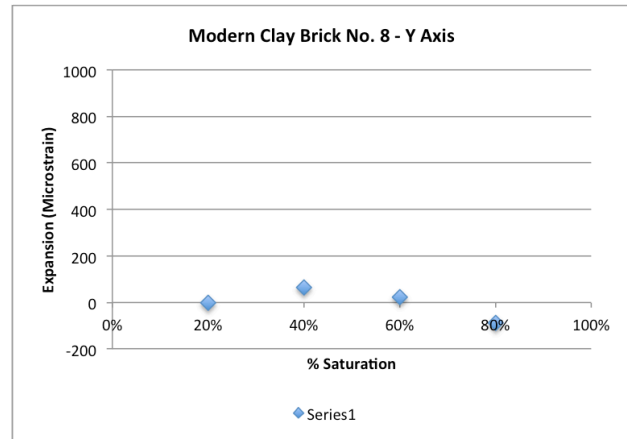
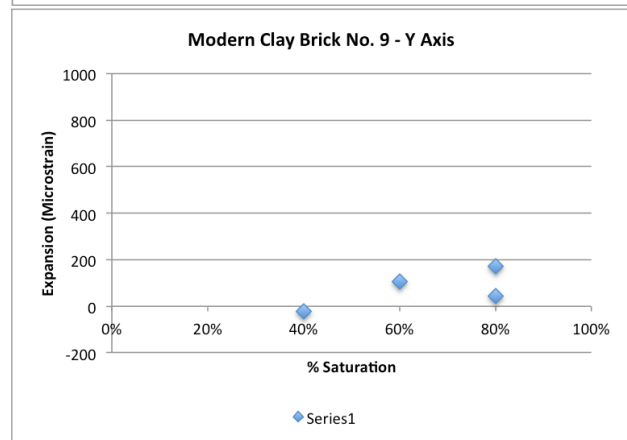
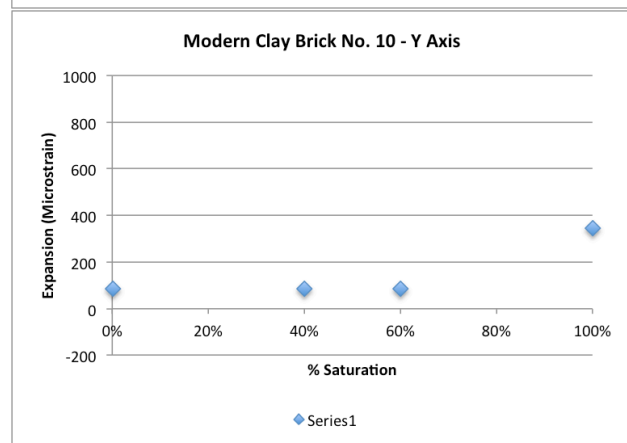
FIGURE 79:2-DIMENSIONAL FROST DILATOMETRY RESULTS – AVERAGE S_{CRIT} MEASUREMENTS MODERN BRICK SPECIMENS 8, 9 AND 10.

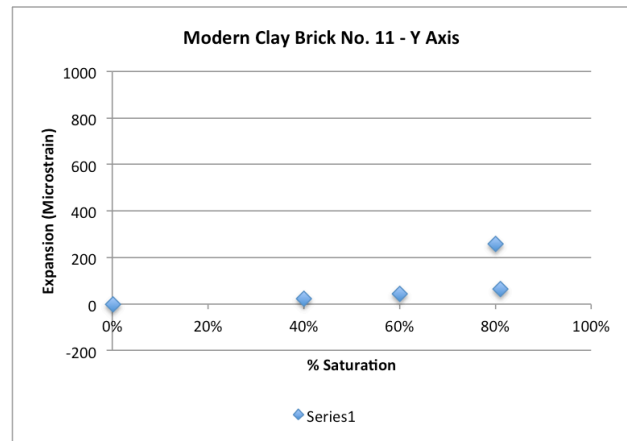
FIGURE 80:2-DIMENSIONAL FROST DILATOMETRY RESULTS – AVERAGE S_{CRIT} MEASUREMENTS FOR MODERN BRICK SPECIMEN No. 11.

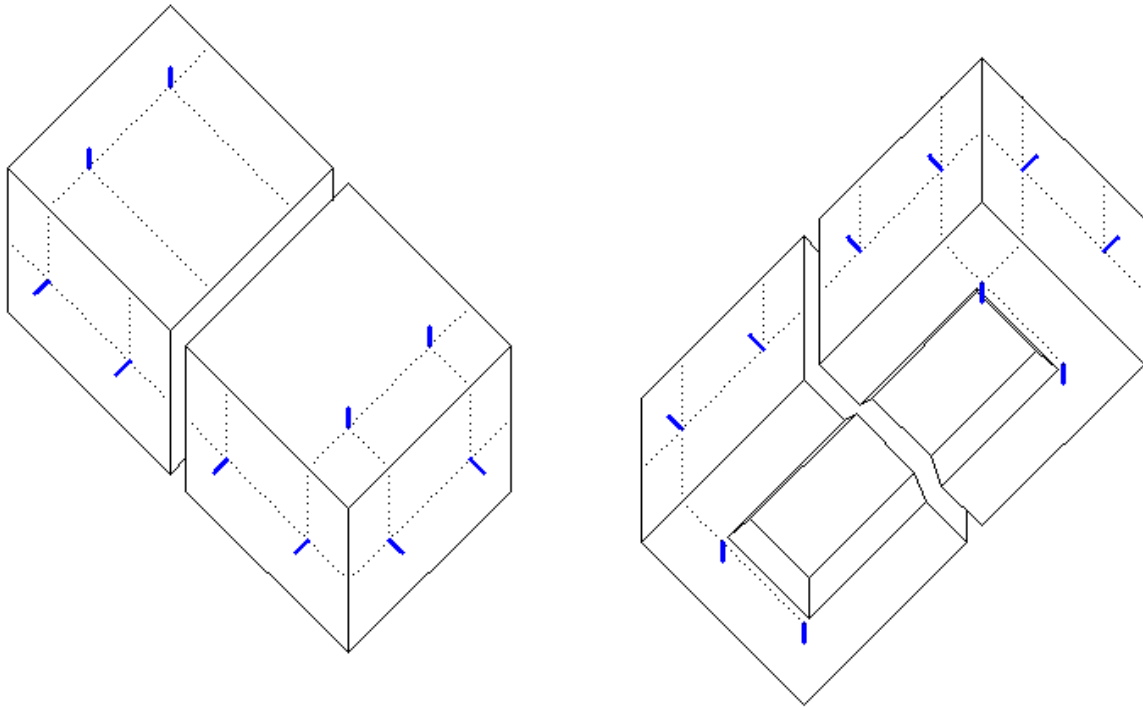
FIGURE 81: 3-DIMENSIONAL FROST DILATOMETRY – PIN PLACEMENT DIAGRAM.

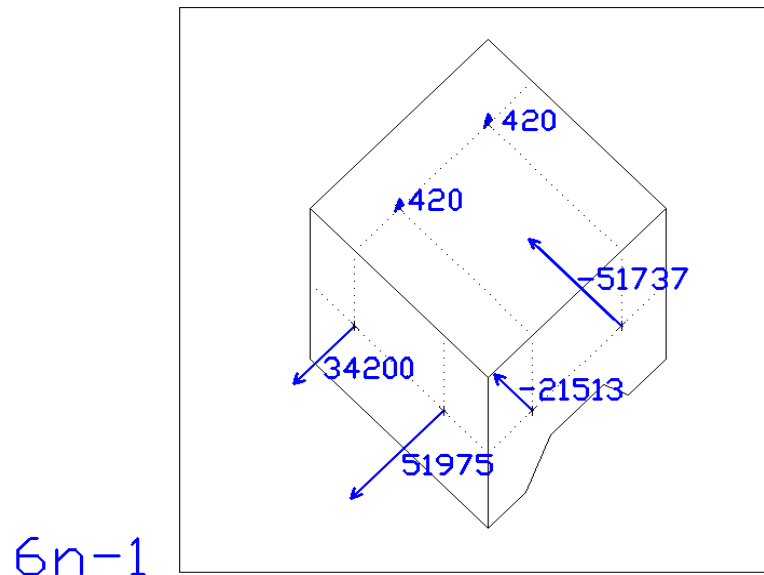
FIGURE 82: 3-DIMENSIONAL FROST DILATOMETRY RESULTS – AVERAGE ϵ_{SCRIT} MEASUREMENTS FOR BRICK SPECIMEN 6N-1.

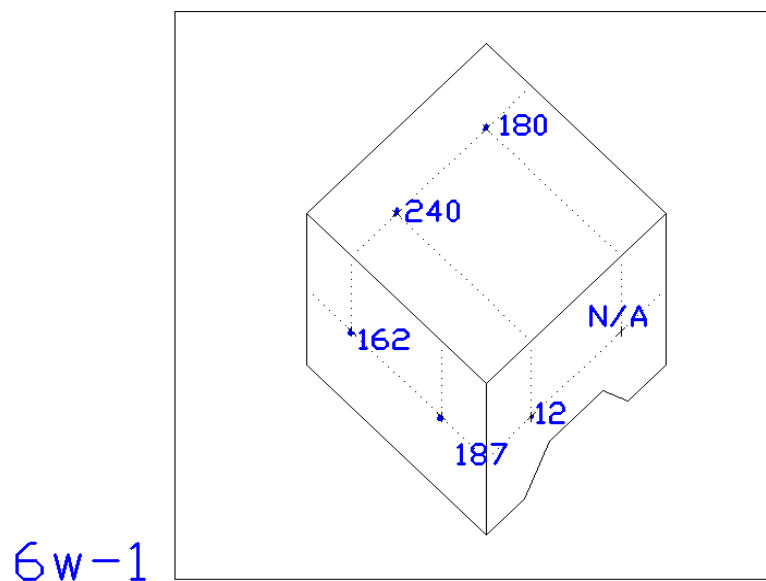
FIGURE 83: 3-DIMENSIONAL FROST DILATOMETRY RESULTS – AVERAGE ϵ_{SCRIT} MEASUREMENTS FOR BRICK SPECIMEN 6W-1.

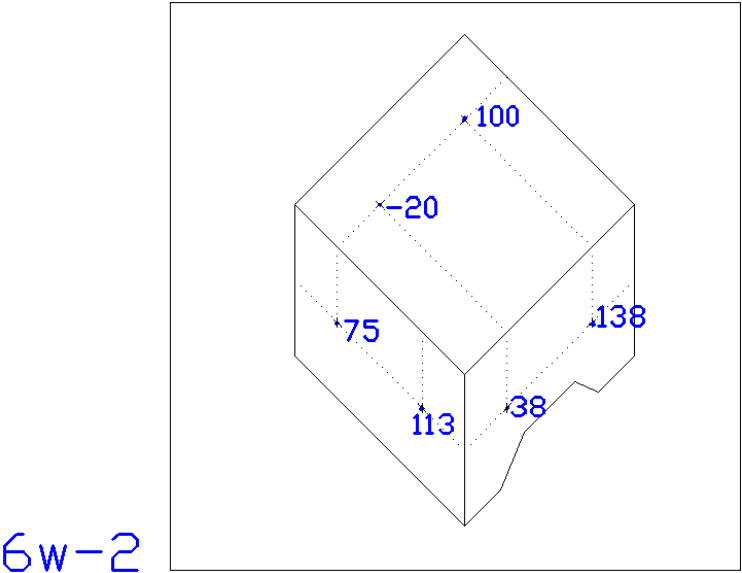
FIGURE 84: 3-DIMENSIONAL FROST DILATOMETRY RESULTS – AVERAGE S_{CRIT} MEASUREMENTS FOR BRICK SPECIMEN 6W-2.

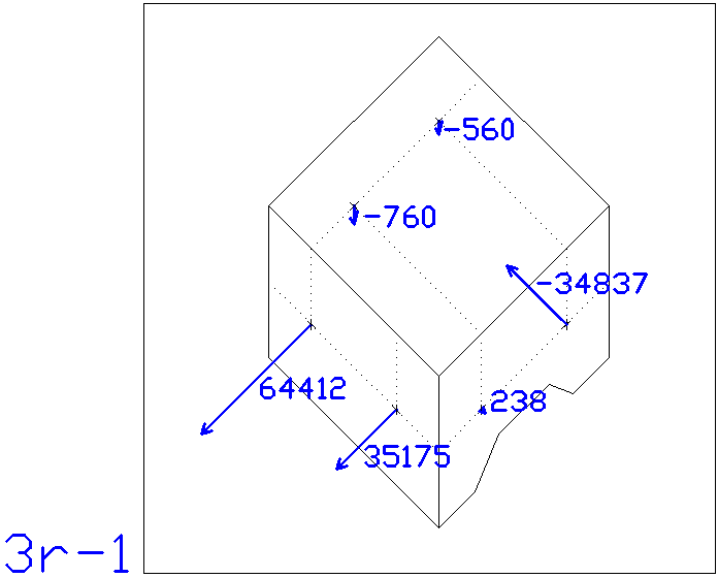
FIGURE 85: 3-DIMENSIONAL FROST DILATOMETRY RESULTS – AVERAGE S_{CRIT} MEASUREMENTS FOR BRICK SPECIMEN 3R-1.

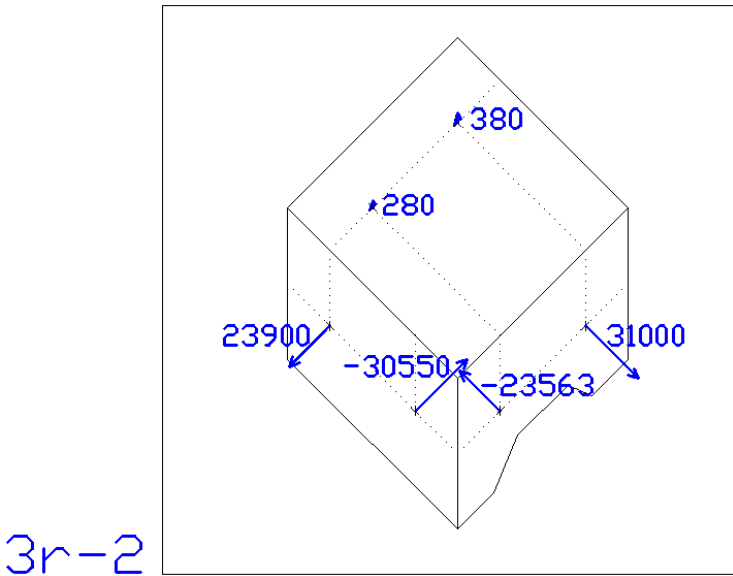
FIGURE 86: 3-DIMENSIONAL FROST DILATOMETRY RESULTS – AVERAGE ϵ_{SCRIT} MEASUREMENTS FOR BRICK SPECIMEN 3R-2.

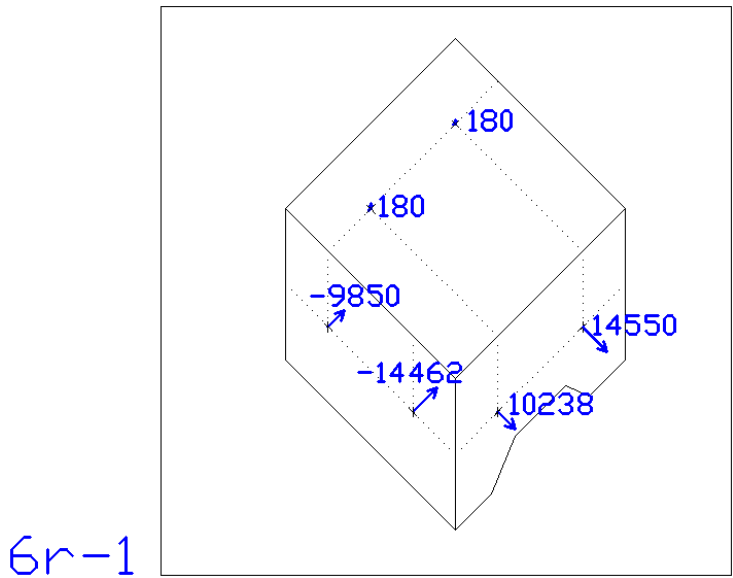
FIGURE 87: 3-DIMENSIONAL FROST DILATOMETRY RESULTS – AVERAGE ϵ_{SCRIT} MEASUREMENTS FOR BRICK SPECIMEN 6R-1.

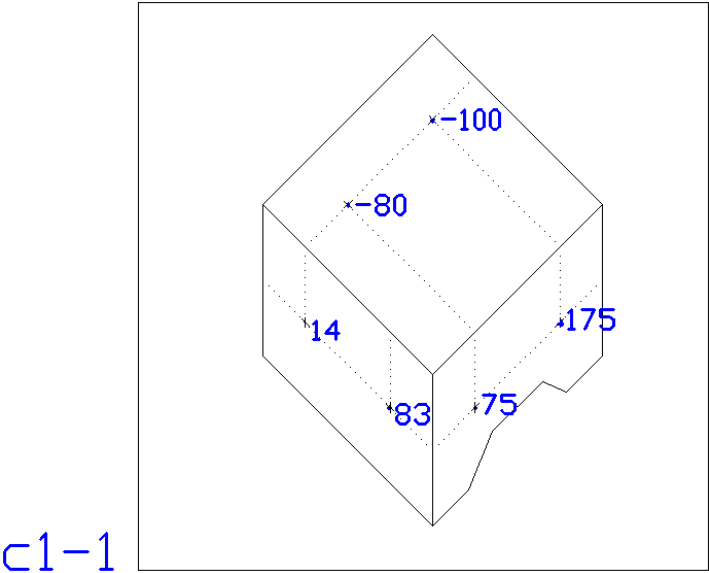
FIGURE 88: 3-DIMENSIONAL FROST DILATOMETRY RESULTS – AVERAGE ϵ_{SCRIT} MEASUREMENTS FOR BRICK SPECIMEN C1-1.

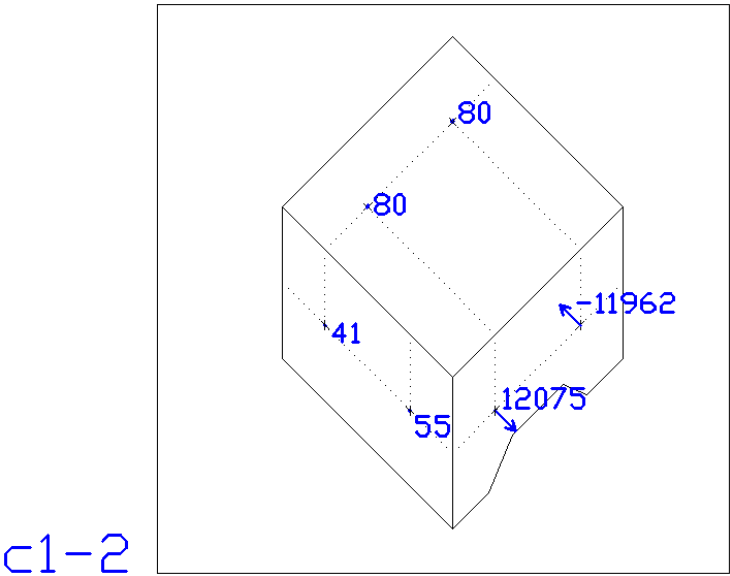
FIGURE 89: 3-DIMENSIONAL FROST DILATOMETRY RESULTS – AVERAGE ϵ_{SCRIT} MEASUREMENTS FOR BRICK SPECIMEN C1-2.

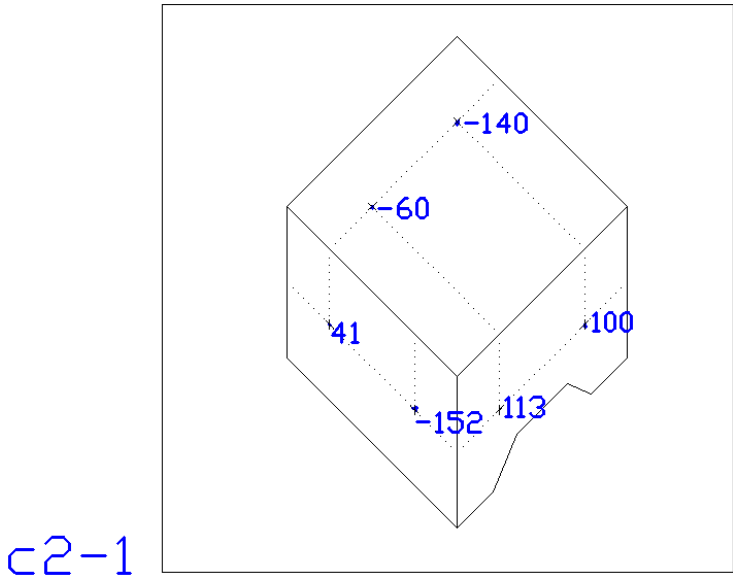
FIGURE 90: 3-DIMENSIONAL FROST DILATOMETRY RESULTS – AVERAGE ϵ_{SCRIT} MEASUREMENTS FOR BRICK SPECIMEN C2-1.

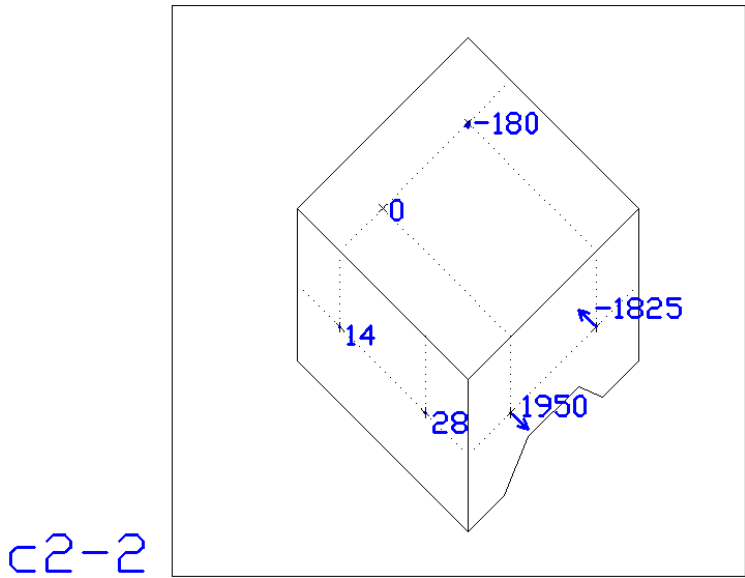
FIGURE 91: 3-DIMENSIONAL FROST DILATOMETRY RESULTS – AVERAGE ϵ_{SCRIT} MEASUREMENTS FOR BRICK SPECIMEN C2-2.

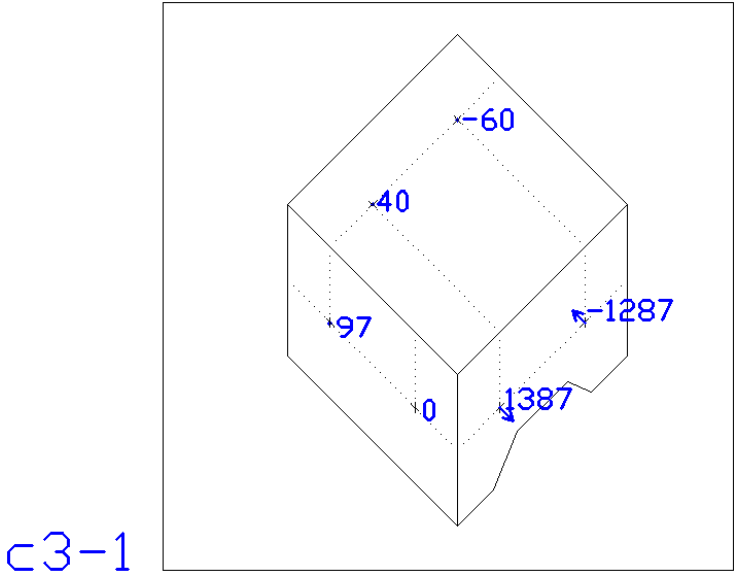
FIGURE 92: 3-DIMENSIONAL FROST DILATOMETRY RESULTS – AVERAGE ϵ_{CRIT} MEASUREMENTS FOR BRICK SPECIMEN C3-1.

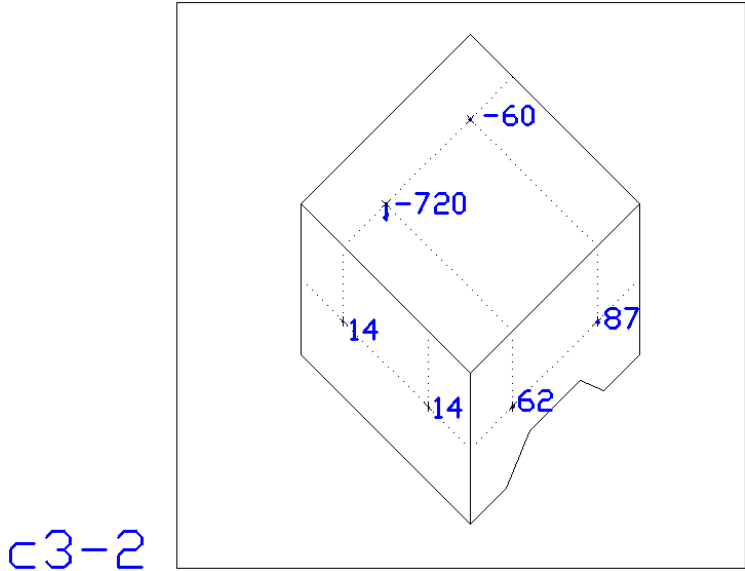
FIGURE 93: 3-DIMENSIONAL FROST DILATOMETRY RESULTS – AVERAGE ϵ_{CRIT} MEASUREMENTS FOR BRICK SPECIMEN C3-2.

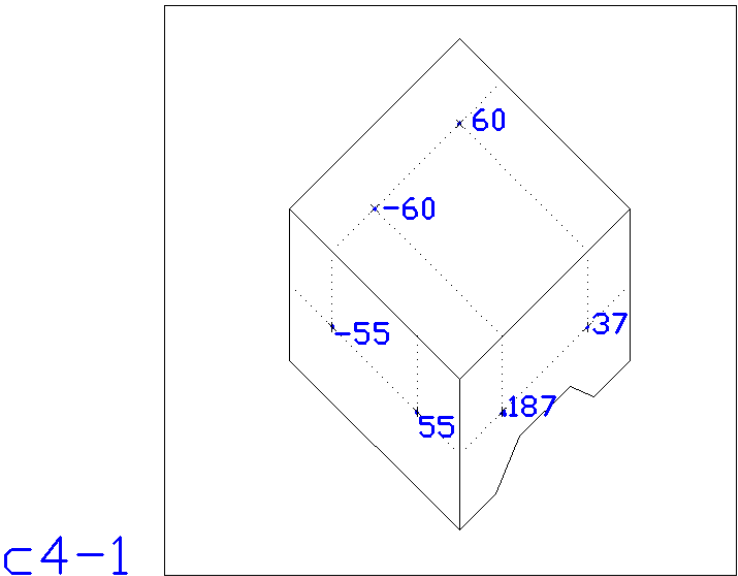
FIGURE 94: 3-DIMENSIONAL FROST DILATOMETRY RESULTS – AVERAGE S_{CRIT} MEASUREMENTS FOR BRICK SPECIMEN c4-1.

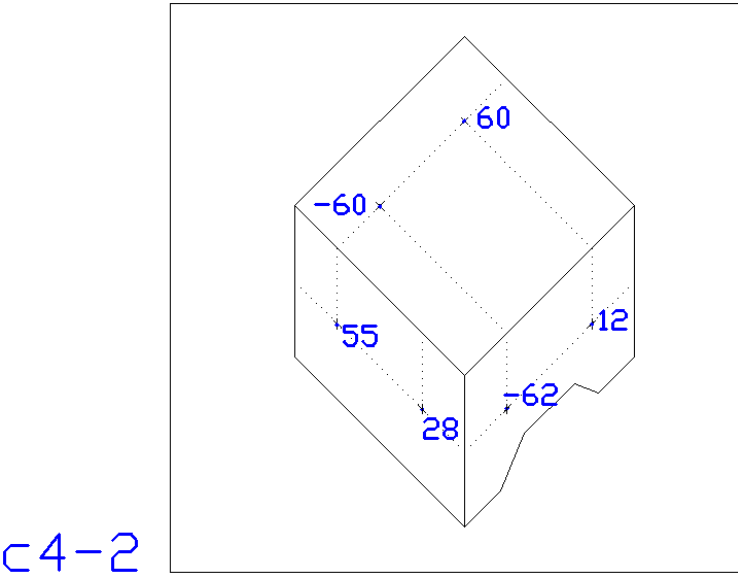
FIGURE 95: 3-DIMENSIONAL FROST DILATOMETRY RESULTS – AVERAGE S_{CRIT} MEASUREMENTS AND BRICK SPECIMEN c4-2.

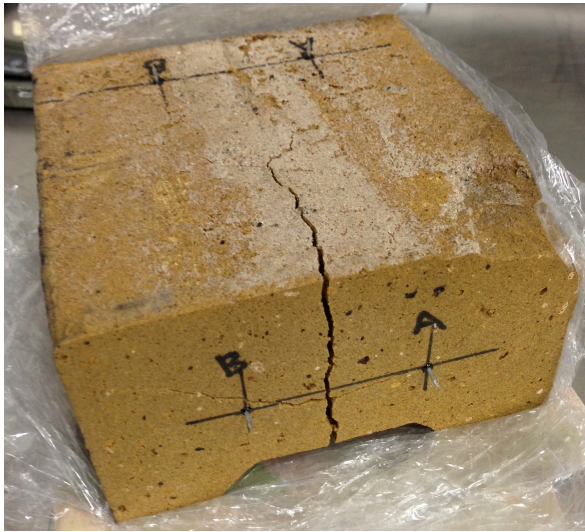
FIGURE 96: 3D FROST DILATOMETRY; UNEVEN EXPANSION.

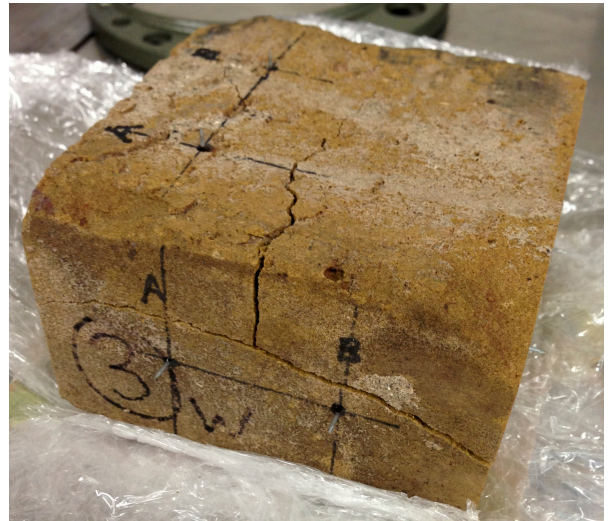
FIGURE 97: 3D FROST DILATOMETRY; UNEVEN EXPANSION.

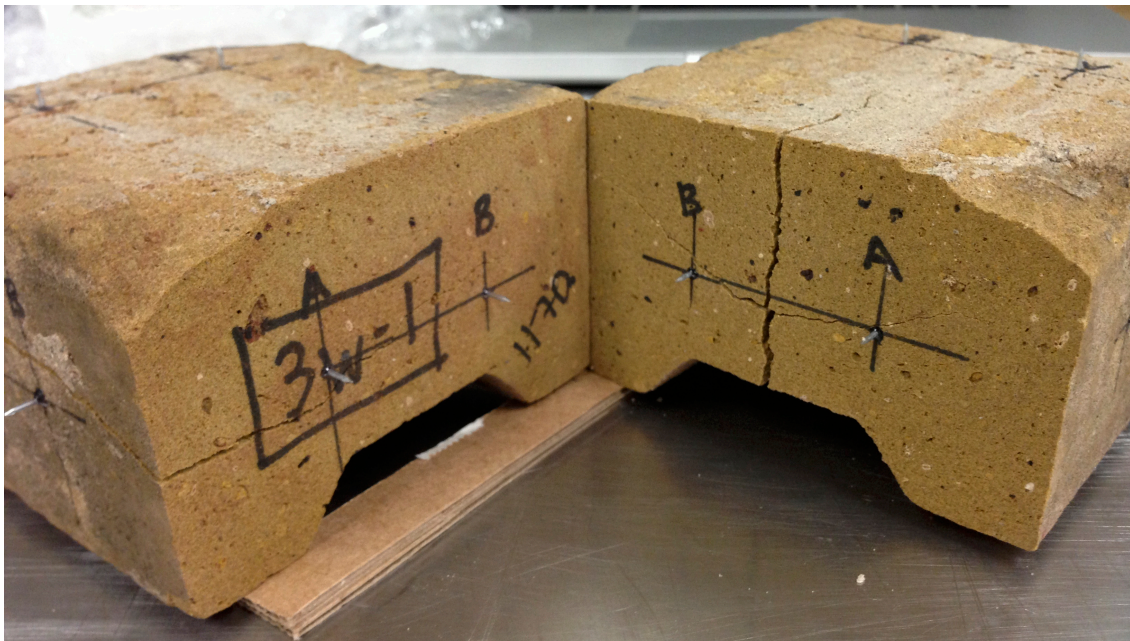
FIGURE 98: 3D FROST DILATOMETRY; CLAY BRICK EXPERIENCED DIFFERENT INTERNAL FORCES AND EXPANSION ON EITHER SIDE OF THE CUT.

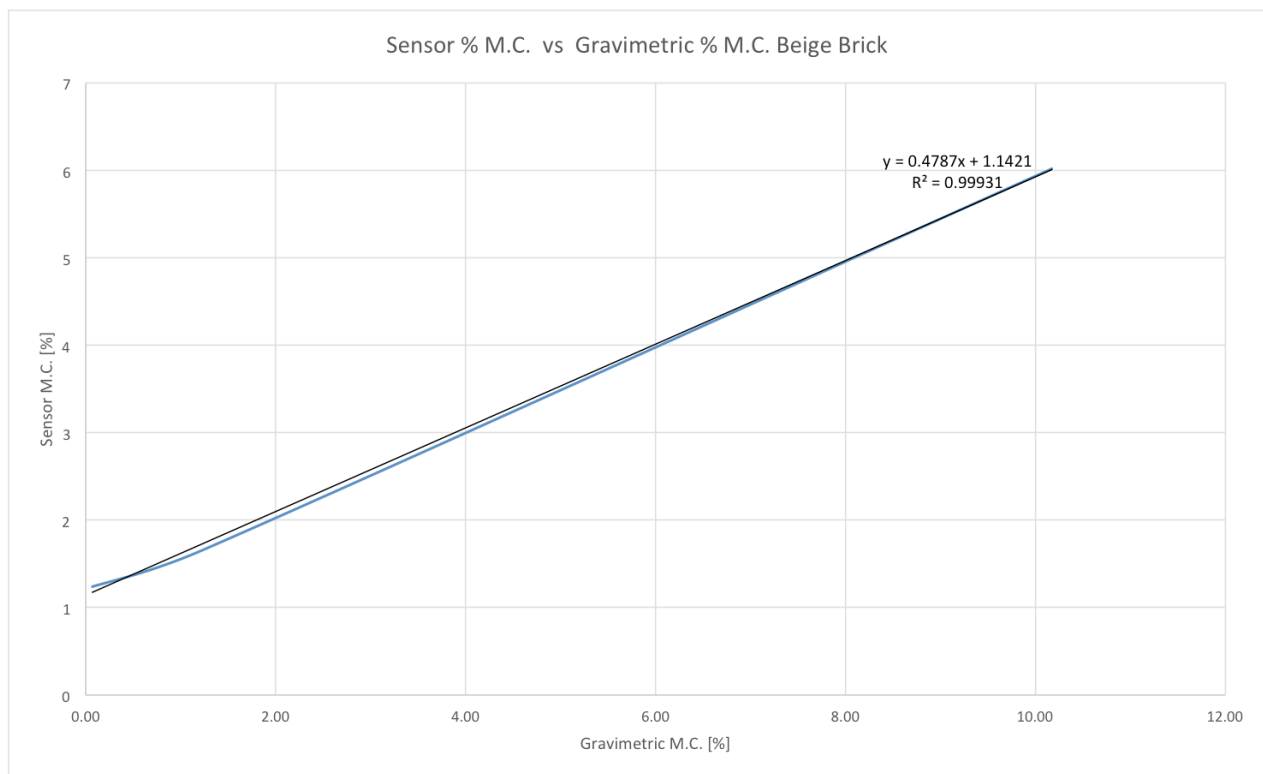
FIGURE 104: MOISTURE CONTENT SENSOR CORRELATION TO GRAVIMETRIC MOISTURE CONTENT FOR BEIGE CLAY BRICK.

Once the gravimetric measurements were taken of both brick types at different humidities, the entire process was repeated with Moisture Content sensors installed within bricks. The bricks, and sensors within, were sealed inside a vessel with a controlled relative humidity, and allowed to acclimatize over a 1-week period. The following calibration curves were obtained by charting the gravimetric moisture content against the moisture content sensor for each type of clay brick (Refer to Figure 104 and Figure 105).

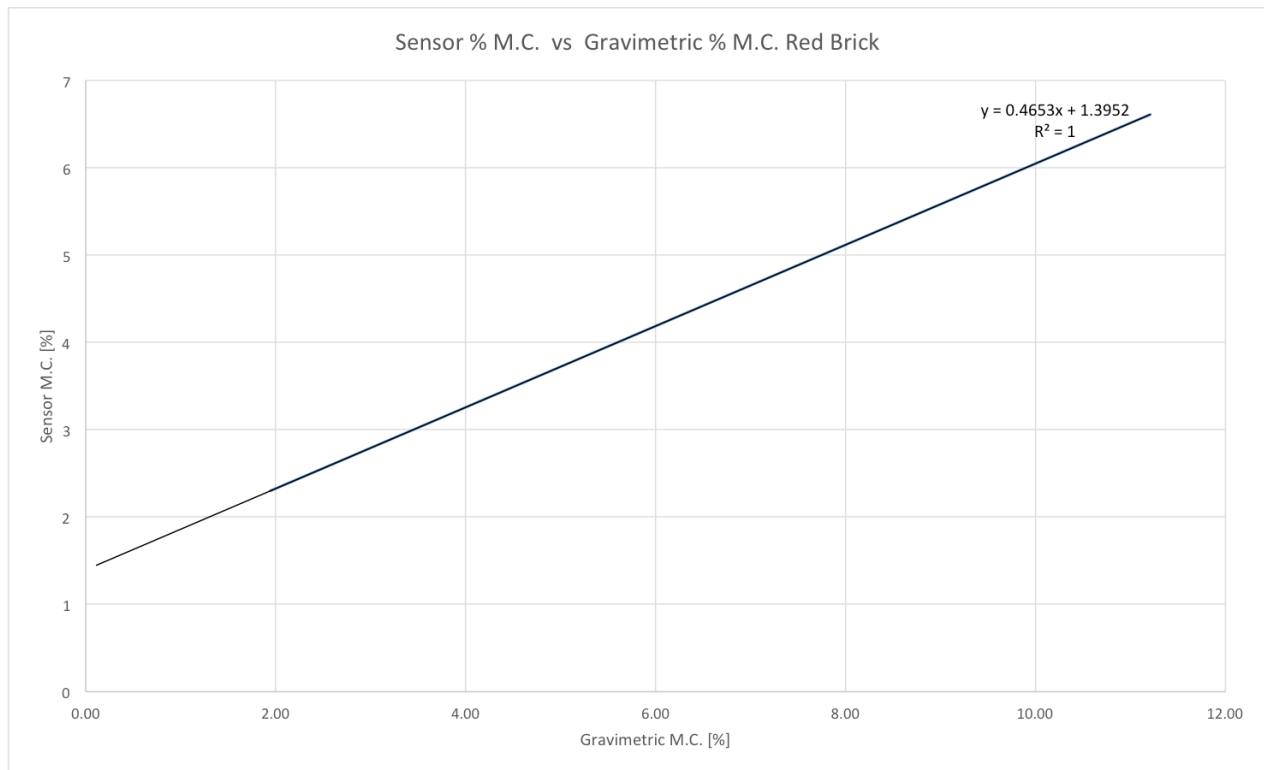
FIGURE 105: MOISTURE CONTENT SENSOR CORRELATION TO GRAVIMETRIC MOISTURE CONTENT FOR RED CLAY BRICK.
