**RECONSTRUCTING A BUILDING OF HISTORIC SIGNIFICANCE WITHIN CURRENT  
REGULATORY CONTEXT**

Focusing on Frank Lloyd Wright's Banff Pavilion

A Major Research Project

Master of Building Science

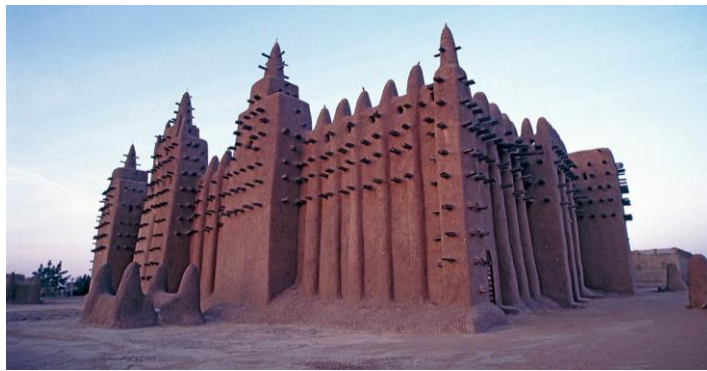
**Figure 4 The Great Mosque of Djenné, Mali. The massive walls are erected by sun-dried mud bricks with mud mortar joints and plaster [28].**

Another example of intangible aspects of heritage related to authenticity are the traditions and rituals in some conservation approaches [27]. This concept can be seen on local masons' practices in Djenné in Mali (see Figure 4). The traditional skills were preserved by means of a guild which safeguarded the architectural heritage. The guild's practices and philosophy were not dictated through any text but were transmitted by craftsmen experience [27]. Consequently, authentic means of conservation is characterized by the performance-based traditional transmission of knowledge in which principles are set by the guild [27]. However, such practices may suffer a lack of documentation when they are only transmitted by experience, and thus lack of authentication.

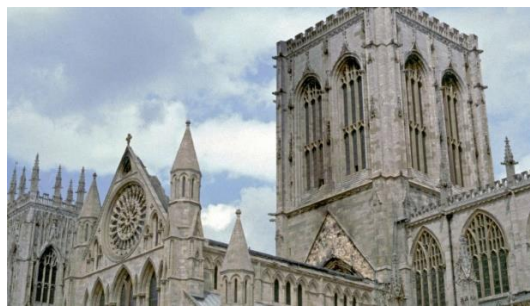
Figure 9 York Minster south vault destroyed by a fire in 1984 [37].

In England, an eleventh-century cathedral known as York Minster saw the south portion of its roof destroyed by fire in 1984 (see Figure 9). Builders debated the design of the new roof and vault as well as the material of the elements. The decision made by the estate manager for the cathedral was to replicate the original design with minor differences to preserve the architectural character of the Minster (see Figure 10). Yet the sheathings which primarily capped the web of the vault (Figure 11) were replaced by a metal mesh sandwiched between fire-retardant plasterboards in order to prevent flames spread [9]. From the above-stated approaches, this example used the authentic (partial) reconstruction approach.

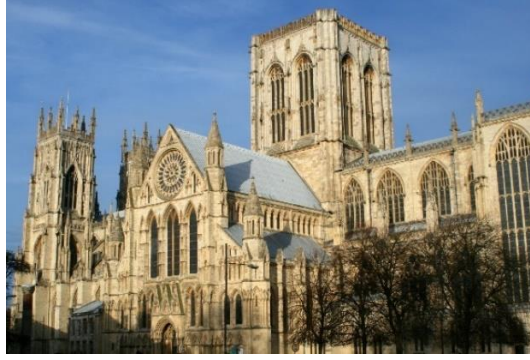
**Figure 10 York Minster cathedral after restoration of the roof [38].**

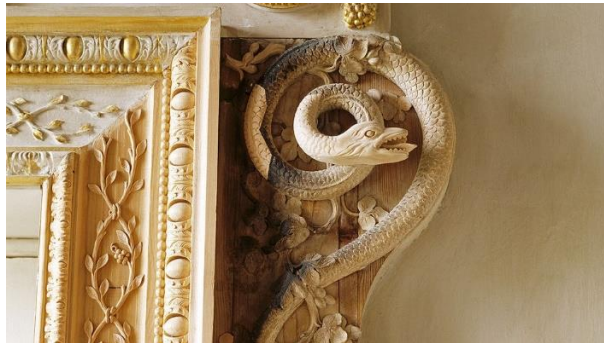
**Figure 13 At Uppark, some burnt details were left unpainted to show where the old and new meet [43].**

reconstruction and opt for rehabilitation, the pressure of affordability and competitive tenders meant that absolute repair work had to be compromised to be eligible for insurance cover [9]. In sum, the reconstruction was meant to reinstate the building at its condition before the fire (see Figure 13). Also, the process included thorough photographic and photogrammetric records as well as computer-aided design (CAD), which made the work more accurate within a shorter time slot [42]. In addition, the original material was collected and put into 3,860 dustbins labelled with the grid references, which permitted reinstatement and relocation of the original elements at the right place (see Figure 14) [9].

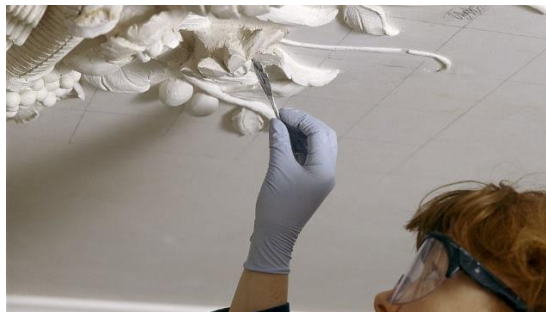
**Figure 14 A plasterer working on the reinstatement of the ceiling of the Red Drawing Room at Uppark [43].**

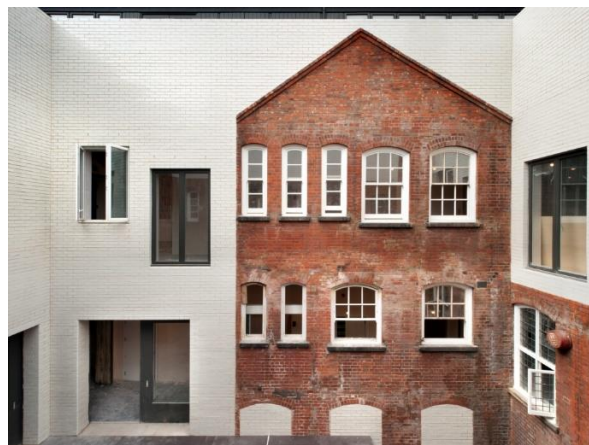
**Figure 15** Reconstructed envelope on the Battersea Arts Centre using original salvaged bricks [44].

An example of adaptive reconstruction is the Battersea Arts Centre in London, which was damaged by fire in 2015. The Grand Hall's upper parts were destroyed by fire as well as the lower level fabric finishes [9]. Other elements were damaged by water following the firefighting action. The external envelope was rebuilt to match the original using 10,000 salvaged original bricks (see Figure 15). The surviving elements of the Grand Hall were preserved. In order to recover for the lost material, a new timber mesh ceiling and a demountable gallery were added at a high level (see Figure 16). Other elements were also reinstated to return to their original state [9]. The resulting building is an example of authentic reconstruction of the exterior envelope and equivalent reconstruction mixed with contemporary design (Figure 17) to the Grand Hall made improvements to allow for a wider range of events in the centre [9]. Hence, replacing lost elements with contemporary material rather than replicating them was determined by the needs of functionality embedded in the twenty-first-century activities of the local community.

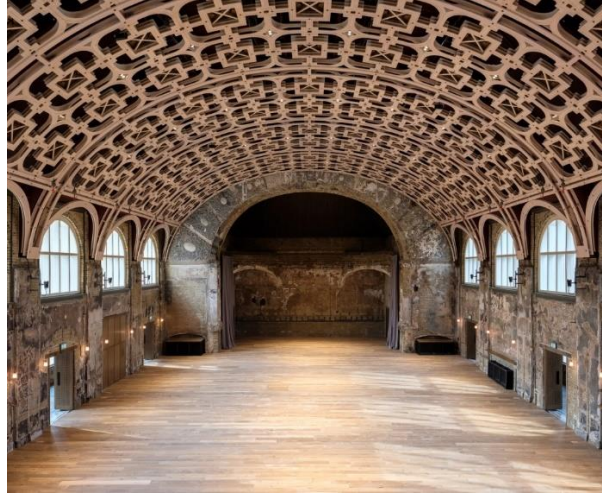
Figure 16 New timber lattice ceiling at the Battersea Arts Centre [45].

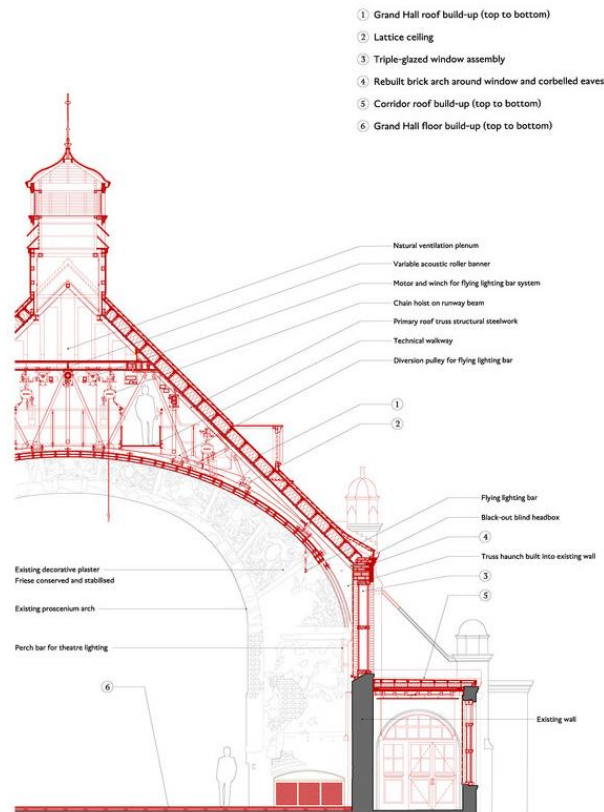
Figure 17 A detail section of the Grand Hall in Battersea Arts Centre [44].

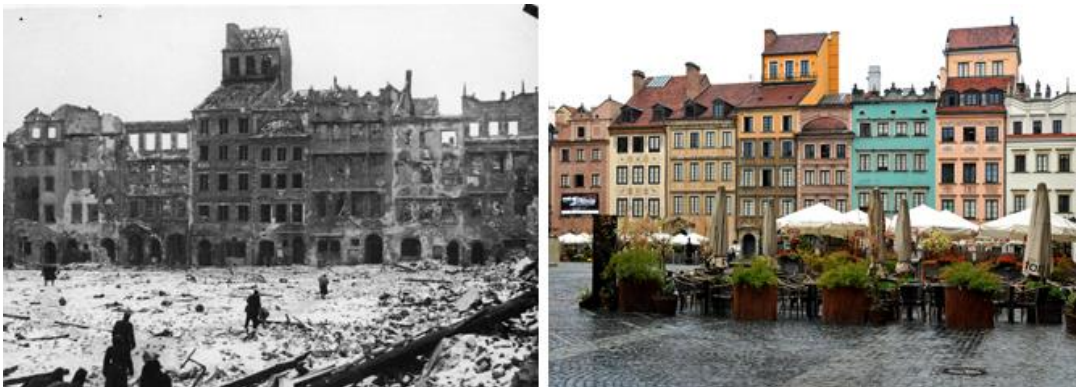
Figure 18 The Marketplace of the Old Town (Stare Miasto) of Warsaw following the WWII attacks (left), and following reconstruction (right) [46].

Moreover, the function of a building is sometimes valued as a heritage character. The Stare Miasto was supposed to be reconstructed with dwellings with some services and activities to instore a new beginning in the region [9]. The buildings facing the main market were given earlier service functions such as restaurants and shops (see Figure 18). Hence, the goal was to preserve the layout plan, which dated from

the eighteenth century [9]. However, many monumental entrance halls dating from the Middle Ages and the Renaissance were altered over time. It was difficult to adopt new regulations concerning living conditions as well as kitchen and sanitary installations that had to be implemented in every apartment. The rooms' dispositions were to be maintained if the authentic fragments of the building were deemed of great architectural value. Also, the building would not be converted to larger apartments if the transformation altered the character. Instead, they would host cultural institutions. The façades were to be kept intact as well as the roofscape. The roofscape was conserved by keeping the old chimneys for ventilation with central heating systems installed under the floors [9].

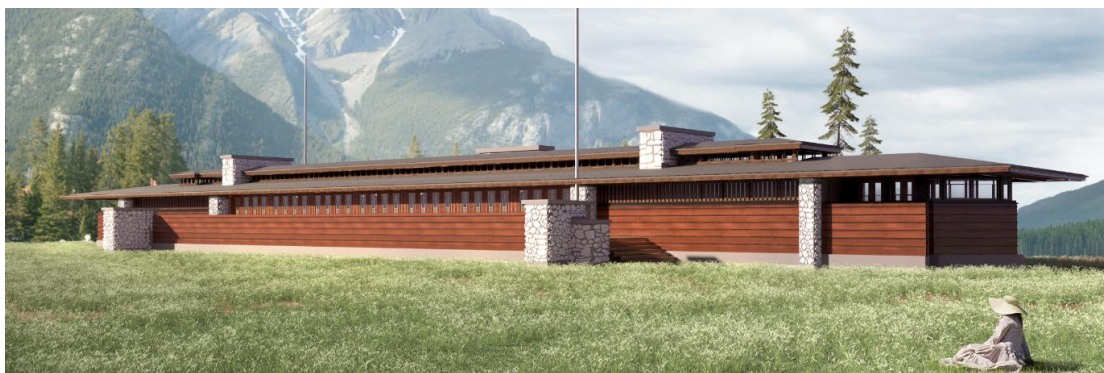
**Figure 21 Banff Pavilion architectural modelling by a team of students at Ryerson University led by Pr. Yew-Thong Leong [1].**

At the time of this study, a group of researchers from Ryerson University in Toronto are involved in the reconstruction of the Banff Pavilion (see Figure 21). The group mandated the author of this study to examine the River Forest Tennis Club in Chicago, Illinois, a building designed and constructed by FLW in the 1900s and has a similar design to the Banff Pavilion (see Figure 32). The goal of this visit was to assess typical FLW's Character-Defining Elements within the building in order to produce a Statement of Significance (SOS). During the visit, many characters were identified as essential to FLW prairie style buildings, which later helped pinpointing essential Banff Pavilion character-defining elements to be preserved.

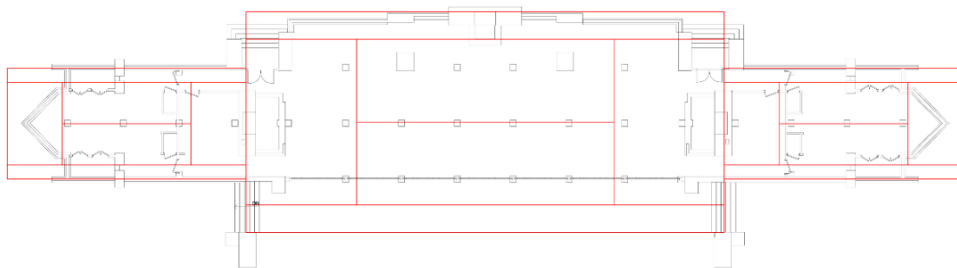
Figure 24 Plan drawing showing possible tennis court proportion in the Banff Pavilion design [53].

The building and many of its elements are defined by logical and consistent proportions. Pr. Kendra Smith from Ryerson University analyzed the proportions of the Banff Pavilion using plans of the River Forest Tennis club (RFTC), where both buildings share almost identical characteristics in plan [53]. As can be seen in Figure 24 and Figure 25, it was remarked that the Banff Pavilion has proportions similar to a Tennis Court, which yields the possibility that FLW may have purposely incorporated these proportions to relate the River Forest Tennis Club to a Tennis court [53].

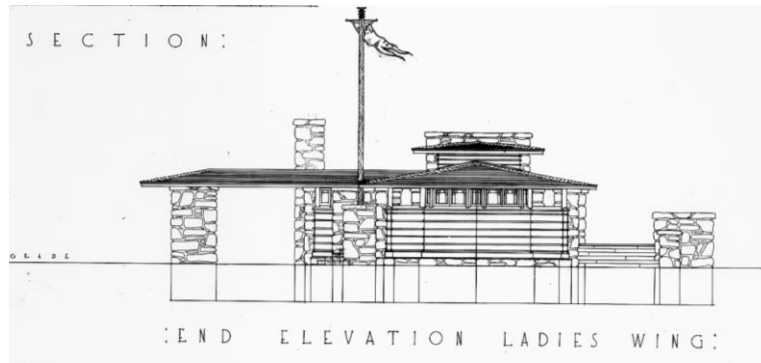
**Figure 26 End Elevation Ladies Wing [49].**

The natural face of a stone, without any cut surface. The stone should preserve its natural shape between mortar joints. Figure 26 shows how the end elevation is dominated by the stone elements, compared to the front and rear elevation, which are dominated by wooden elements.

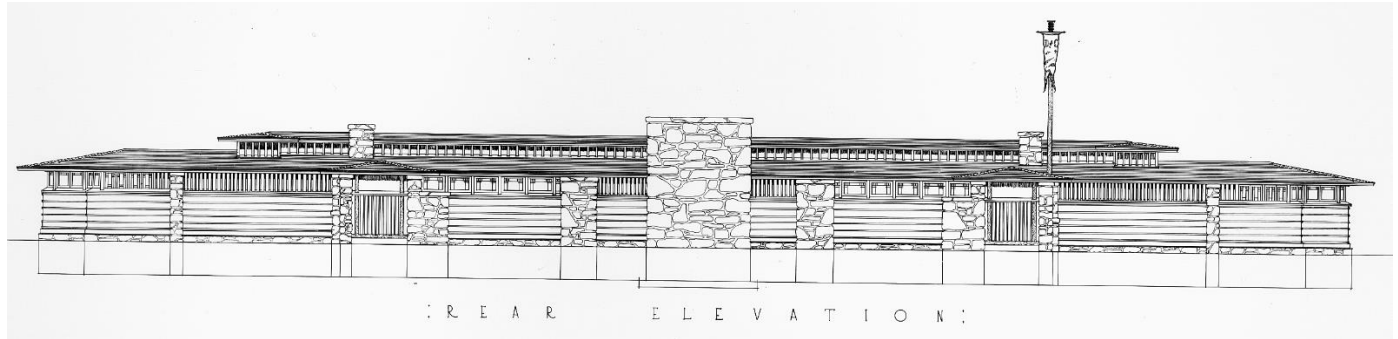
**Figure 28 Rear Elevation Drawing [49].**

The gentle slope of the roof emphasizes its horizontality. In fact, when viewing the elevation plan, the sloped section of the roof is merged into the long horizontal surrounding elements, which makes it almost negligible. Also, the 4 feet cedar shingles used on the roof demonstrates the small width of parallel lines created on an elevation (see Figure 28).

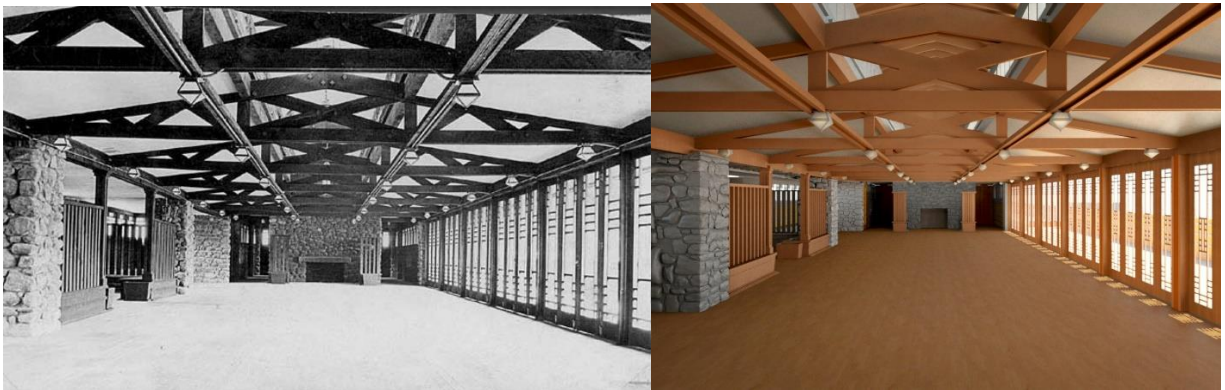
**Figure 29 The original Banff Pavilion viewed from inside (left) [55] and a 3D model rendering (right) [1].**

As can be seen in Figure 29, the wood truss (including rafters) supporting the roof is very clearly announced on the interior. The contrast of the dark wood brown with the clear white (more or less) emphasizes the stunning appearance of the truss.

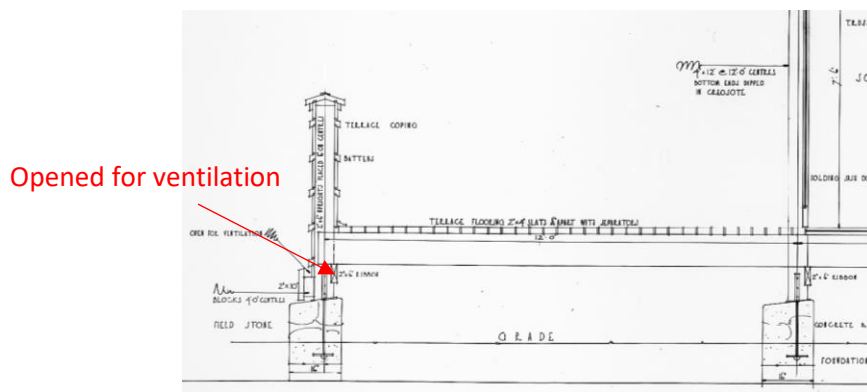
Figure 31 Cross section thro pavilion showing open ventilation system under the terrace [49].

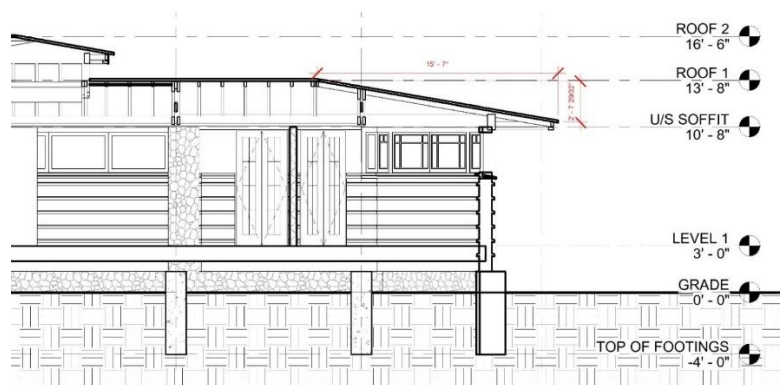
**Building Shape and Proportions:** In the roofing section of Part 9, it is required that wood shingles must have a minimum slope of 1 in 4. However, as seen in Figure 32 and Figure 33, the slope of the roof is approximately 1 in 6 based on the original drawings which is less than the minimum requirement. An increase in the slope of the roof will alter the horizontality and flattened shape of the building, which are emphasised as main characters in FLW prairie-style buildings.

Figure 32 Cut section on the east side of the Banff Pavilion showing the slope (1 in 6) of the roof in an east-west axis.

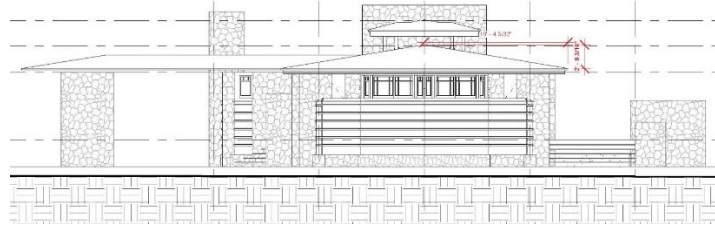
**Figure 33** Elevation on the west side of the building showing the slope (1 in 6) of the roof in a south-north axis.

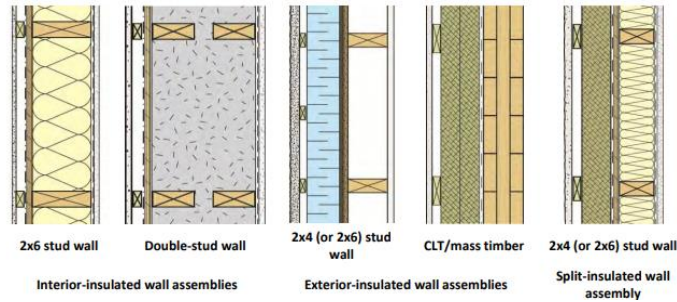
**Figure 34 Typical above-grade wood-frame wall assemblies with different insulation types [62].**

The *Guide for Designing Energy-Efficient Building Enclosures* presents in Figure 34 typical above-grade wood-frame wall assemblies with different insulation types. For the purpose of this study, the standard 2x6 stud wall is considered as it represents the original design of the Banff Pavilion. Table 3 presents the thermal resistance for various installed insulation options in 2x6 wood frame walls and their corresponding minimum thickness to comply with the wood-frame wall prescriptive minimum requirements as stated in Table 1.

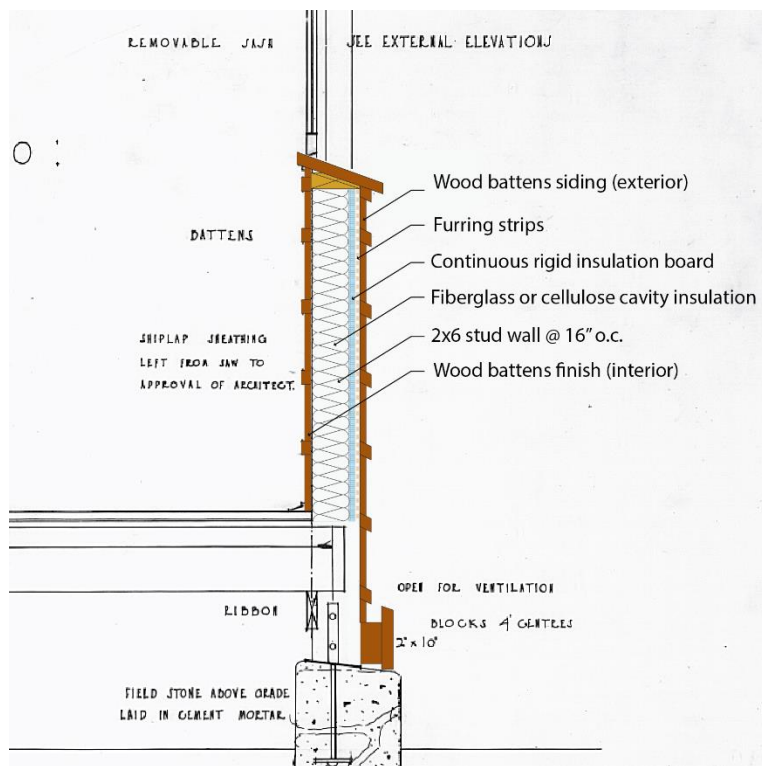
Figure 36 Overview summarizing XPS on 2x6 wood frame wall construction [64].

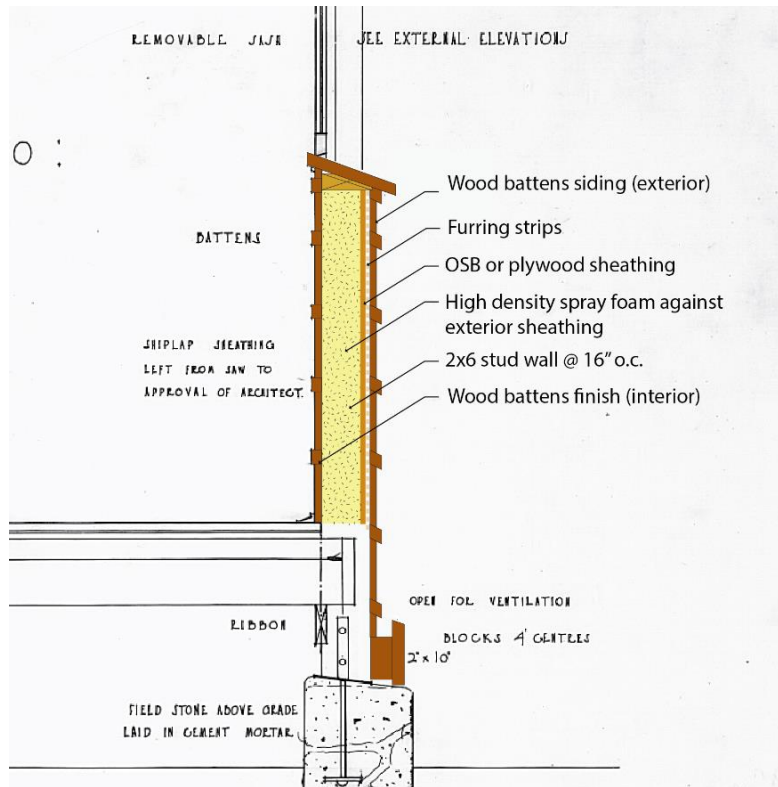
Figure 37 Overview summarizing spray foam on 2x6 wood frame wall construction [65].

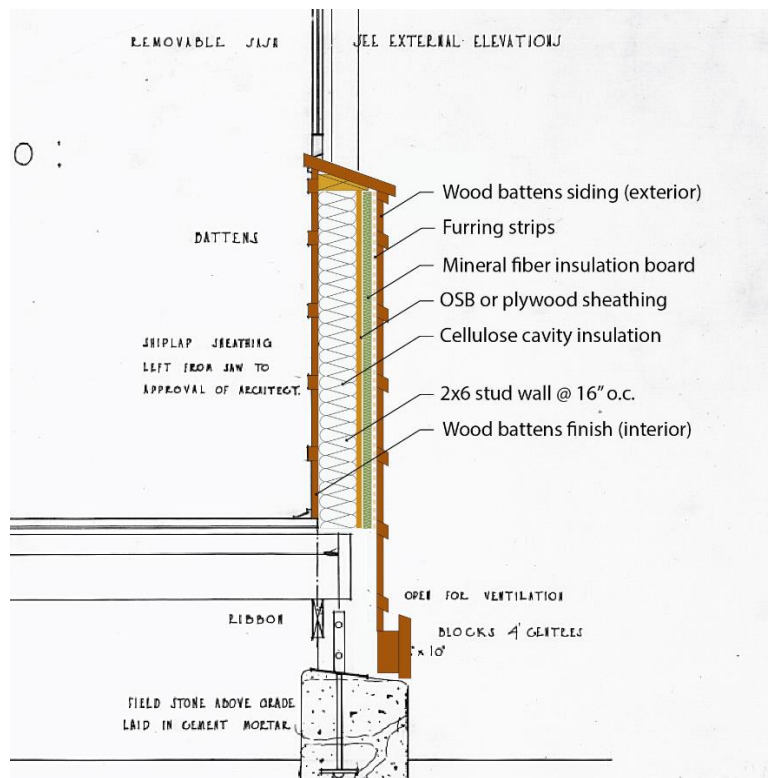
Figure 38 Overview summarizing 2x6 wood-frame wall assembly with mineral fiber insulation boards [66].

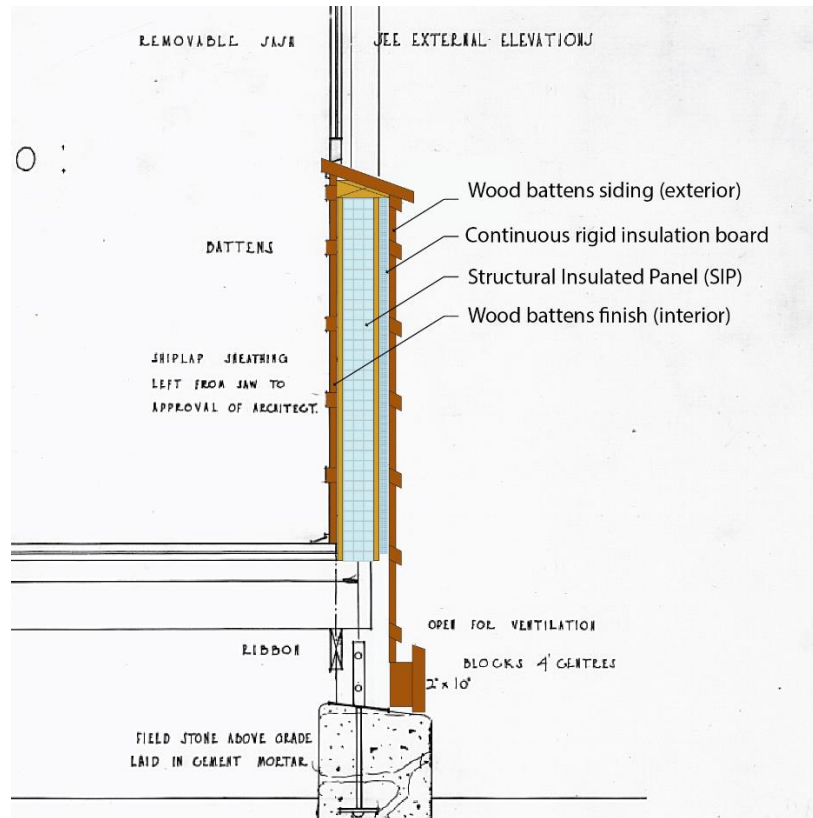
Figure 39 Overview summarizing SIPs wall construction [68].

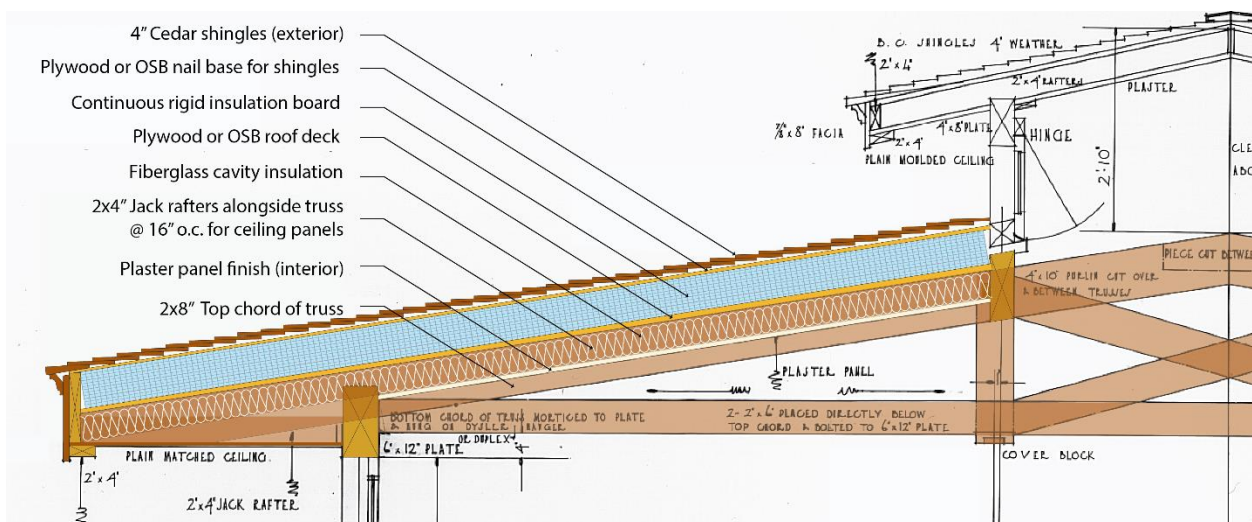
**Figure 41 Compact unvented roof assembly using fiberglass cavity insulation and continuous rigid insulation above roof deck [69].**

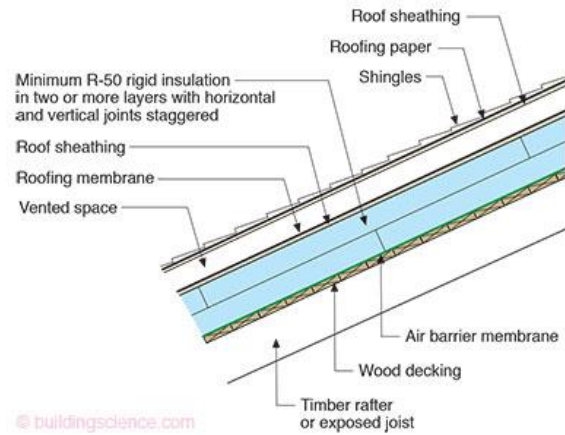
Figure 44 The unvented “under-roof” is topped with a vented “over-roof” to control ice-damming [70].

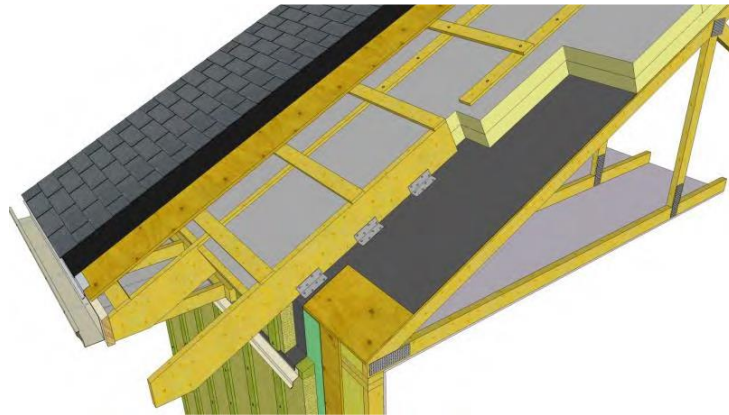
Figure 45 Pitched roof assembly with unvented “under-roof” is topped with a vented “over-roof” [62].

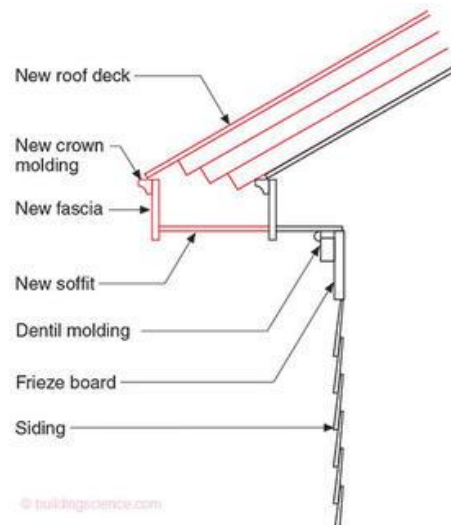
Figure 46 Pitched roof assembly showing the impact of the layers of insulation on the aesthetics of the roof edges [70].

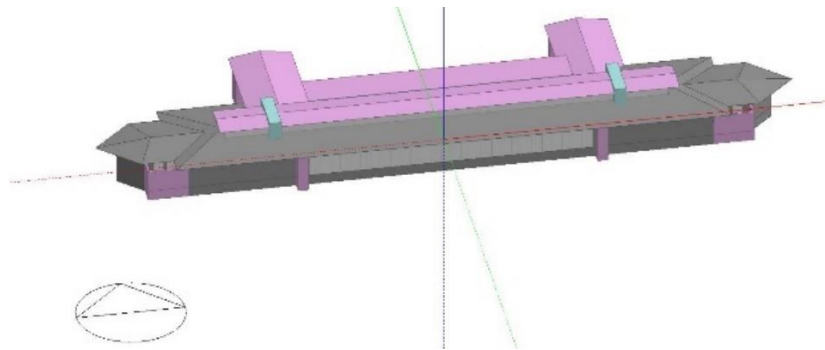
**Figure 47 A 3D model of the Banff Pavilion original design which serves as trade-off proposed building.**

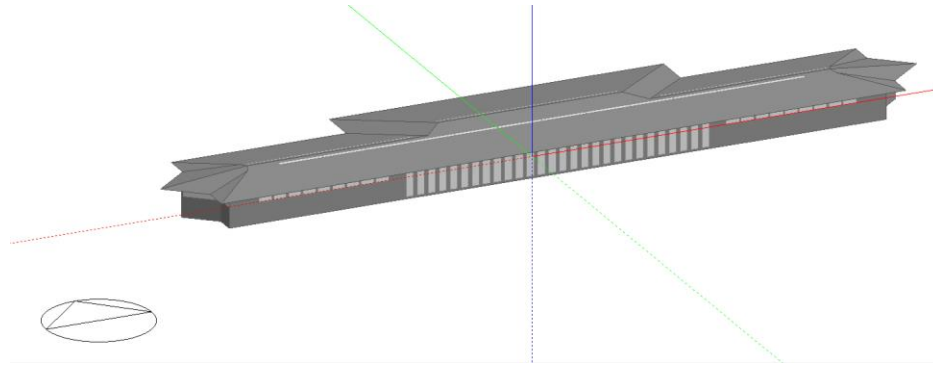
**Figure 48 The 3D model of the Banff Pavilion original design after dimensions simplifications.**

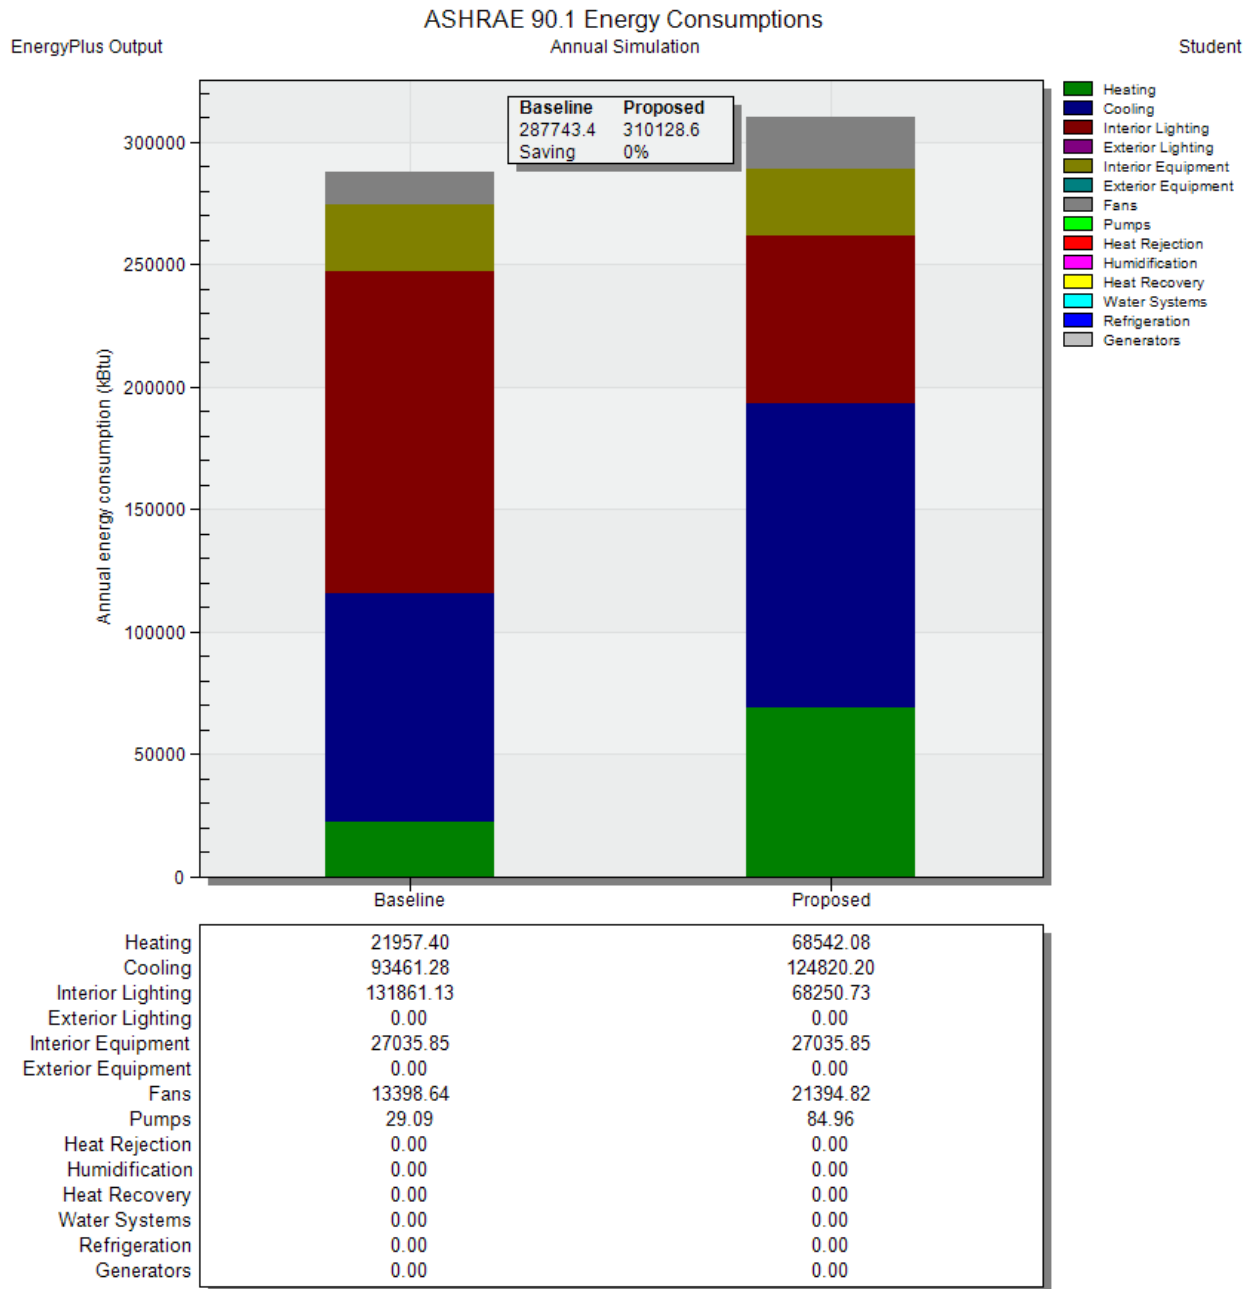
Figure 49 Energy consumption output for baseline and proposed building.

First, the results of the simulation (Figure 49) have shown that the *Total Annual Energy Consumption* of the baseline building is 284,615.53 kBtu compared to 310,128.64 kBtu for the proposed building, which represents a 9% difference that deems the proposed design not compliant. The *Energy Per Total Building Area* is at 45.09 kBtu/ft<sup>2</sup> for the Proposed Building compared to 41.38 kBtu/ft<sup>2</sup> for the baseline building. The missing insulation and the single glazing in the wall and roof assemblies for the proposed building explain the difference in performance. The next step is to upgrade the proposed building envelope design to compensate for the excess energy consumption compared to the baseline building.

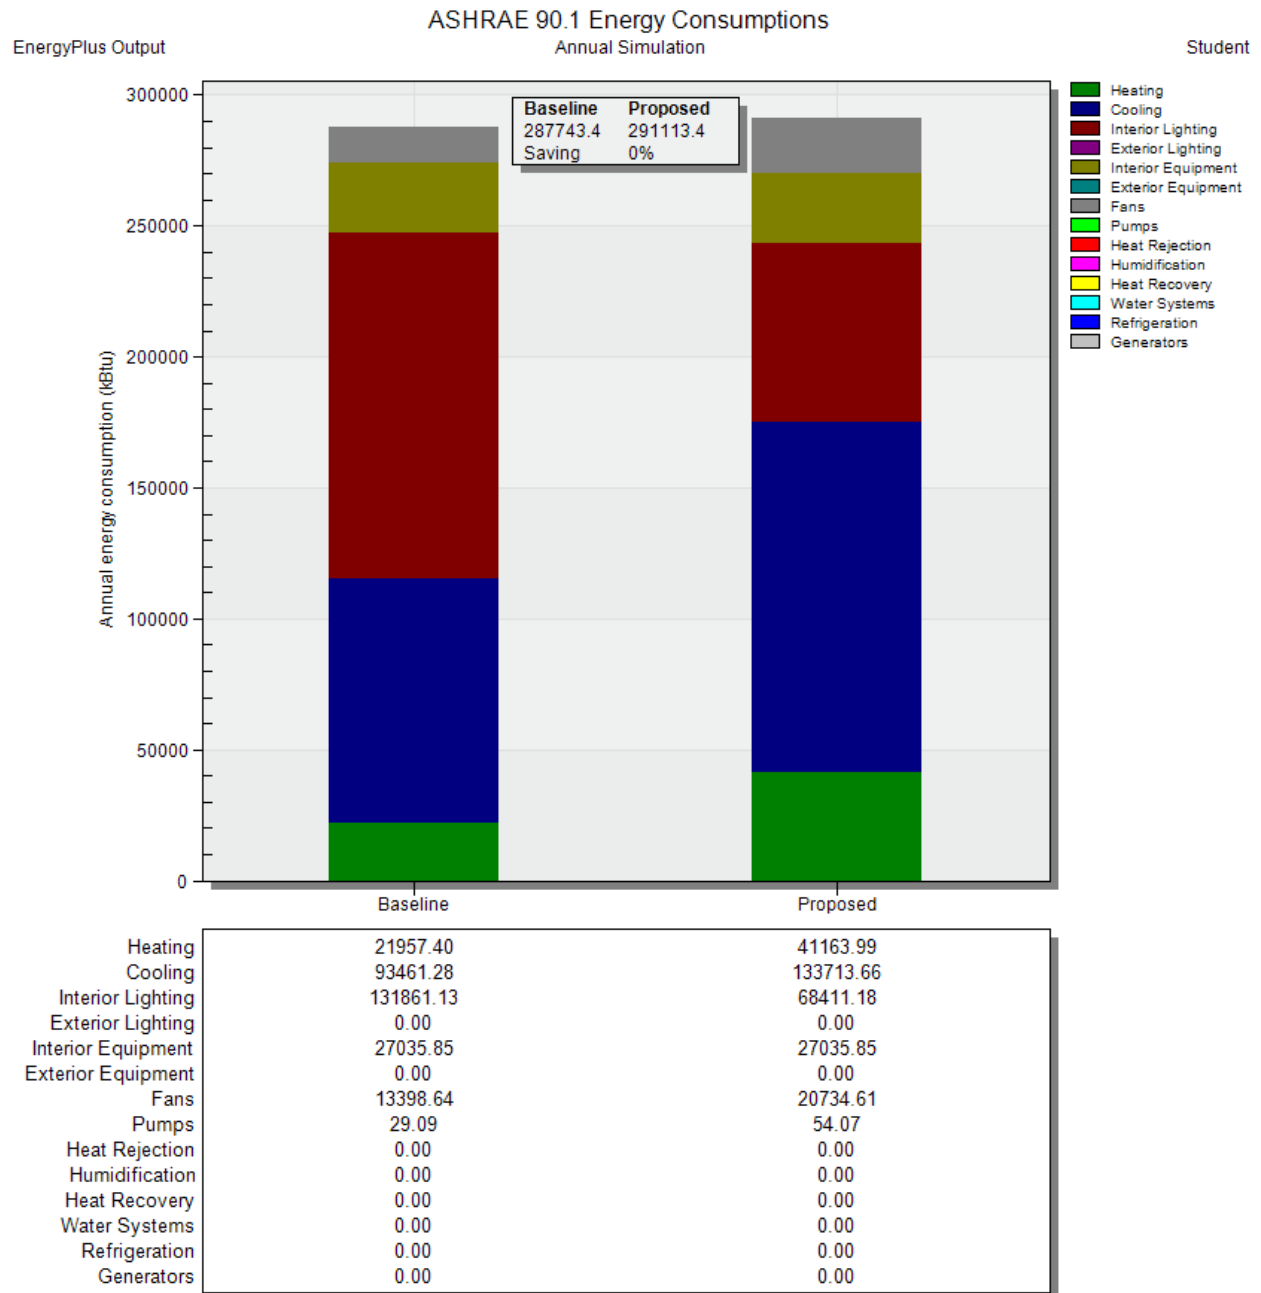
Figure 50 Energy consumption output for baseline and the upgraded proposed building.
