# **Structural Repair on a Composite Aircraft Fuselage Damaged by Fire**

**A Report**

In partial fulfillment of the requirements for the degree of  
Master of Engineering  
In the Program of  
Aerospace Engineering

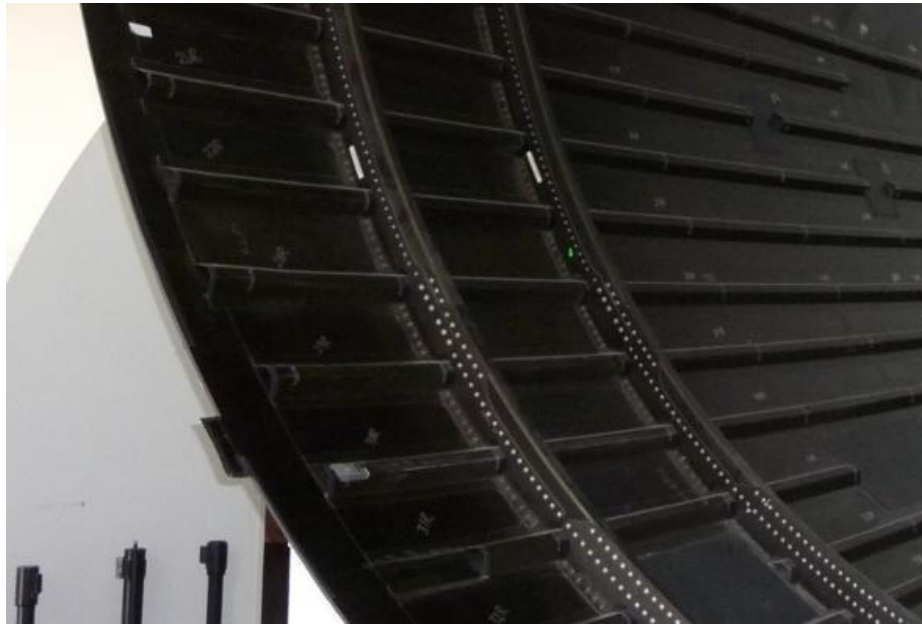
**Figure 1 - Cross Section of the 787 Fuselage Skin with the Longeron "Mesh" and the Small Ribs[8]**

The other problem with having damage on a large portion of an aircraft fuselage is the replacement of the damaged section. For the purpose of this report the damaged section analyzed will be a large section from the tail section of a automated tape layered composite fuselage structure, similar to that of the Boeing 787 [6]. This structure utilizes a composite grid stiffened automated tape layered composite skin that is reinforced with titanium ribs; see Figure 1 [7].

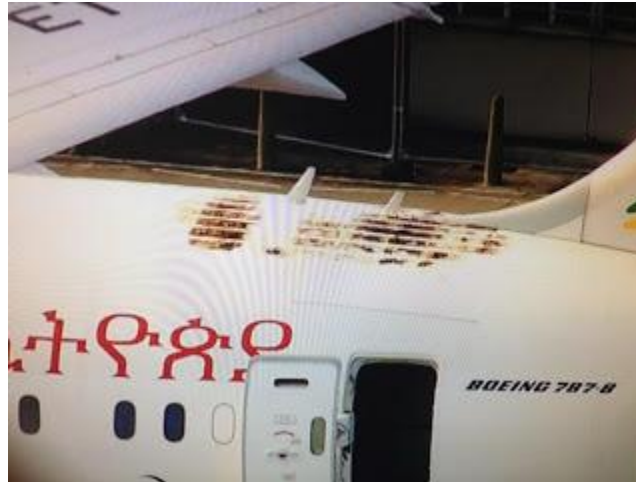
**Figure 2 - Visible Damage on the 787 Fuselage[11]**

For this report, the repair of a similar sized damaged section of composite fuselage will be examined. The location of the damage will also be similar to the real world example. The damaged area is located at the top of the tail section, starting at the tip of the tail and extending forward. For a visual example of this damage see Figure 2.

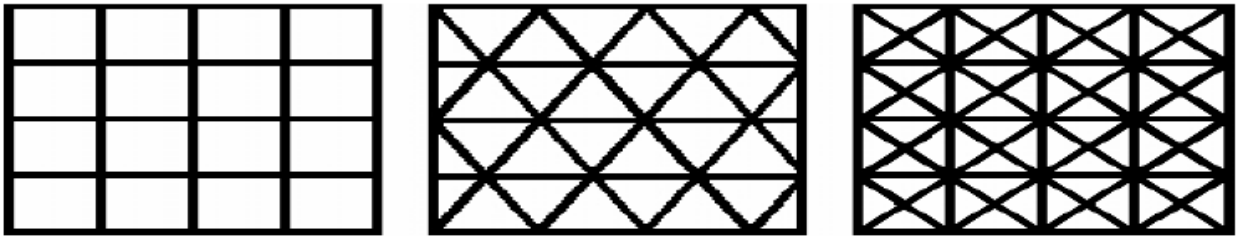
**Figure 3 - Typical Stiffener Arrangements for GSCS [15]**

A grid stiffened composite structure or GSCS, is any structure that is reinforced by a series of longitudinal and lateral stiffeners that are made out of any type of fiber reinforced plastic composite. By doing this a lattice structure is created which is exceptional at resisting higher loads of bending and twisting moments. This design could incorporate anything from a simple crisscross pattern of stiffeners intersecting at  $90^{\circ}$  of each other, to a complex multilayered honeycomb structure. Generally however, a typical GSCS will consist of an outer shell, which in this case would be the aircraft skin, which will be supported by the grid of stiffeners underneath. These stiffeners would typically only run in 2 to 4 different directions which can be seen in Figure 3 [14].

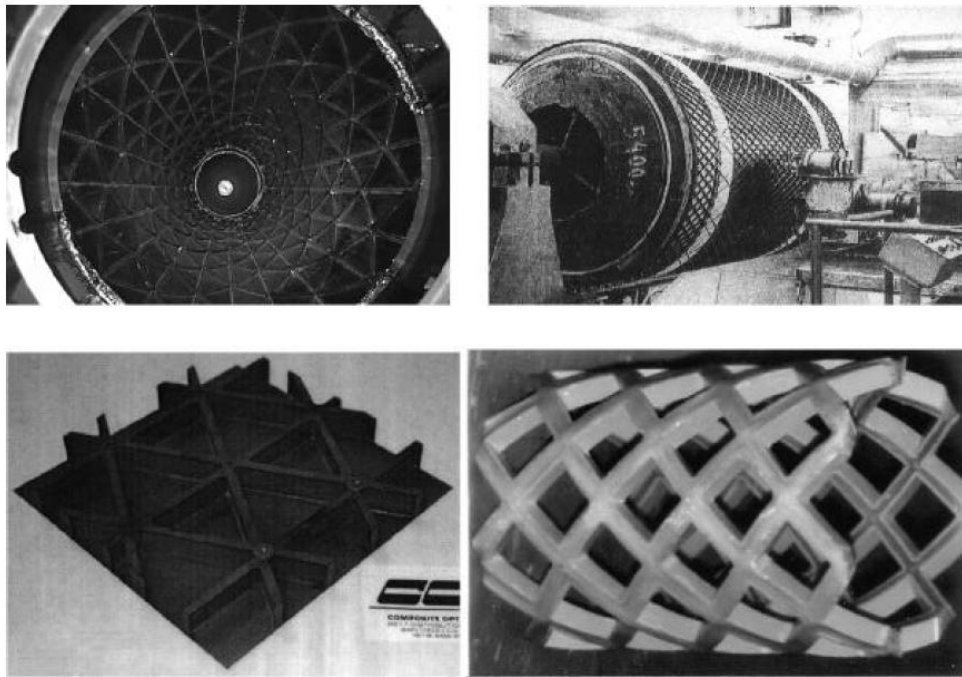
**Figure 4 - Examples of Grid GSCS [14]**

While a 2 directional grid is the most cost effective, a 4 directional grid has superior structural rigidity in more loading scenarios such as twisting moments. Figure 4 shows different examples of simple GSCS.

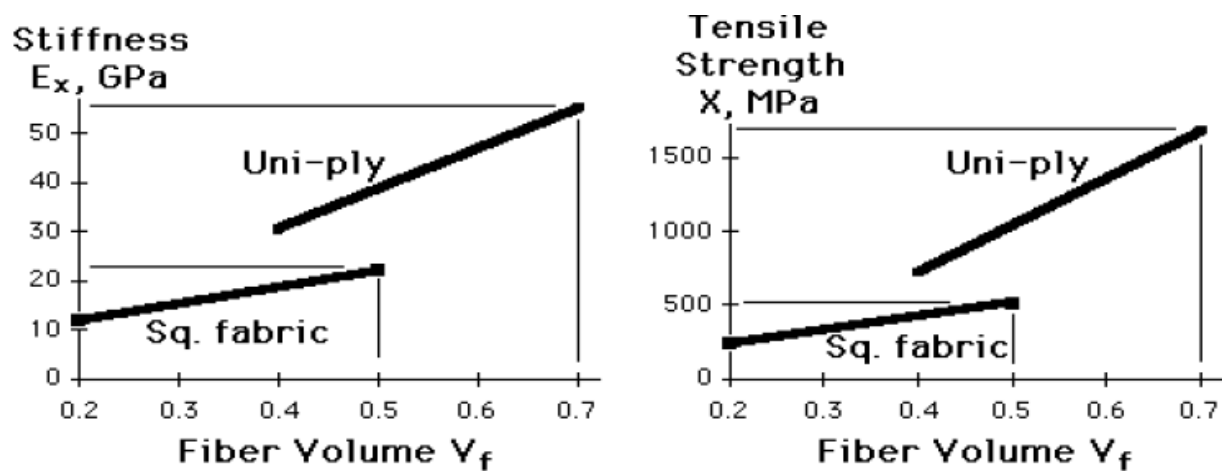
Figure 5 - Stiffness and Strength of Uni-plies Compared to Woven Fabrics[15]

panels. For example due to the material mismatch, laminated woven fabrics tend to be more susceptible to delaminating and micro-cracking when compared to uni-ply GSCS which is generally more robust in this case due to the uni-ply characteristic, as well as the damage mitigation inherent in the grid design. Once a crack has formed on the outer shell it is easily contained within the affected grid cell and is restricted from propagating further. This causes them to have lower impact and fatigue resistance. Additionally the GSCS tend to have higher flexural rigidity and are less susceptible to moisture incursion to their open nature which lends to better ventilation over sandwiched panels. The one drawback of the GSCS however is that the entire structure itself is much thicker than the multiply for the same amount of material [15]. Figure 5 compares the general material properties of stiffness and tensile strength of both the uni-ply and woven fabric composites.

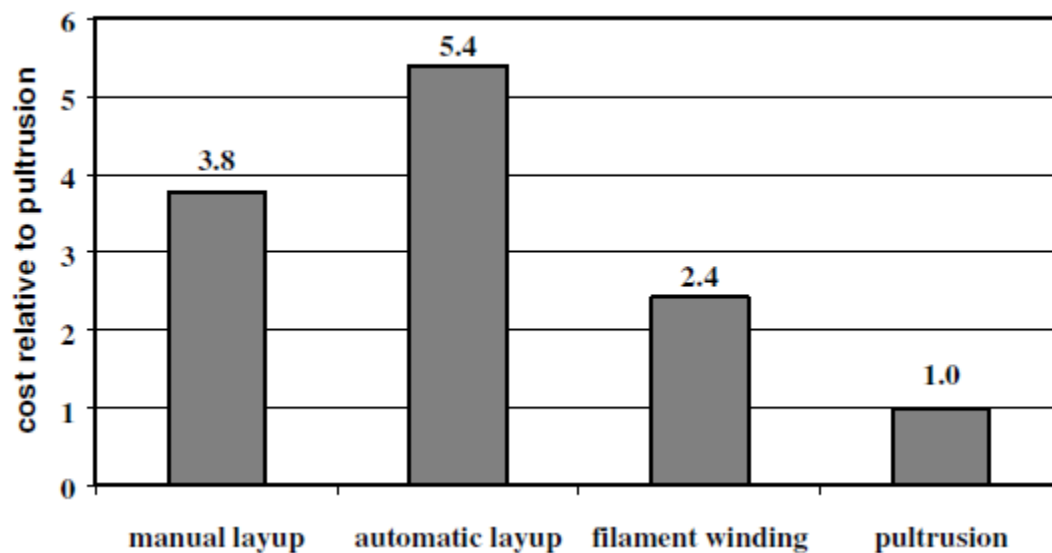
Figure 6 - Relative Cost of Different Layup Methods Compared to Pultrusion[15]

the automated low-cost manufacturing. This automated, single cure process is superior to the conventional skin construction consisting of stringer and skin sandwich bonding, which requires costly and time consuming hand layup operations. This benefit tends to be superior when constructing cylindrical or conical structures, which directly related to aircraft structures [14]. Ultimately an automated pultrusion method is seen as the most beneficial in terms of manufacturing as is the most cost effective. Figure 6 shows the comparison of the relative cost between pultrusion and other composite layup methods [15].

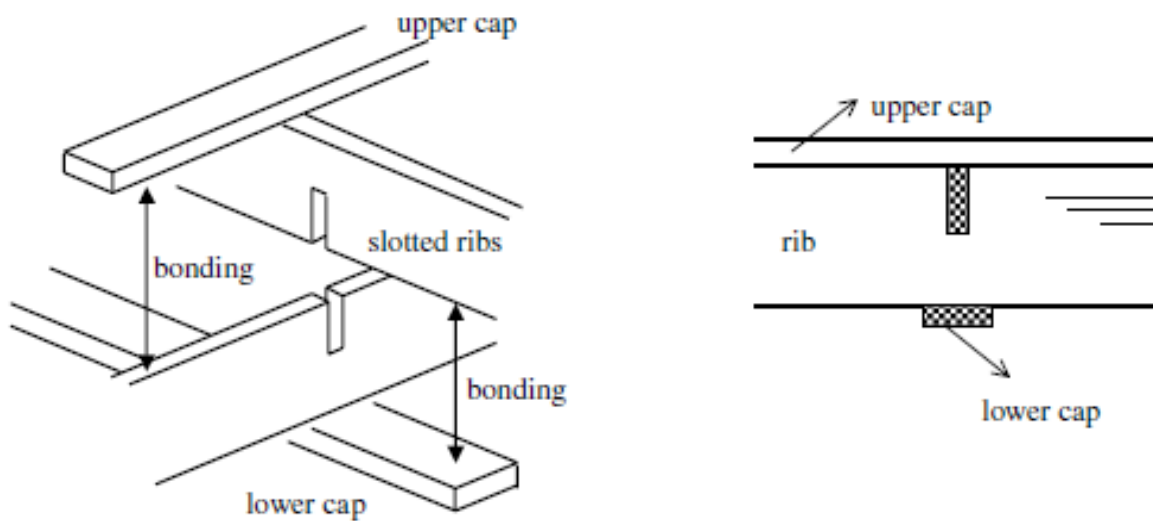
Figure 7 - Interlocking Composite Grid[15]

behavior [14]. Additionally, the method most used to connect intersection of the grids is an interlocking method, where notches are cut out of the stringers so they can fit together. The problem here is that at the node points where the reinforcements connect are weak points and need to be reinforced [15]. Figure 7 shows a simple example of the interlocking structure and cap reinforcements. Because of these drawbacks there have been little practical large scale applications to utilize this type of composite structure in full service.

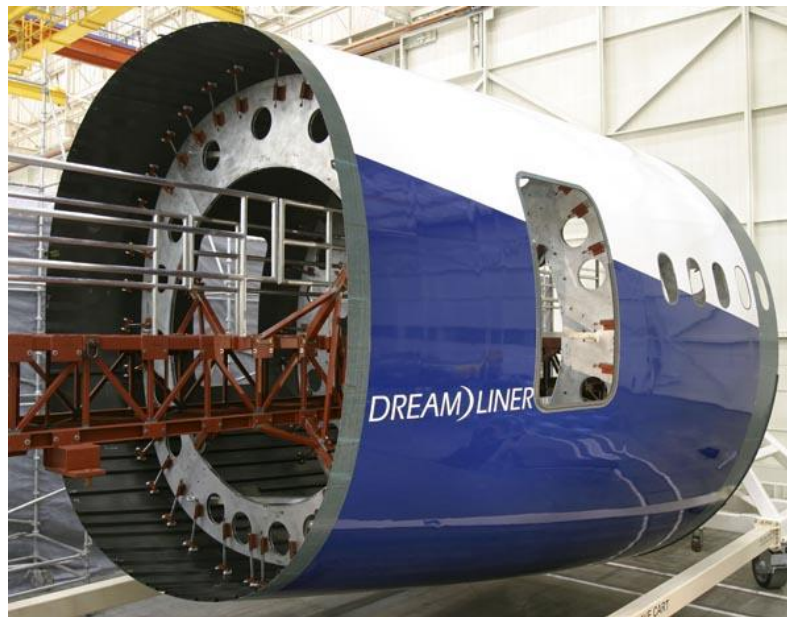
**Figure 8 - Supplementary Supports in the 787 [16]**

Additionally, as seen in Figure 8 the 787 is equipped with supplementary supports consisting of metal cross-members and metal ribs.

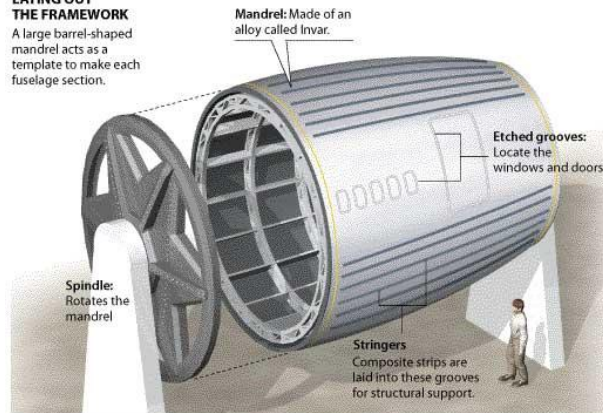
### LAYING OUT THE FRAMEWORK

A large barrel-shaped mandrel acts as a template to make each fuselage section.

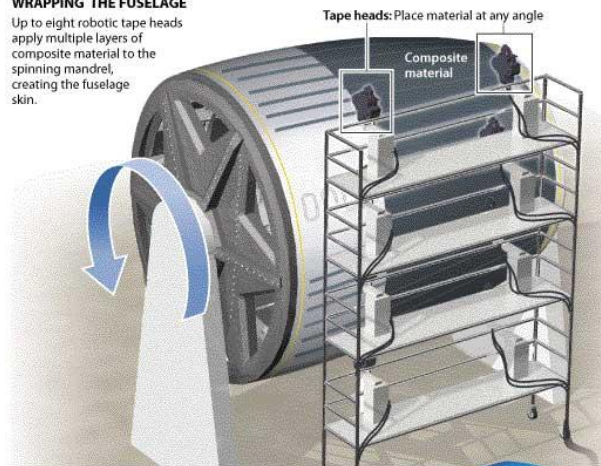
### WRAPPING THE FUSELAGE

Up to eight robotic tape heads apply multiple layers of composite material to the spinning mandrel, creating the fuselage skin.

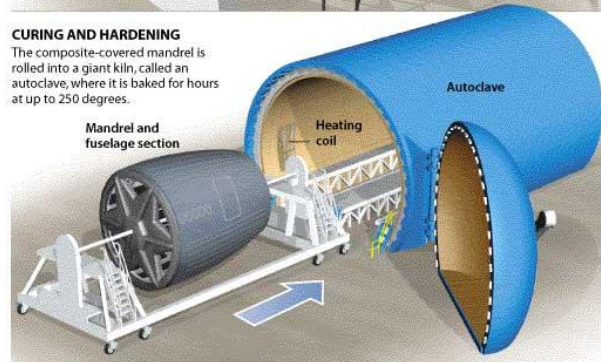
### CURING AND HARDENING

The composite-covered mandrel is rolled into a giant kiln, called an autoclave, where it is baked for hours at up to 250 degrees.

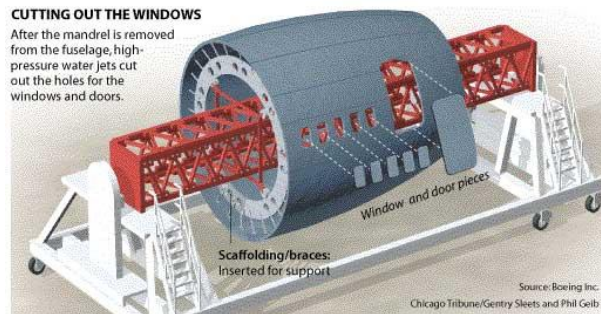
### CUTTING OUT THE WINDOWS

After the mandrel is removed from the fuselage, high-pressure water jets cut out the holes for the windows and doors.

Figure 9 – Tape-Laying Process [22]

The 787 utilizes a continuous carbon fiber reinforced polymer structure in its main fuselage design, and Boeing has been researching both GSCS and ATL for over a decade [21]. Based on this research Boeing utilizes a type of filament winding called robotic automated tape-laying on its fuselage structures [9]. ATL is very similar to filament winding in that both process involve protruding continuous fibers that are pre-impregnated with epoxy over a mandrel or shape and then will need to be cured in a curing oven. This will result in a similar structure with similar physical attributes as filament winding. ATL is much more complex than filament winding however, as there can be several printing heads used to protrude several strands at the same time resulting in a tape laying process. Using this method much more complex geometries can be constructed with more accuracy and complexity in fiber orientation as well. Using this process it is also not necessary to construct only cylindrical structures. Since each “spindle” essentially prints the material onto the surface, non continuous mandrels, such as a complete round cylinders or barrels, can be used to print on. This opens up countless possibilities where this fully automated process can very accurately print a complete composite structure. This process can also be relatively quicker than filament winding [17]. Figure 9 describes the specific process Boeing takes to manufacture the 787 fuselage using the tape laying method.

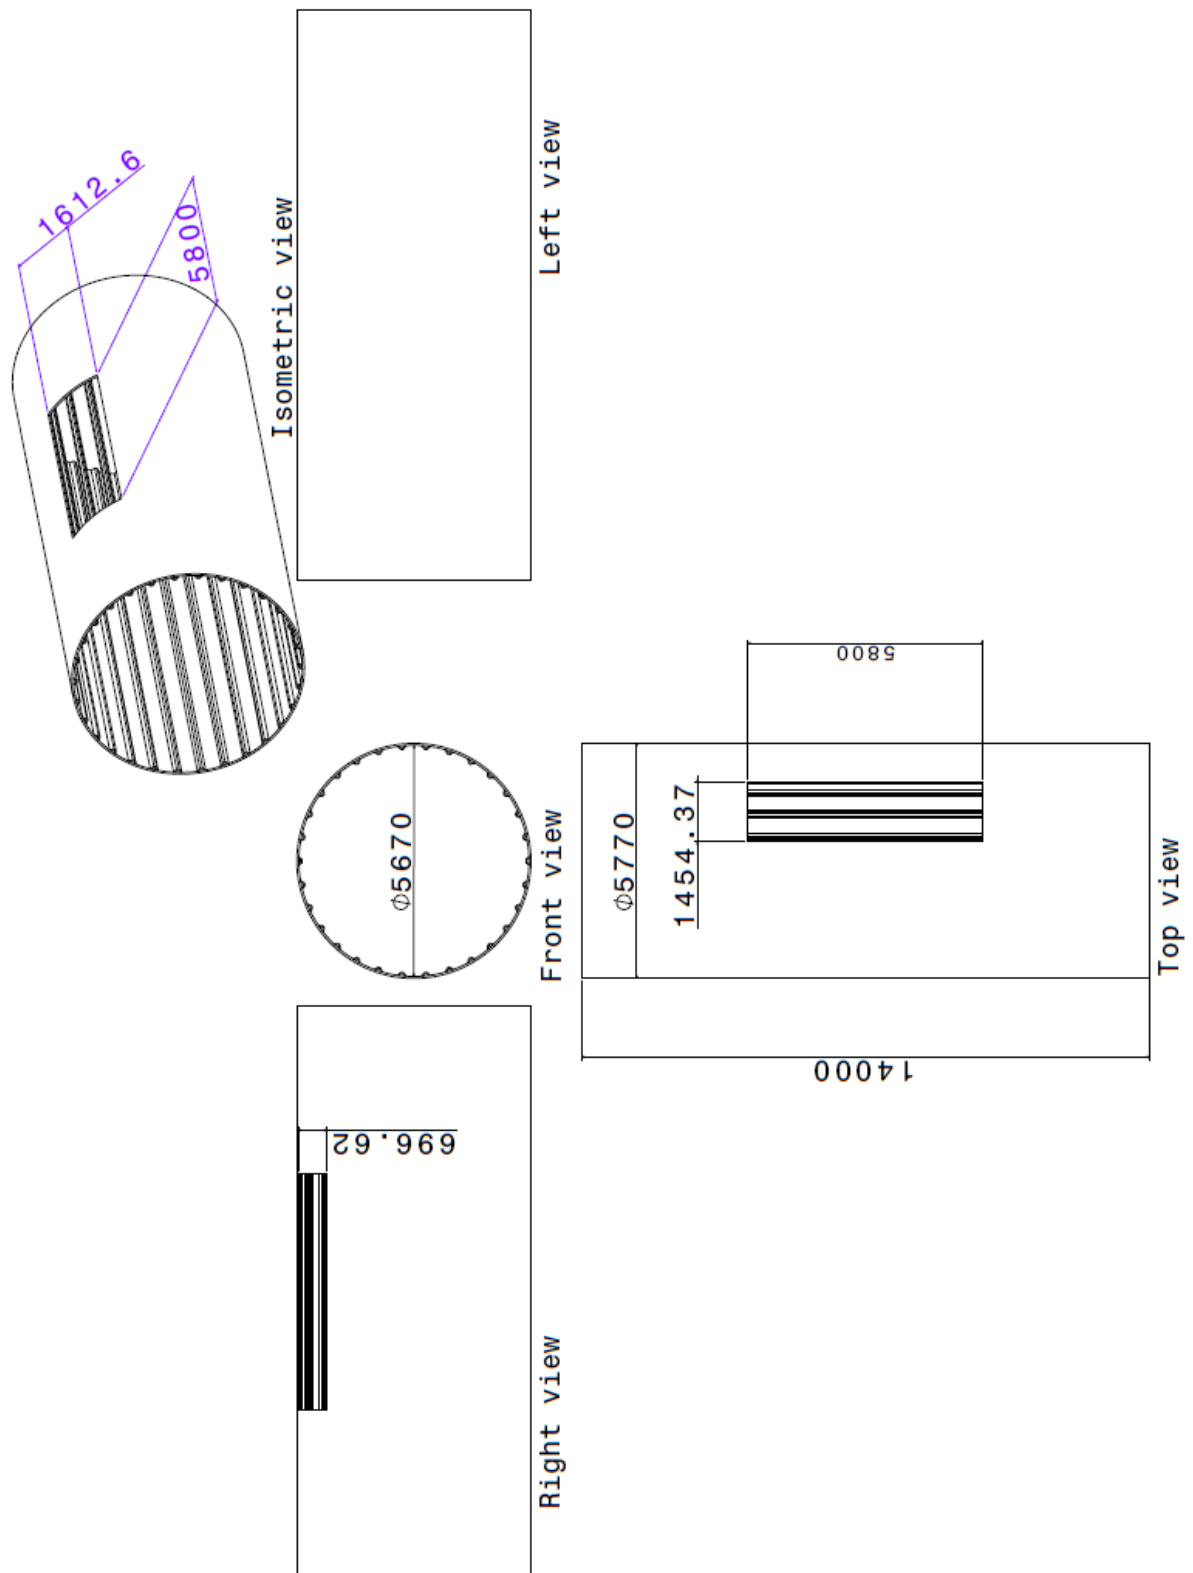
Figure 10 - Dimensions of the Damaged Fuselage Section (mm)

In order to further explore these two system concepts, two models were created in CATIA V5. Due to the lack of available knowledge of the material or the dimensions of the fuselage structure some assumptions were made. Firstly the design itself is roughly the size and shape of the 787 main fuselage barrel, complete with stringers that run the length of the cylinder. While the radius and length are accurate to the real world fuselage dimensions the stringers themselves are not; this was done to simplify the analysis and create an “over engineered” version of the model due to the unknowns. Secondly the material was chosen to be the stock epoxy that is in the CATIA database, which has a density of  $1300 \text{ kg/m}^3$ , a Poisson ratio of 0.37 and a Young modulus of  $3\text{E}^9 \text{ N/m}^2$ . Thus the stress analysis performed was merely performed to show visually what the concepts could potentially look like and the stress concentrations on them. Figure 10 shows the dimensions of the designed fuselage barrel and damaged section. For simplicity the design consists of a cylindrical fuselage section, where the damaged section on the top port side of the aircraft is already cut out.

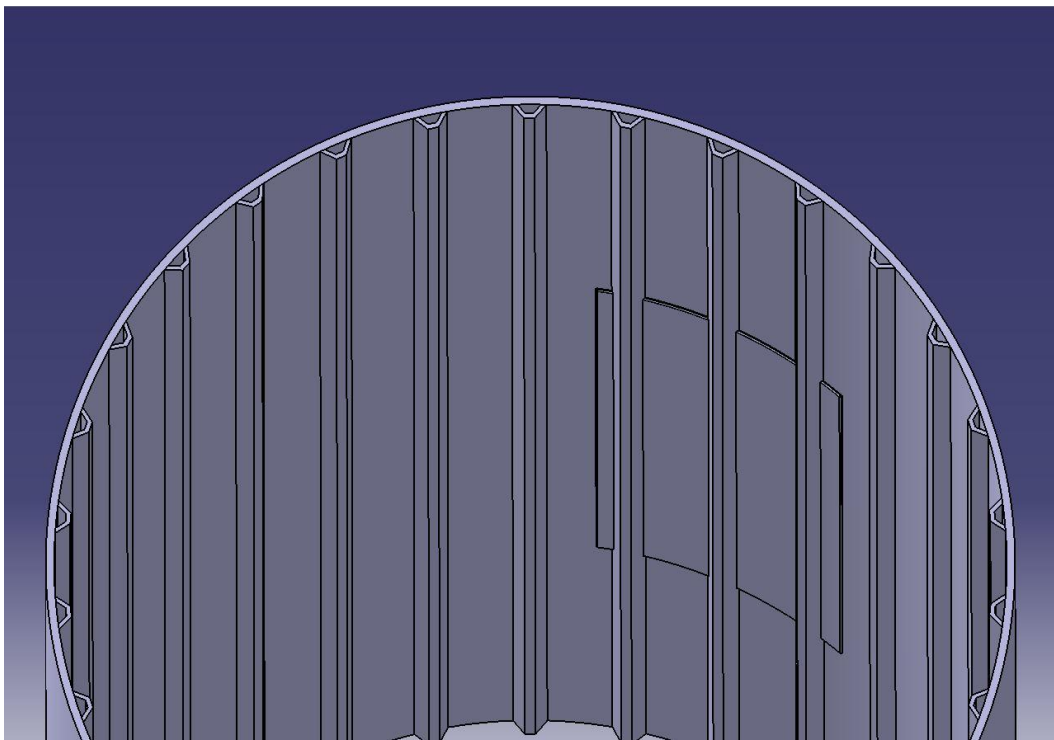
**Figure 11 - Interior of the Fuselage Barrel Section Showing the Bonded Patch**

The system concepts consisted of other assumptions for simplicity and due to lack of available knowledge surrounding the practical and virtual analysis process of repairing such a large scale composite structure. For the bonded permanent repair the model consisted of a larger patch of material to cover the damaged area. This was done to represent the extra material required to safely restore the damaged section to the original strength, and even make it stronger due to the unknowns of bonded repair on this large of a scale. Figure 11 and Figure 12 show the dimensions of the bonded patch geometry.

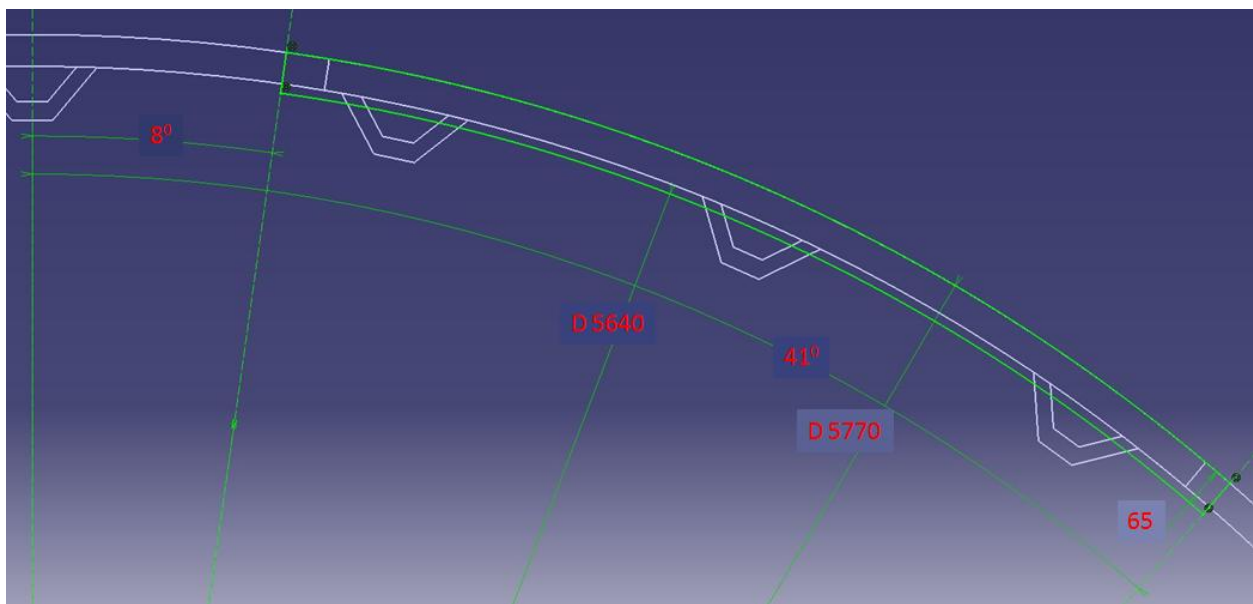
**Figure 12 - Dimensions for the Bonded Patch (mm)**

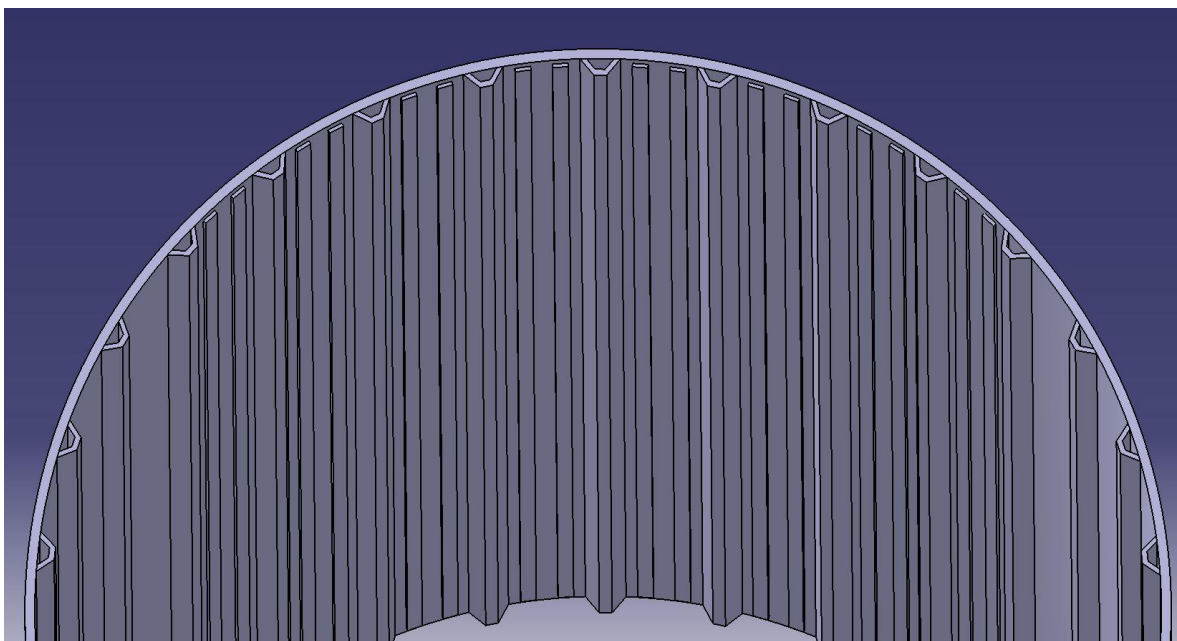
**Figure 13 - Fuselage Barrel Interior with the Additional Stringers on the Bolted Repair**

The bolted repair consisted of a lighter weight patch where the damaged section was and additional stringers on the interior dorsal section of the fuselage for added strength and rigidity. Figure 13 and Figure 14 show the dimensions and geometry of the stringers used to reinforce the bolted repair.

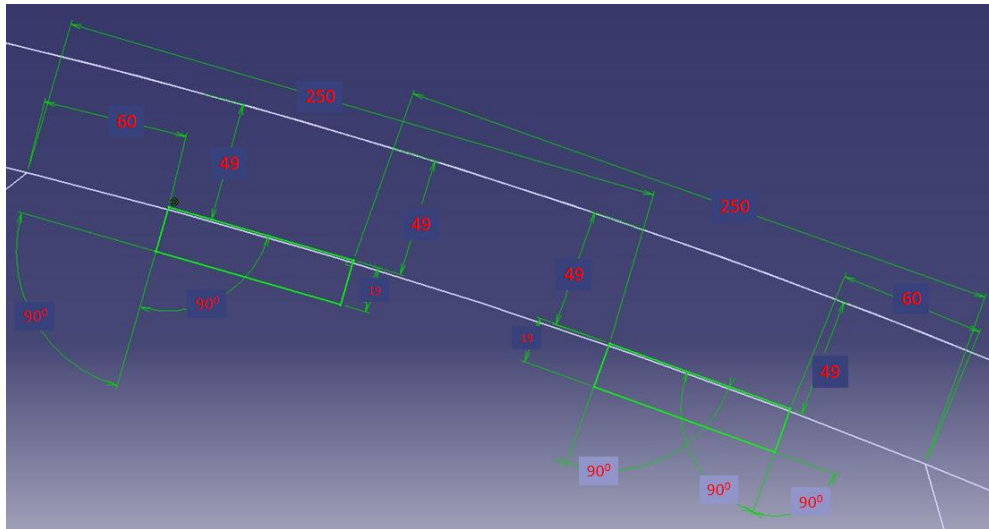
**Figure 14 - Dimensions for the Additional Stringers (mm)**

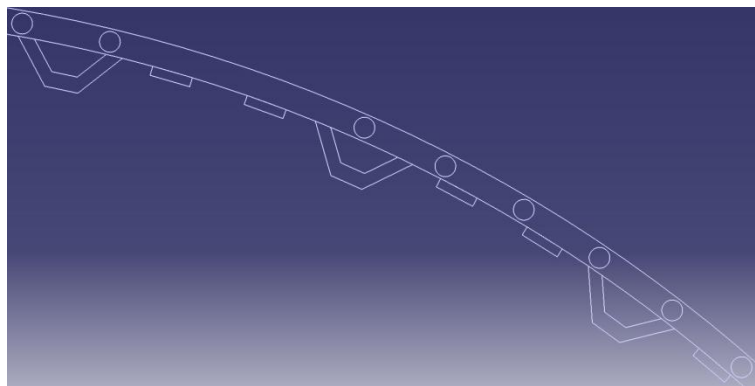
**Figure 15 – Holes used to Lighten and Weaken the Bolted Patch Repair**

Figure 15 shows the holes implemented into the bolted patch to more accurately represent lighter, less robust patch applied in this scenario, compared to the bonded scenario where an ATL patch is used.

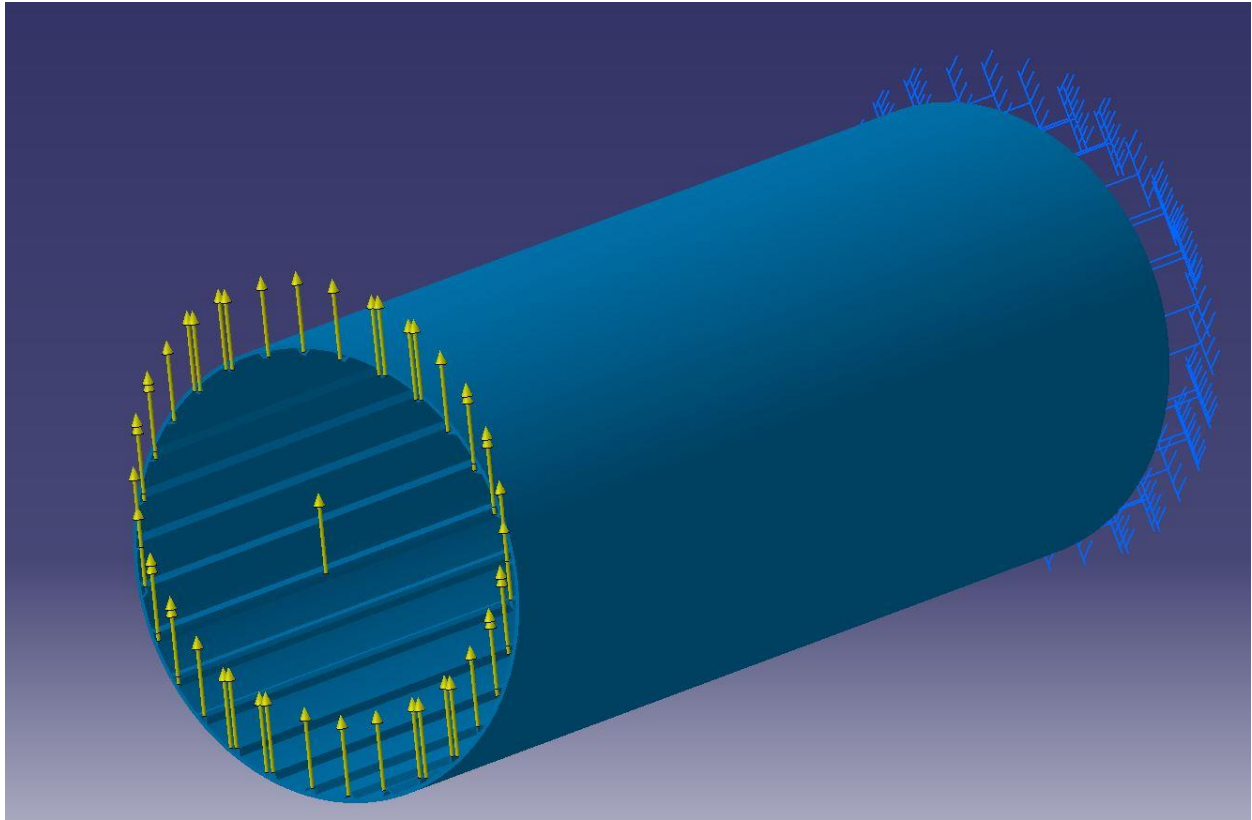
**Figure 16 – Stress Analysis Loading Conditions**

The finite element stress analysis was completed in CATIA V5. The loading condition consisted of clamping one end of the fuselage cylinder and applying a load of 600kN to the other. This represents a real world loading case scenario that the aircraft could experience [30]. Figure 16 shows the boundary conditions of the stress analysis model.

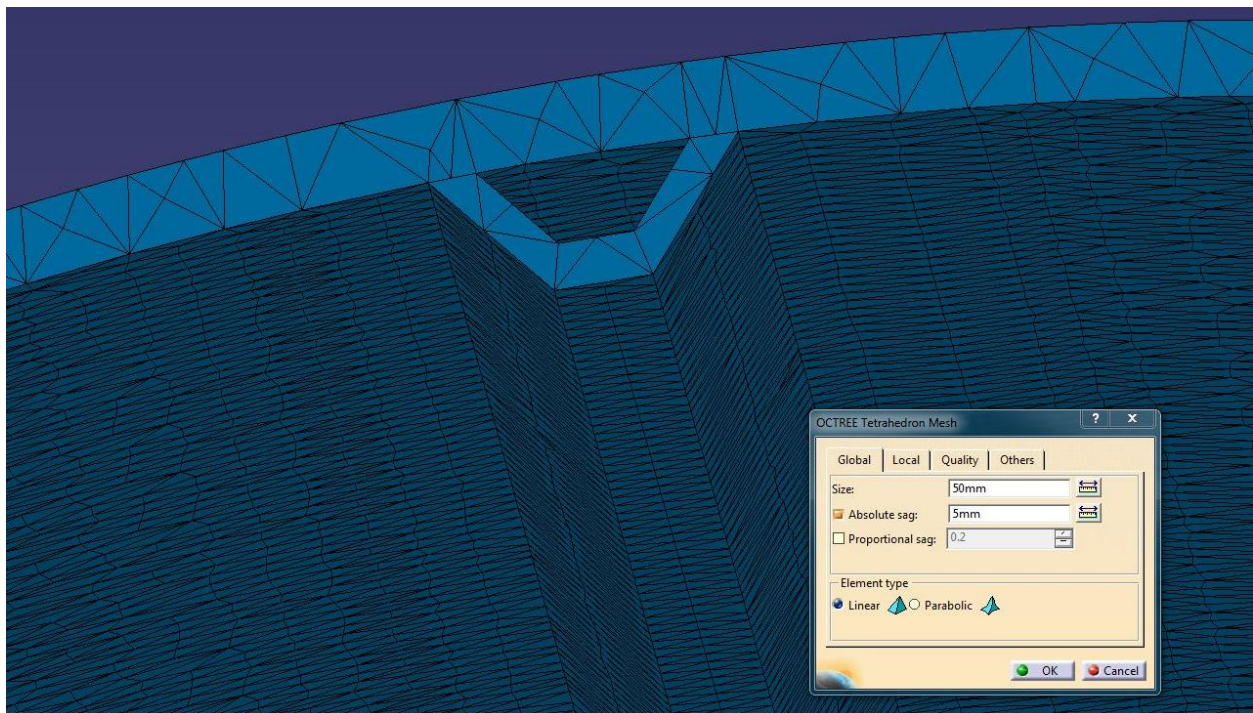
**Figure 17 – Finite Element Mesh**

While the model and loading conditions are simplified this was done solely due to lack of available knowledge regarding the composite material, shape of the fuselage and the loading the aircraft experiences. All of the different models where loaded exactly the same way. Similarly all of the test models were meshed the same way in CATIA. Figure 17 shows a close up view of the mesh on one of the stringers as well as the main properties of the mesh which are that a linear OCTREE tetrahedron mesh was used with a mesh size of 50 mm and an absolute sag of 5 mm. Table 2 displays the additional information about the mesh used for analysis.

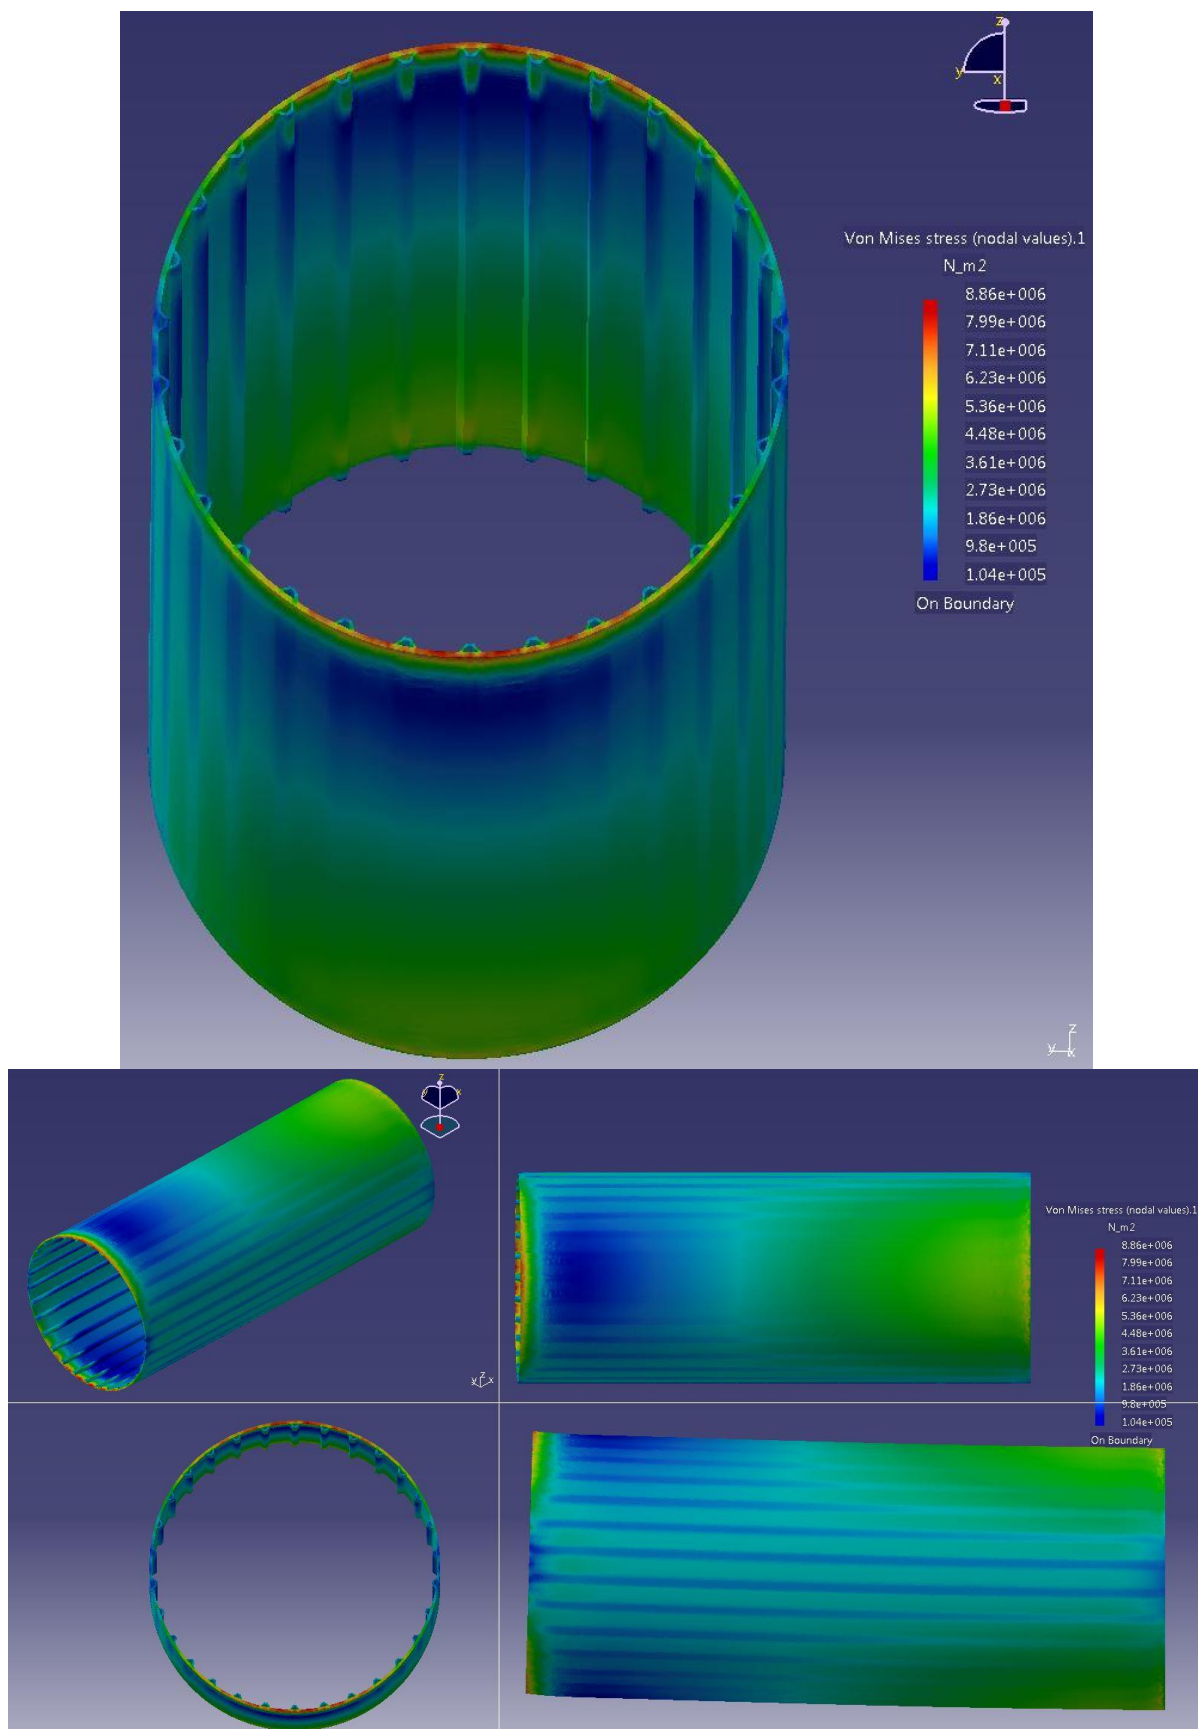
Once the analysis was completed, the results were documented in the following figures. These results are not meant to act as direct comparisons or designs for real world scenarios, but rather proof of concepts for stress concentrations and design principles. Firstly the undamaged stock section was tested; it will be known as the “clean” configuration. Figure 18 shows the Von-Mises stress values, as well as the stress concentrations and the deformation of the fuselage section.

As expected the highest points of stress are where at the point where the force was applied, as well as the top and bottom of the barrel at the two ends. Figure 19 shows the damaged fuselage barrel stress analysis, showcasing the high levels of stress concentrated on the corners of the damaged section, as well as the high degree of deformation throughout.

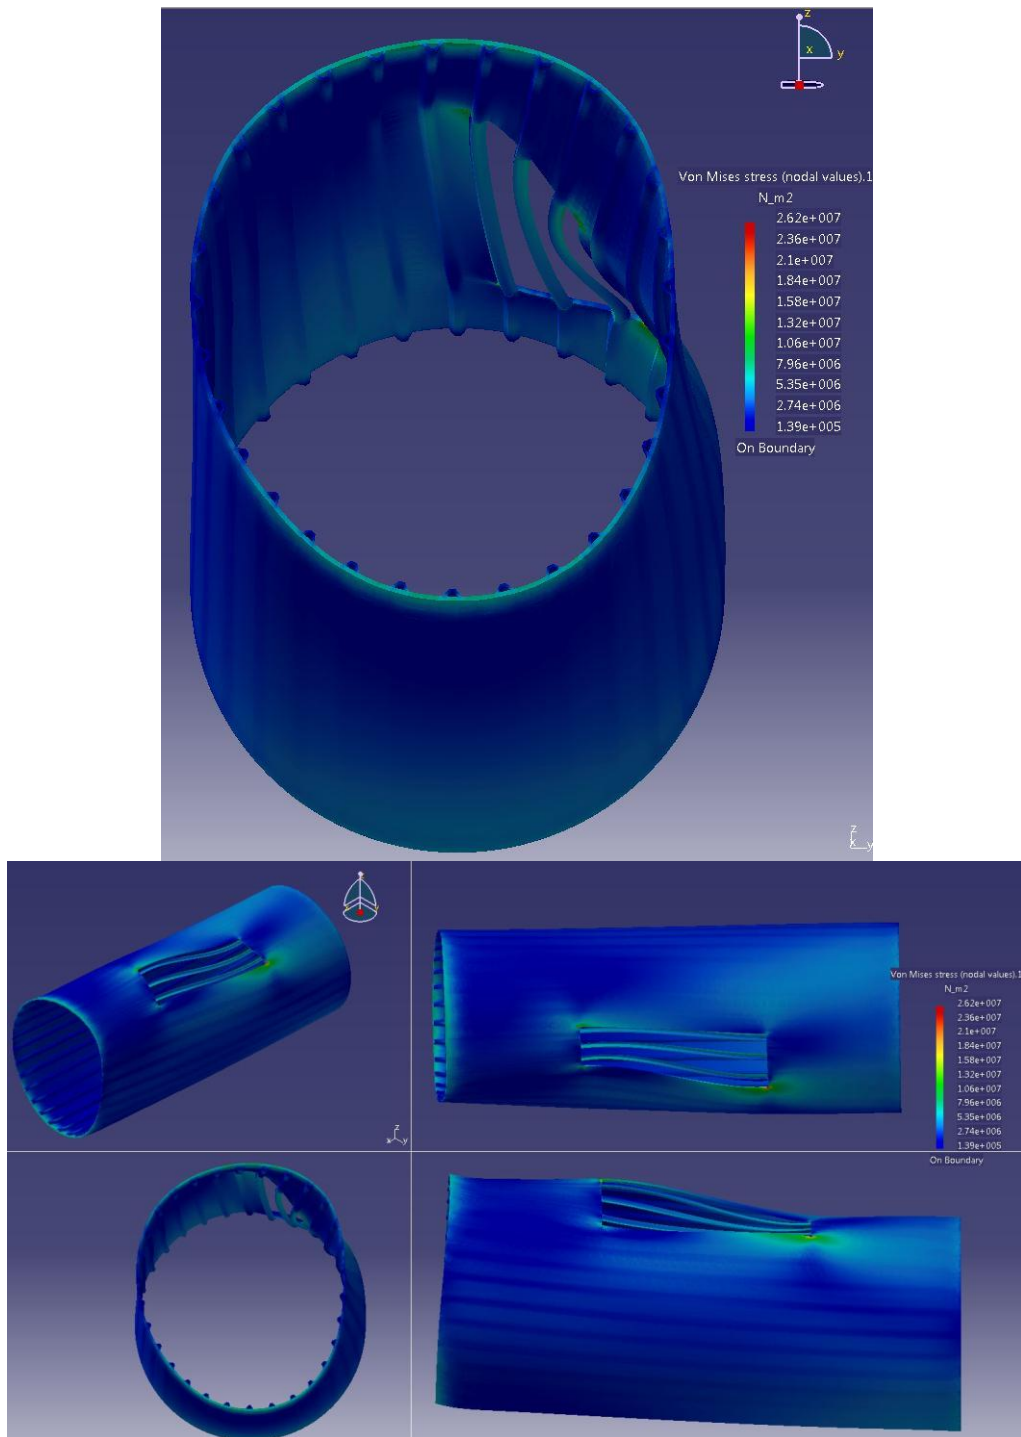
Figure 19 - Damaged Configuration Stress Analysis

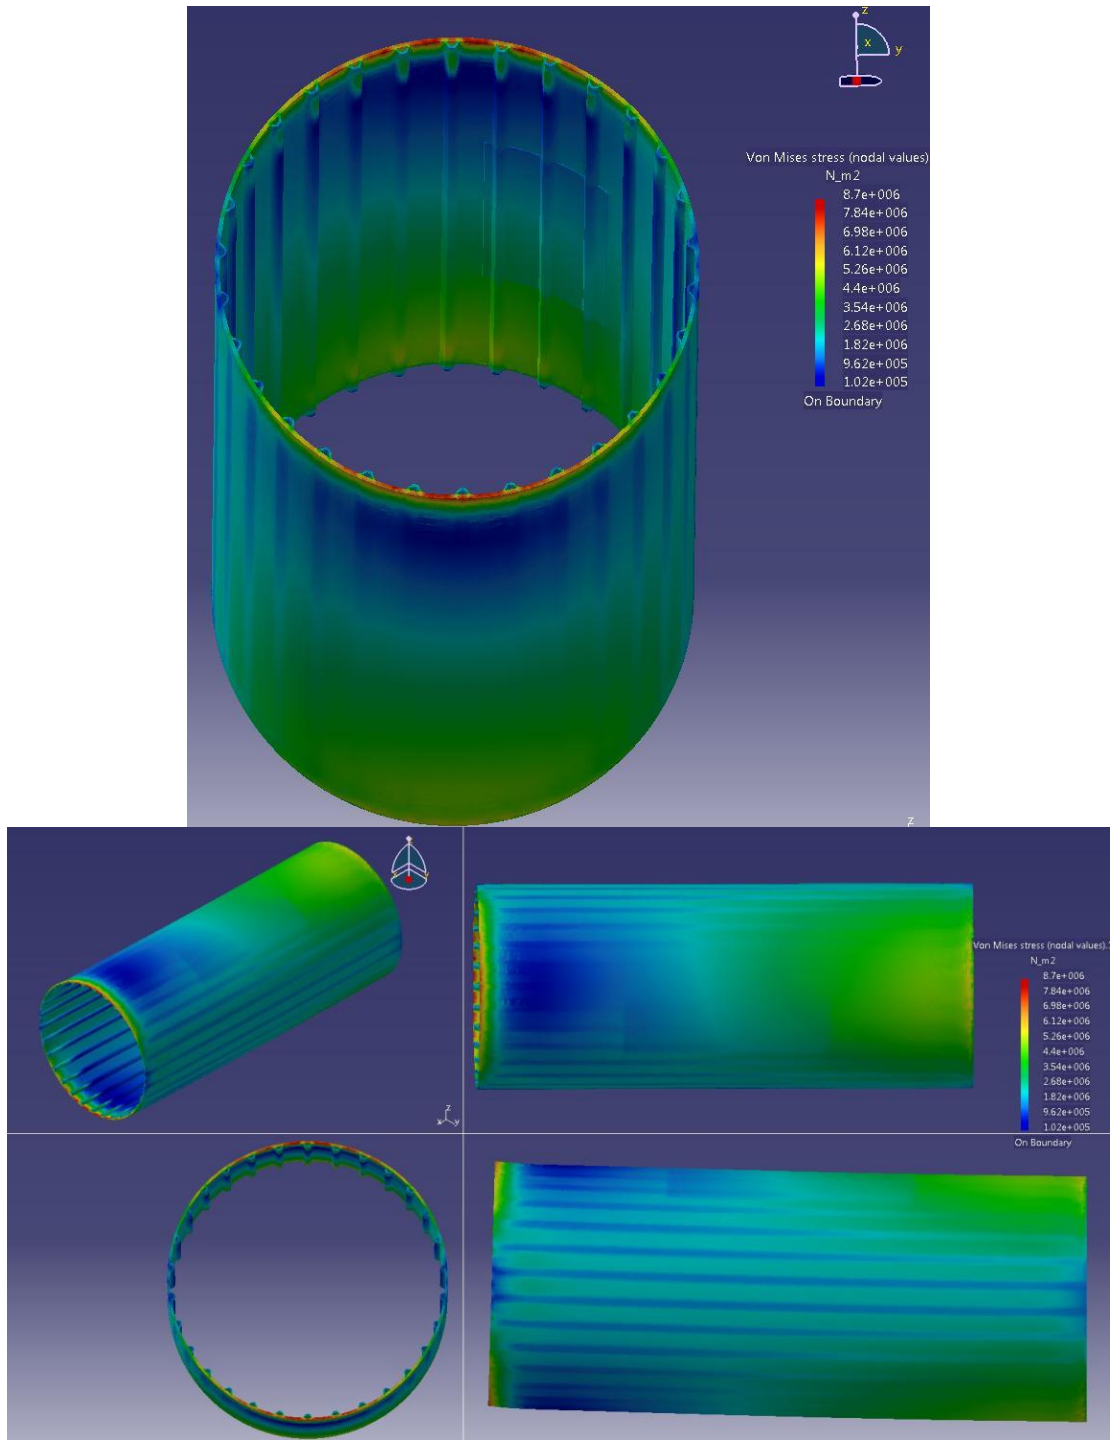
Figure 20 - Bonded Configuration Stress Analysis

Figure 20 shows the stress analysis for the bonded configuration. Here it can be seen that the stress distribution very closely resembles that of the clean configuration, however there are slight differences. For example the maximum Von-Mises stress has decreased from  $8.86\text{E}^6$  to  $8.70\text{E}^6 \text{ N/m}^2$ , and there is a slight reduction in stress in the around the patch itself.

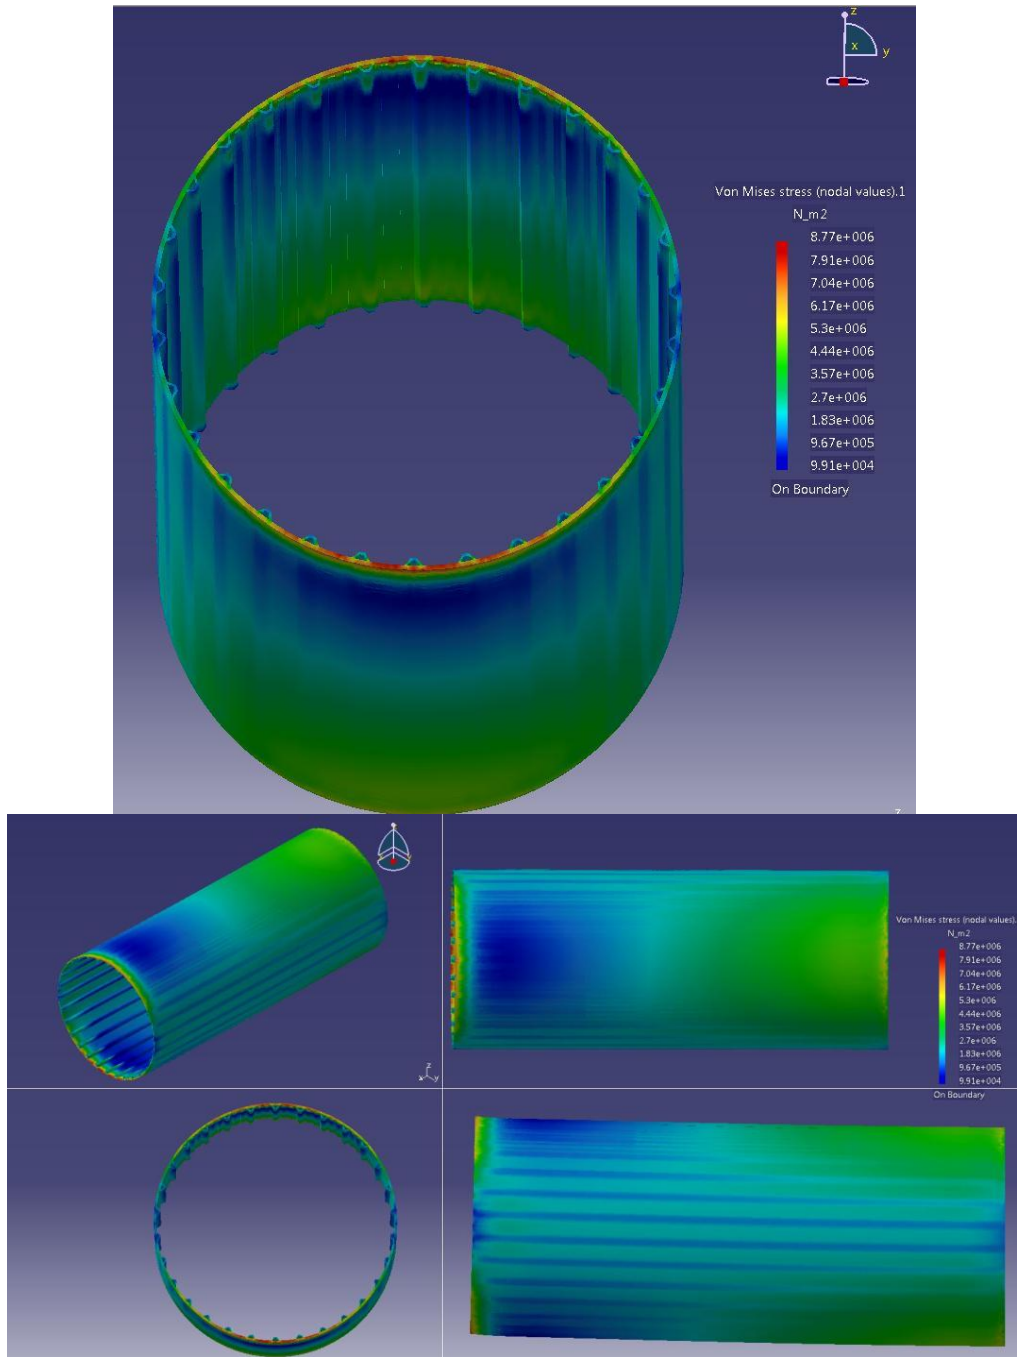
**Figure 21 - Bolted Configuration Stress Analysis**

Figure 21 shows the stress analysis for the bolted repair. On this model it can be seen that while the maximum stress is less than the clean configuration, it is still slightly higher than the bonded repair at  $8.77\text{E}^6 \text{ N/m}^2$ . From all of the tests on all of these models it can be seen that both patch methods are effective at restoring the structural strength to be stronger than the original.
